# Lowell Park

## Town of Barnstable ADA Transition Plan

September 2021

Institute for Human Centered Design

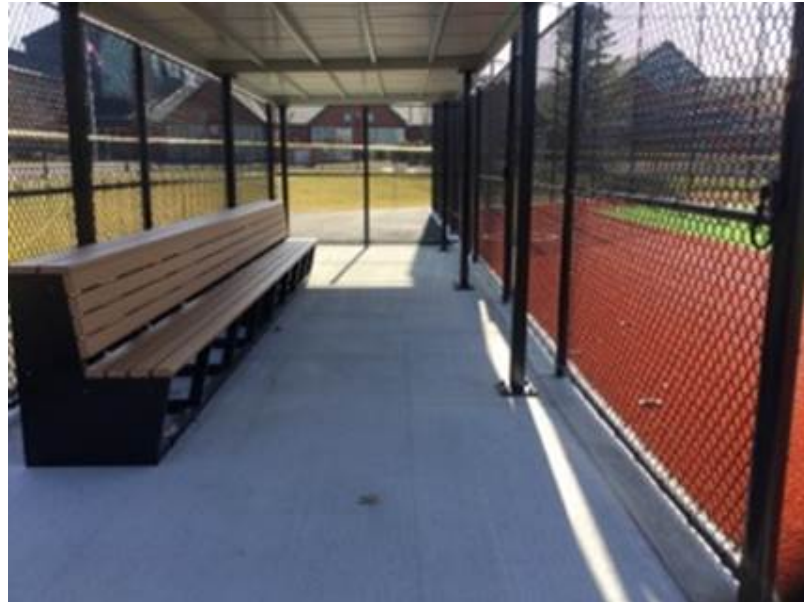
**Image 1:** Example of an accessible dugout including team seating with clear floor space.

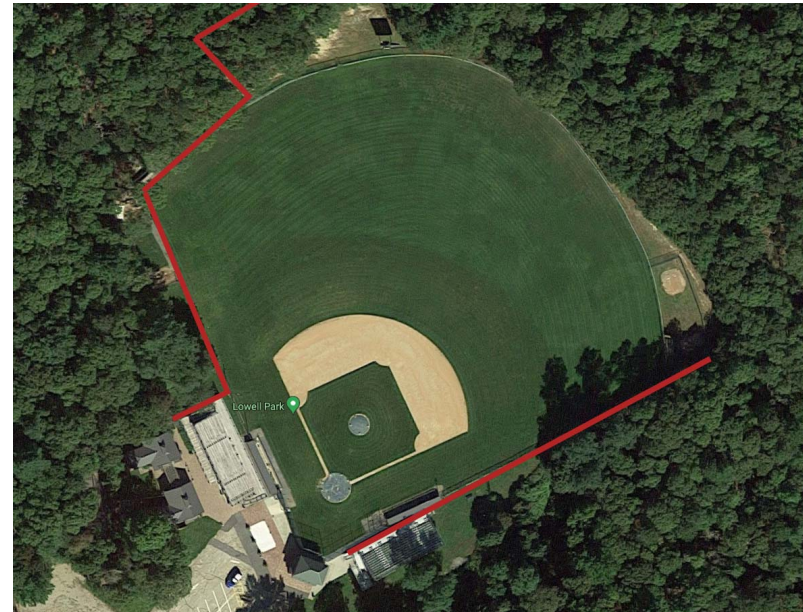
**Image 2:** Red lines show the approximate location of a path providing suggested accessible routes to the boundary of sport activity, player and spectator seating and practice areas.

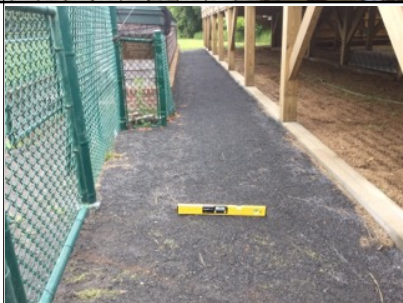
Cross slope > 1:50 (2.00%)	8%	Reduce cross slope to be no steeper than 1:50 (2.00%).  (Cost provided in ID #3.)	1	-	\$0
3	Path to West Side Bleachers	Ext.		Exterior Access Route	Sidewalk

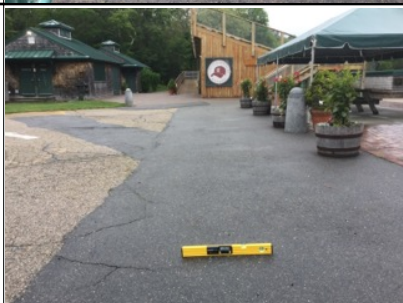
Cross slope > 1:50 (2.00%)	5.4%	Reduce cross slope to be no steeper than 1:50 (2.00%).  (Cost based on a 4' by 4' asphalt patch.)	1	160	\$160
4	Path to Practice Field	Ext.		Exterior Access Route	Exterior

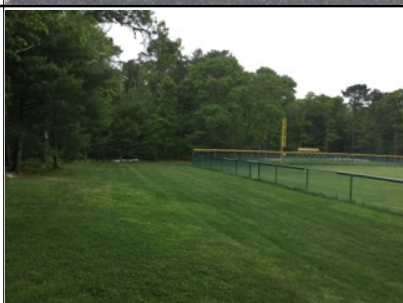
Cross slope > 1:50 (2.00%) Accessible route not provided	10.4% -	Reduce cross slope to be no steeper than 1:50 (2.00%). Ensure an accessible route is provided to all practice fields.  (Cost of providing a 4' by 700' long stone dust path to the boundary of sport activity at the practice field with a run slope of 5% max. and a cross slope of 2% max.)	1	22400	\$22400

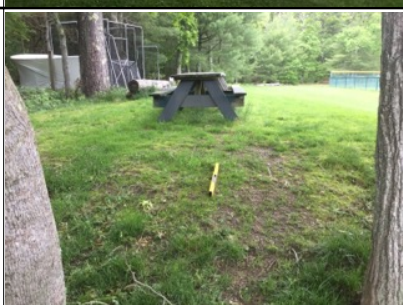
5	Picnic Tables by West Bleachers	Ext.		Exterior Access Route	Exterior

Running slope > 1:20 (5%) Surface is not stable, firm, and slip-resistant Accessible route not provided	16.7% - -	Relocate the accessible picnic table on an accessible route.	1	Labor	\$0

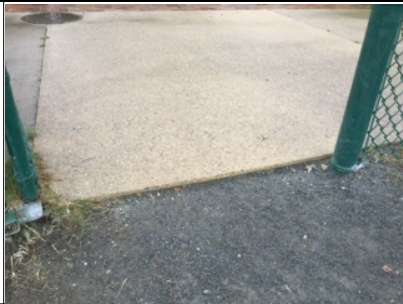
Level changes > 1/4"	0.75"	Alter change in level to be 1/4" high max.  (Cost provided in ID #4.)	1	-	\$0
7	Bleachers (West Side)	Ext.		Exterior Access Route	Exterior

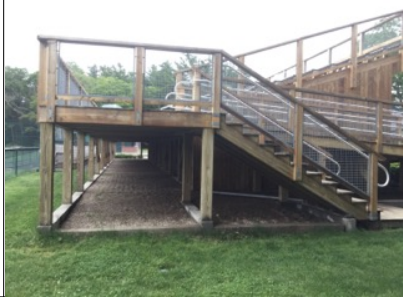
Vertical clearance < 80" above ground	-	Provide a cane-detectable barrier underneath stair.	1	960	\$960
8	Bleachers (East Side)	Ext.		Exterior Access Route	Walkway

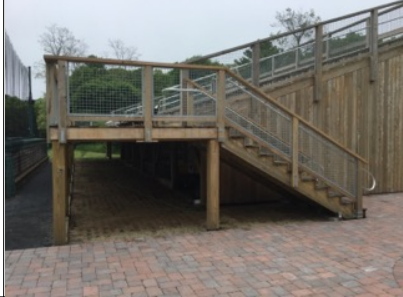
Vertical clearance < 80" above ground	64.5"	Provide a cane-detectable barrier underneath stair.	1	960	\$960
9	Bleachers (East Side)	Ext.		Exterior Access Route	Walkway

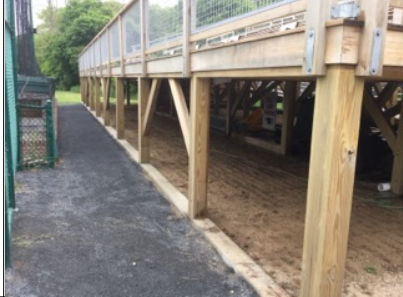
Vertical clearance < 80" above ground	62.25"	Provide a cane-detectable barrier underneath stair.	1	960	\$960
10	Bleachers (East Side)	Ext.		Exterior Access Route	Exterior

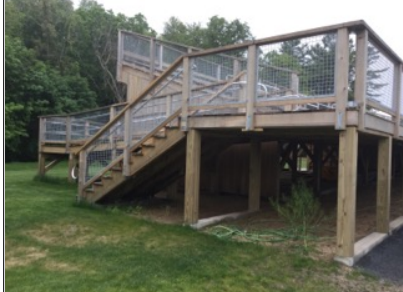
Vertical clearance < 80" above ground	68.5"	Provide a cane-detectable barrier underneath stair.	1	960	\$960

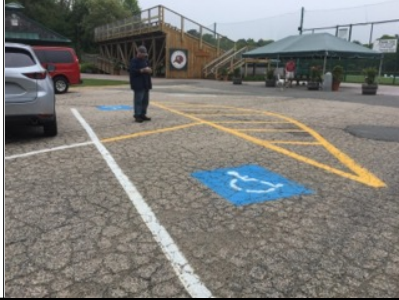
Access aisle not provided	-	Provide a marked access aisle that is at least 60" wide for the full length of the accessible space. (Re-stripe.)	2	300	\$600
12	Parking Lot	Ext.		Off-Street Parking Lot or Garage	Visitor

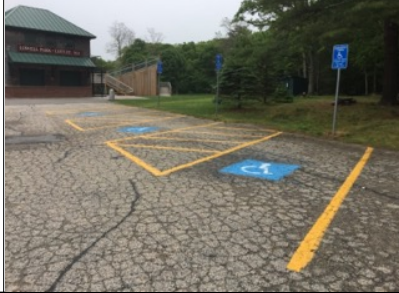
Sign does not have the designation "Van Accessible" Total # of parking Total # of designated accessible parking spaces Total # of designated van accessible spaces	62 4 1 -	Add the designation "Van Accessible" to the sign located at the van accessible space.	1	500	\$500
<b>Access to Goods and Services</b>												
<b>Doors, Doorways, &amp; Gates</b>												
13	Women's Toilet Room	1		Doors, Doorways, & Gates	Toilet Room

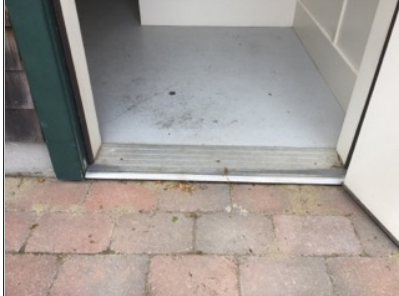
Threshold > 1/2" high	1.5"	Alter the threshold to be 1/2" high max.	1	150	\$150

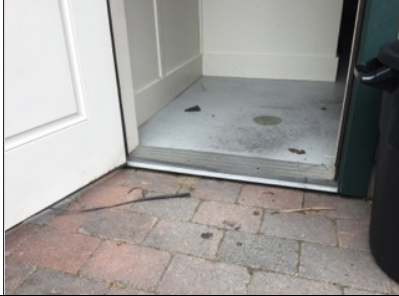
14	Men's Toilet Room	1		Doors, Doorways, & Gates	Toilet Room

Threshold > 1/2" high	1.75"	Alter the threshold to be 1/2" high max.	1	150	\$150
<b>Ramps</b>												
15	Bleachers Ramp (East Side)	Ext.		Ramps	Exterior

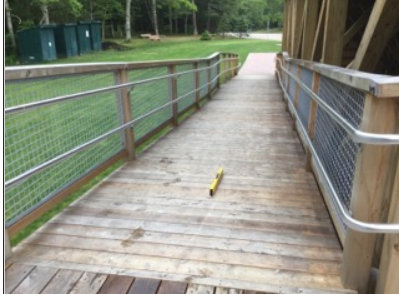
Running slope >1:12 (8.33%)	9.5%	Reduce running slope to be no steeper than 1:12 (8.33%). Provide a new 20' long ramp section at the middle area where the running slope is excessive.  (Cost based on 20' long new pressure treated wood straight ramp.)	1	4718	\$4718

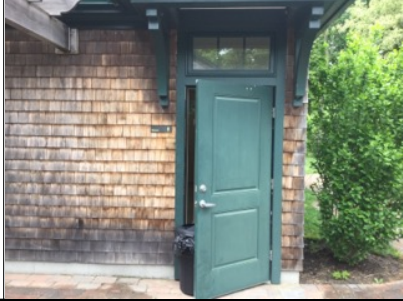
Raised characters not provided Braille not provided	- -	Provide text with raised characters duplicated in braille.	1	232	\$232
17	Men's Toilet Room	Ext.		Signage	Designation

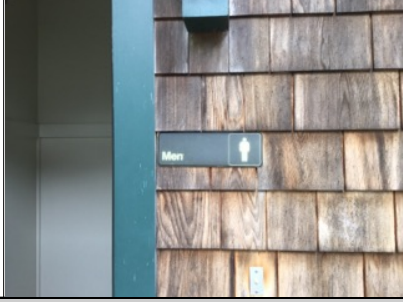
Raised characters not provided Braille not provided	- -	Provide text with raised characters duplicated in braille.	1	232	\$232
<b>Service Counter</b>												
18	Office Counters	Ext.		Service Counter	N/A

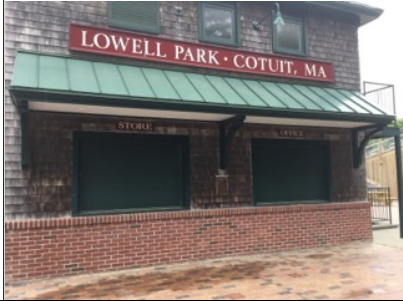
Counter > 36" high	38.5"	Provide a counter that is 36" max. above the ground.	1	880	\$880
19	Kitchen Counter	Ext.		Service Counter	N/A

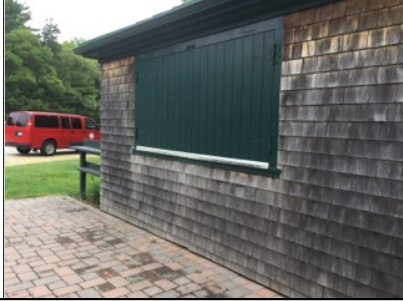
Counter > 36" high	45"	Provide a counter that is 36" max. above the ground.	1	880	\$880
<b>Operable Parts</b>												
20	Dugout Entrance (East Side)	Ext.		Operable Parts	Gate Latch

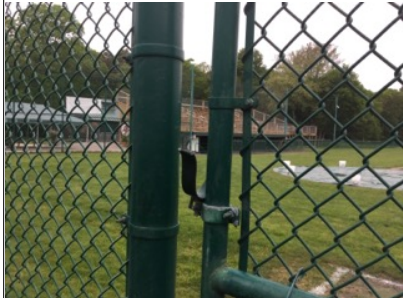
Side reach > 54"	57"	Relocate gate latch so that controls are between 15" - 48" above the finished floor.	1	Labor	\$0

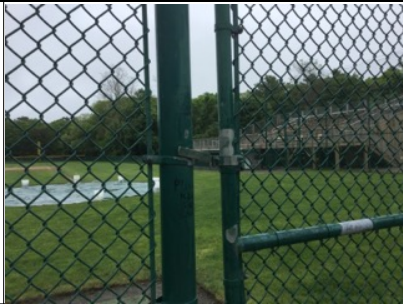
Forward reach if obstruction > 20"- 25" deep is > 44" high	60"	Ensure that gate latch is not higher than 44" above the finished floor.	1	Labor	\$0
<b>Picnic Tables</b>												
22	Press Box (Staff Only)	Ext.		Picnic Tables	N/A

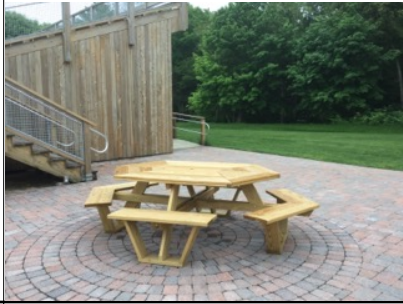
Toe or knee clearance at table not provided	-	Provide at least one picnic table with top between 28"- 34" above the ground and 27" clear height underneath.	1	1400	\$1400
23	Path to West Side Bleachers	Ext.		Picnic Tables	N/A

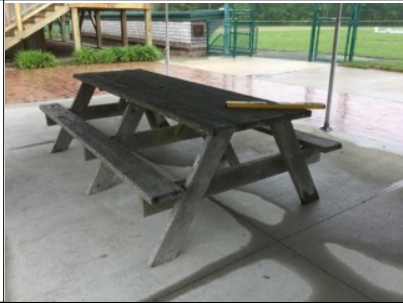
Toe or knee clearance at table not provided	-	Provide one (1) picnic table with top between 28"- 34" above the ground and 27" clear height underneath.	1	1400	\$1400
24	Picnic Tables by West Bleachers	Ext.		Picnic Tables	N/A

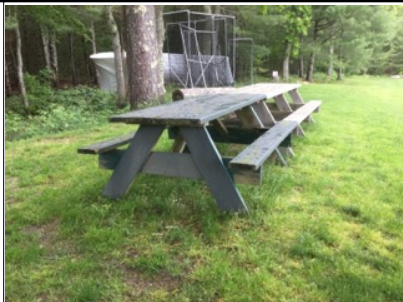
Toe or knee clearance at table not provided Picnic table not on an accessible route	26" -	Provide one (1) picnic table with top between 28"- 34" above the ground and 27" clear height underneath. Ensure that the dining surface is connected to an accessible route.	1	1400	\$1400

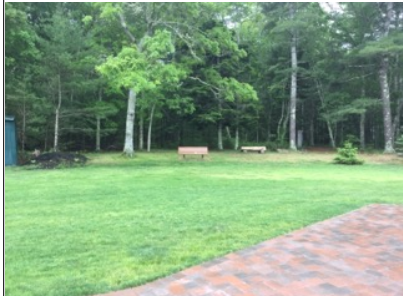
<b>Benches</b>												
25	Bench (East Side)	Ext.		Benches	N/A

No accessible route to one bench in this area	-	Relocate one bench on an accessible route.	1	Labor	\$0

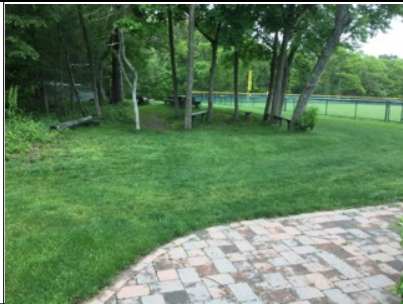
No accessible route to one bench in this area	-	Relocate one bench on an accessible route.	1	Labor	\$0
<b>Toilet &amp; Bathing Rooms</b>												
<b>Lavatory</b>												
27	Women's Toilet Room	1		Lavatory	N/A

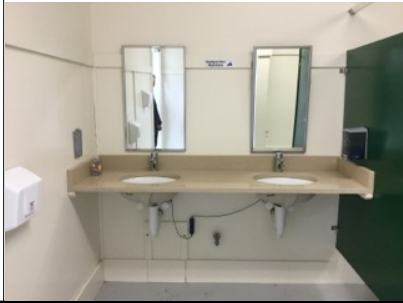
Lavatory rim or counter > 34" high Mirror above lavatory w/reflective surface > 40"	36" 43"	Provide at least one lavatory with the rim no higher than 34". Lower mirror so that the bottom surface is at 40" max. above the finished floor.	1	3350	\$3350
28	Men's Toilet Room	1		Lavatory	N/A

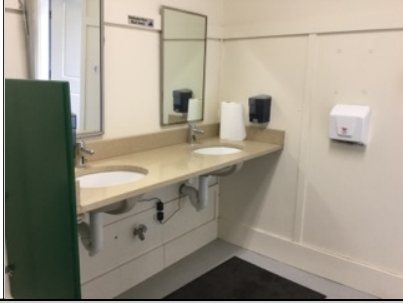
Lavatory rim or counter > 34" high Mirror above lavatory w/reflective surface > 40"	35" 42"	Provide at least one lavatory with the rim no higher than 34". Lower mirror so that the bottom surface is at 40" max. above the finished floor.	1	3350	\$3350

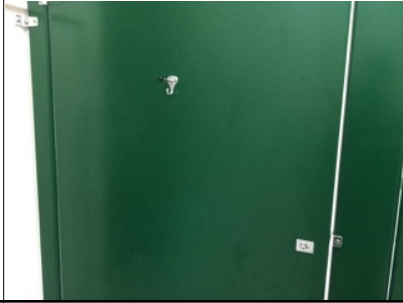
<b>Toilet Compartment</b>												
29	Women's Toilet Room	1		Toilet Compartment	Accessible Compartment

Coat hook > 48" Door pull not provided	57" -	Lower coat hook so that it is no higher than 48".	1	220	\$220
30	Men's Toilet Room	1		Toilet Compartment	Accessible Compartment

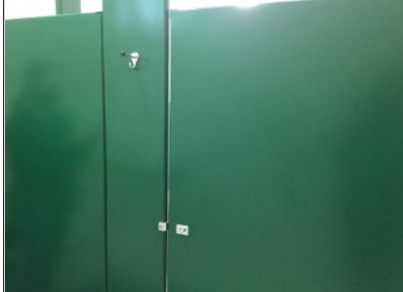
Coat hook > 48" Door pull not provided	64" -	Lower coat hook so that it is no higher than 48".	1	150	\$150

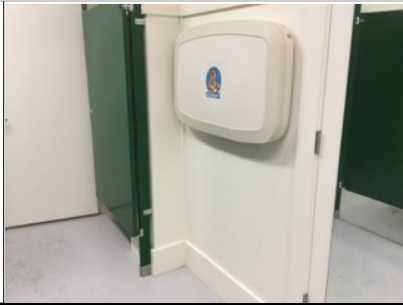
Controls > 48" (MAAB)	62"	Relocate so the changing table controls are 48" max. above the finished floor.	1	256	\$256
32	Men's Toilet Room	1		Dispensers	Baby Changing Station

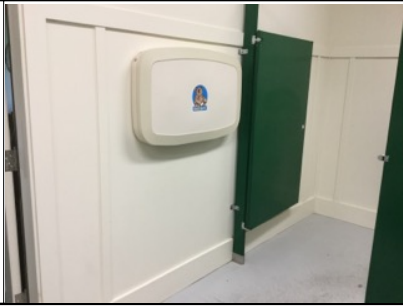
Controls > 48" (MAAB)	63"	Relocate so the changing table controls are 48" max. above the finished floor.	1	256	\$256
<b>Additional Access</b>												
<b>Drinking Fountains</b>												
33	Path Between Toilet Rooms	Ext.		Drinking Fountains	Seated

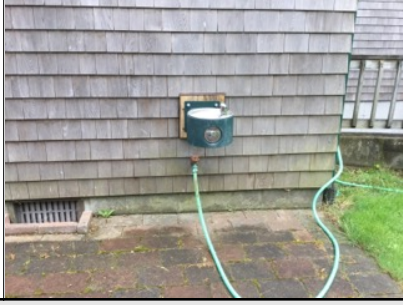
No drinking fountain provided for standing users Knee or toe clearance not provided	- 24	Provide an additional drinking fountain for standing users or install a Hi-Lo drinking fountain. Ensure 27" min. knee clearance at seated fountain.	1	6056	\$6056
<b>Play and Sport Areas</b>

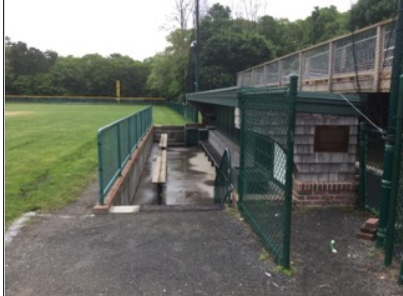
<b>Field</b>												
34	Teams Dugouts	Ext.		Field	Baseball

Accessible spaces are not provided at team seating	-	Provide two (2) new at grade dugouts on an accessible route with a 36" x 48" clear floor space at team seating.  (See sample illustration in the report narrative.)	1	-	\$0

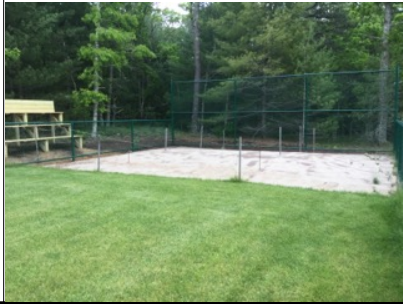
Practice areas are not on an accessible route	-	Provide an accessible route to all practice areas. (Cost provided in ID #4.)	1	-	\$0
<b>Bleachers</b>												
36	Practice Field Bleachers	Ext.		Bleachers	N/A

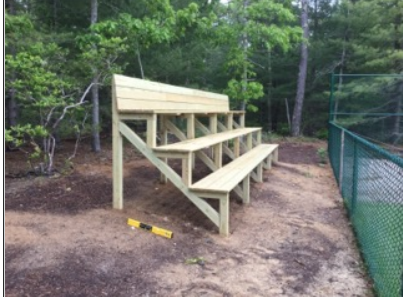
Cross slope > 1:50 (2.00%) Seats not connected by accessible route Min. # of designated wheelchair spaces not provided	16% -	Reduce cross slope to be no steeper than 1:50 (2.00%). Provide an accessible route to the seating area. Provide a stable and firm 36"x48" space on both ends of the bleacher with a max. slope of 2.00% in all directions.  (Cost provided in ID #4.)	1	-	\$0
