Gateway Marina

ADA Transition Plan

October 2021

**Town of Barnstable
Gateway Marina**

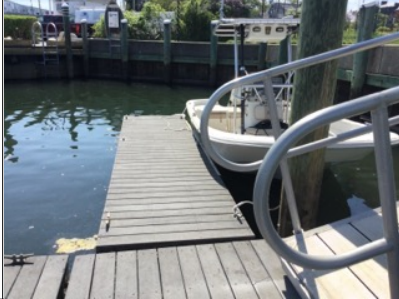
Total number of boat slips Minimum # of accessible boat slips not provided Boat slip clearance < 60" wide Edge protection at boat slips not provided	12 - 47" -	Provide at least one (1) accessible boat slip. Ensure there is at least a 60" wide clear pier space at the boat slip. Provide edge protection at boat slips. It may be technically infeasible to provide an accessible route to the dock.	1	-	\$0
2	Parking Lot	Ext.		Exterior Access Route	Exterior

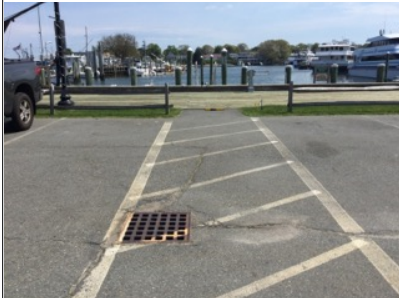
Surface openings > 1/2" Level changes > 1/4"	2.5" 2.5"	Replace or reposition so that openings are 1/2" max. and the long opening dimension is perpendicular to the dominant direction of travel. Alter change in level at wooden walkway to be 1/4" high max.	1	3162	\$3162

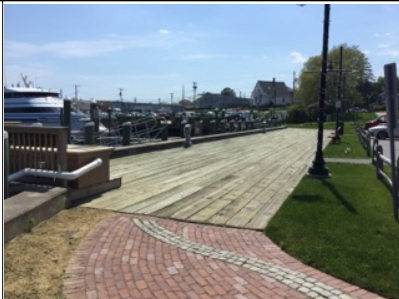
3	Trail From Steamship Authority to Gateway Boardwalk	Ext.		Exterior Access Route	Walkway

Level changes > 1/4"	1"	Alter change in level at wooden walkway to be 1/4" high max.	1	256	\$256
4	Parking Lot to Boardwalk	Ext.		Exterior Access Route	Walkway

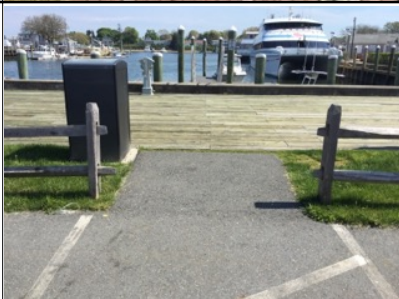
Level changes > 1/4"	1.25"	Alter change in level at wooden walkway to be 1/4" high max.	1	256	\$256
5	Near Aselton Park	Ext.		Exterior Access Route	Walkway

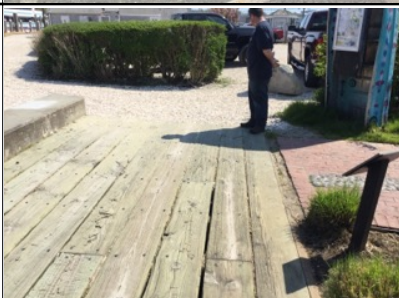
Level changes > 1/4"	1"	Alter change in level at brick to Aselton Park to be 1/4" high max.	1	256	\$256

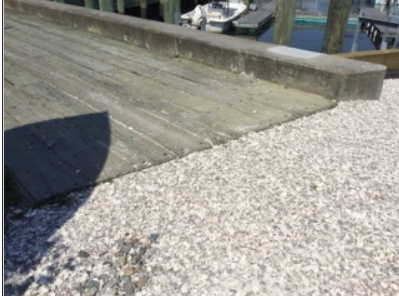
ID	Location	Floor	Room	Element	Type	Photo	Issues	Current Measure	Recommendations	Quantity	Price	Cost Estimation
6	Near Aselton Park Towards Spanky's	Ext.		Exterior Access Route	Walkway

Level changes > 1/4"	1"	Alter change in level at wooden walkway to be 1/4" high max.	1	256	\$256
7	Boardwalk at Spanky's	Ext.		Exterior Access Route	Walkway

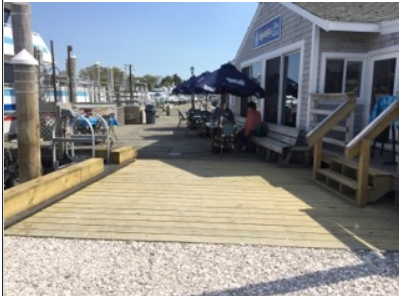
Level changes > 1/4"	.75"	Alter change in level at wooden walkway to be 1/4" high max.	1	256	\$256
8	Boardwalk at Spanky's	Ext.		Exterior Access Route	Walkway

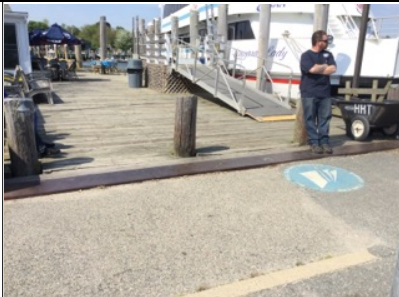
Level changes > 1/4"	2"	Alter change in level to wooden walkway at metal to be 1/4" high max.	1	256	\$256
9	Walkway Towards Spanky's From Near Aselton Park	Ext.		Exterior Access Route	Walkway

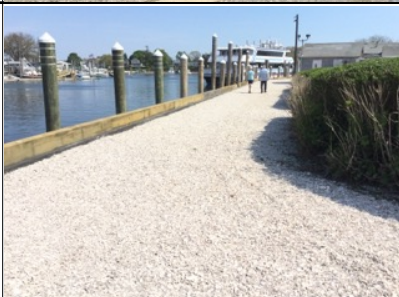
Surface is not stable, firm, and slip-resistant	-	Repair surface. Provide a 48" wide stable, firm and slip-resistant path. (Costing provided for 4' x 200' asphalt path.)	1	8000	\$8000
10	Dock A	Ext.		Exterior Access Route	Exterior

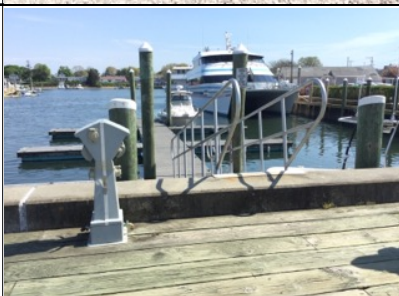
Accessible route not provided	-	Ensure an accessible route is provided to ramp. It may be technically infeasible to provide a 12 foot long ramp with a landing of 60" at the ramp top and bottom.	1	-	\$0

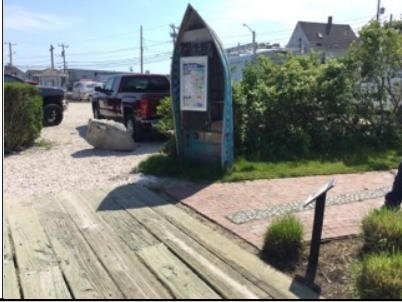
ID	Location	Floor	Room	Element	Type	Photo	Issues	Current Measure	Recommendations	Quantity	Price	Cost Estimation
11	Near Aselton Park	Ext.		Exterior Access Route	Walkway

Accessible route not provided	-	Ensure an accessible route is provided to information display.	1	240	\$240
Off-Street Parking Lot or Garage												
12	Parking Lot	Ext.		Off-Street Parking Lot or Garage	N/A

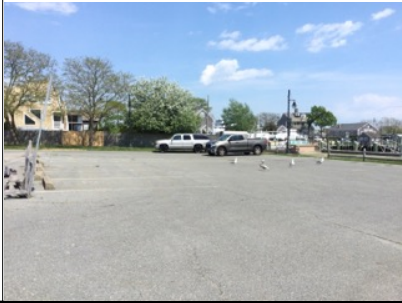
Total # of parking Total # of designated accessible parking spaces Total # of designated van accessible spaces	23 0 0	Provide a van accessible parking space. (Costing provided for one accessible space, access aisle, sign and striping.)	1	1850	\$1850
13	Parking Lot	Ext.		Off-Street Parking Lot or Garage	N/A

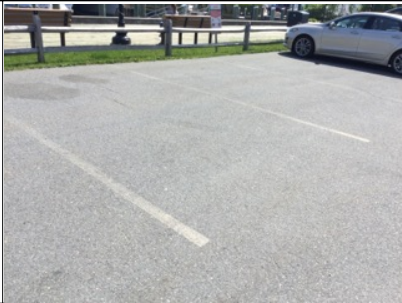
Striping faded	-	Re-stripe parking surface.	1	-	\$0
Access to Goods and Services												
Ramps												
14	Dock A	Ext.		Ramps	Exterior

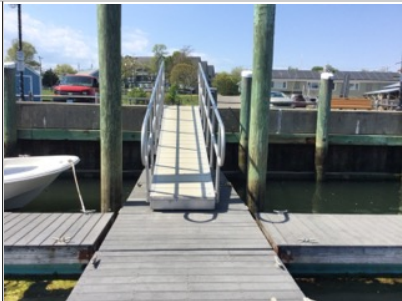
Level changes > 1/4" Edge protection < 4" high	9.5" -	Provide a transition plate. Provide edge protection that prevents the passage of a 4" diameter sphere, where any portion of the sphere is within 4" of the finished ramp surface. It may be technically infeasible to provide an accessible route to the dock.	1	-	\$0

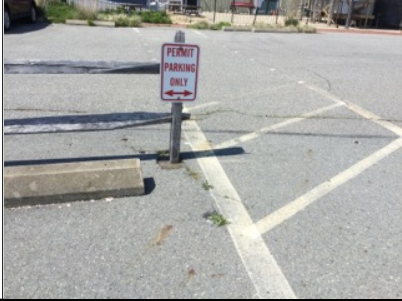
ID	Location	Floor	Room	Element	Type	Photo	Issues	Current Measure	Recommendations	Quantity	Price	Cost Estimation
Signage												
15	Parking Lot	Ext.		Signage	N/A

Visual characters < 40" above ground	20"	Mount visual sign so that the baseline of the lowest character is 40" min. above the ground.	1	Labor	\$0
Best Practice												
16	Benches Near Parking Lot	Ext.

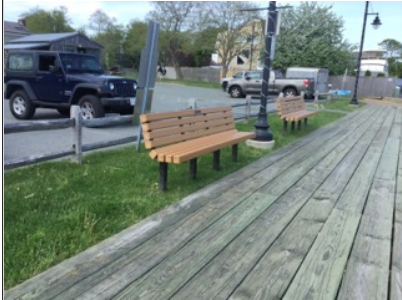
Recommend providing a 36" min. x 48" min. clear floor space adjacent to the bench.	1	-	\$0
18	Oyster Project	Ext.

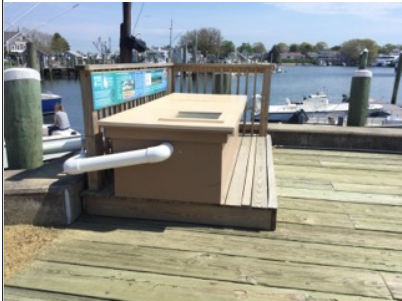
Relocate information sign on an accessible route and ensure that the baseline of the lowest character is 40" min. above the ground.	1	-	\$0
17	Wayside Near Spanky's	Ext.			2

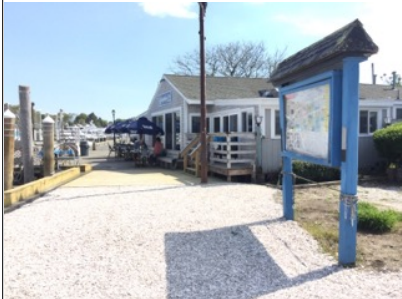
Bottom of exhibit frame > 24-26" (if upright)	48"	Lower bottom of exhibit frame between 24-26". Note: Ensure the exhibit is connected with the firm, stable and slip-resistant path. See ID #9.	1	-	\$0
