Sandy Neck Beach and Bathhouse

ADA Transition Plan

October 2021

Institute for Human Centered Design

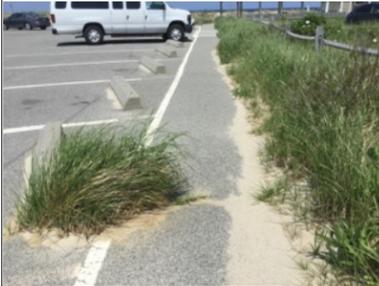
ID	Location	Floor	Room	Element	Type	Photo	Issues	Current Measure	Recommendations	Quantity	Price	Cost Estimation
Approach and Entrance												
Exterior Access Route												
1	Path From Viewing 2 to Bathhouse	Ext.		Exterior Access Route	Exterior

Exterior route < 36" wide Route not maintained in operable working condition	23"	Ensure that a clear width of 36" min. is maintained at the accessible route. Ensure the accessible route is maintained in operable working condition. (Remove sand and weeds from path.)	1	-	\$0
2	Path to Picnic Table	Ext.		Exterior Access Route	Exterior

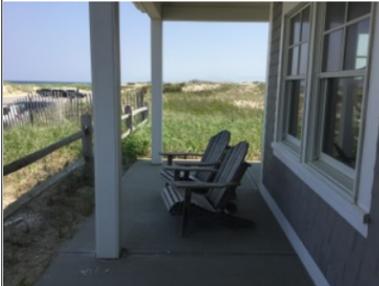
Obstructed by protruding objects	-	Relocate chairs to maintain a 36" min. width accessible route.	1	Labor	\$0
3	Path to Bathhouse and Concession Stand	Ext.		Exterior Access Route	Exterior

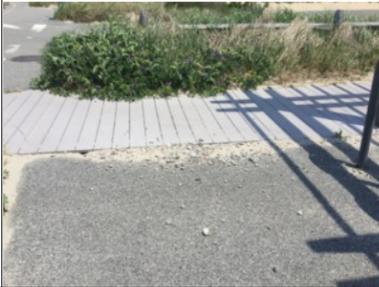
Surface openings > 1/2" Route not maintained in operable working condition	0.75" -	Replace or reposition so that openings are 1/2" max. and the long opening dimension is perpendicular to the dominant direction of travel. Ensure the accessible route is maintained in operable working condition. (Cost for an asphalt patch.)	1	256	\$256

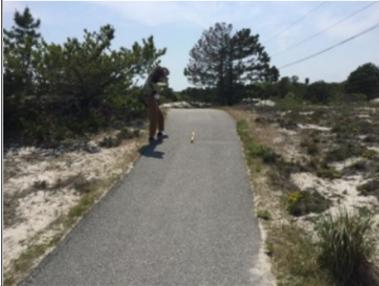
4	Walking Path to Gatehouse	Ext.		Exterior Access Route	Exterior

Running slope > 1:20 (5%)	17.8%	Reduce running slope to be no steeper than 1:20 (5%). (Cost to correct excessive running slope not provided.)	1	-	\$0
5	Walking Path to Gatehouse	Ext.		Exterior Access Route	Exterior

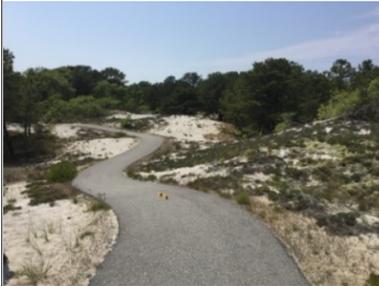
Running slope > 1:20 (5%)	12.2%	Reduce running slope to be no steeper than 1:20 (5%). (Cost to correct excessive running slope not provided.)	1	-	\$0

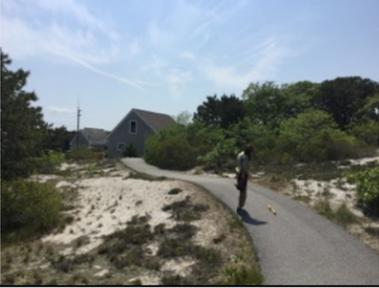
ID	Location	Floor	Room	Element	Type	Photo	Issues	Current Measure	Recommendations	Quantity	Price	Cost Estimation
6	Walking Path to Gatehouse	Ext.		Exterior Access Route	Exterior

Running slope > 1:20 (5%)	9.4%	Reduce running slope to be no steeper than 1:20 (5%). (Cost to correct excessive running slope not provided.)	1	-	\$0
7	Path to Bathhouse and Concession Stand	Ext.		Exterior Access Route	Exterior

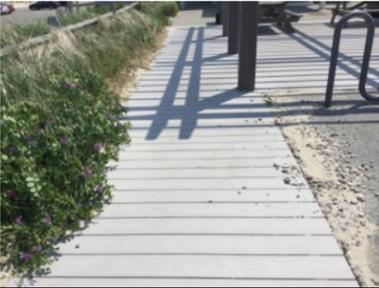
Route not maintained in operable working condition	-	Ensure the accessible route is maintained in operable working condition. (Remove sand and stones.)	1	Labor	\$0
8	Path to Lower Parking Lot	Ext.		Exterior Access Route	Exterior

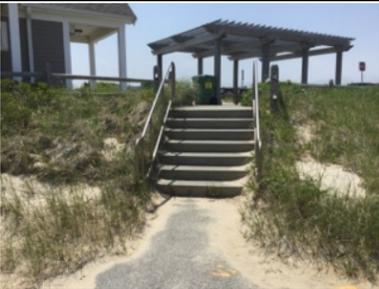
Route not maintained in operable working condition	-	Ensure the accessible route is maintained in operable working condition. (Remove sand.)	1	Labor	\$0
9	Accessible Beach at Lower Parking Lot	Ext.		Exterior Access Route	Exterior

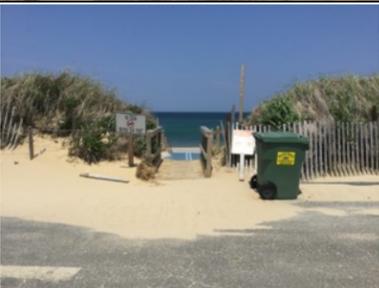
Route not maintained in operable working condition	-	Ensure the accessible route is maintained in operable working condition. (Remove sand.)	1	Labor	\$0

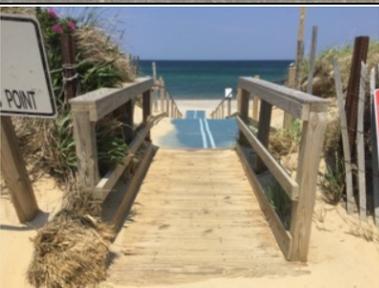
10	Accessible Beach at Lower Parking Lot	Ext.		Exterior Access Route	Exterior

Route not maintained in operable working condition	-	Ensure the accessible route is maintained in operable working condition. (Remove sand.) (See ID #9.)	1	Labor	\$0

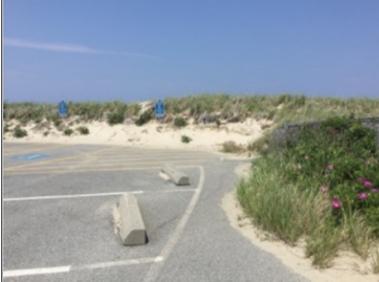
ID	Location	Floor	Room	Element	Type	Photo	Issues	Current Measure	Recommendations	Quantity	Price	Cost Estimation
11	Path Leads to Parking 2	Ext.		Exterior Access Route	Exterior

Route not maintained in operable working condition	-	Ensure the accessible route is maintained in operable working condition. (Remove sand.)	1	Labor	\$0
12	Path From Viewing 2 to Bathhouse	Ext.		Exterior Access Route	Exterior

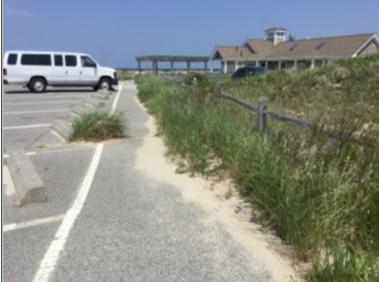
Route not maintained in operable working condition	-	Ensure the accessible route is maintained in operable working condition. (Remove sand and weeds.)	1	Labor	\$0
13	Walking Path to Gatehouse	Ext.		Exterior Access Route	Exterior

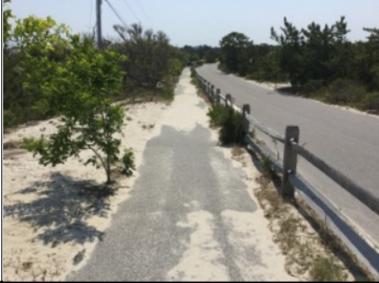
Route not maintained in operable working condition	-	Ensure the accessible route is maintained in operable working condition. (Remove sand.)	1	Labor	\$0
14	Walking Path to Gatehouse	Ext.		Exterior Access Route	Exterior

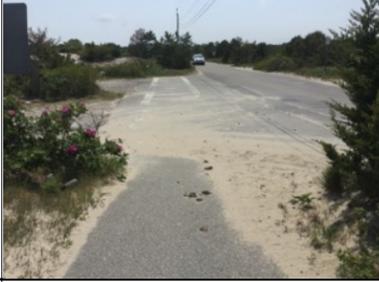
Route not maintained in operable working condition	-	Ensure the accessible route is maintained in operable working condition. (Remove sand.)	1	Labor	\$0

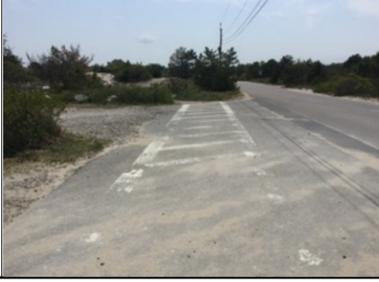
15	Walking Path to Gatehouse	Ext.		Exterior Access Route	Exterior

Route not maintained in operable working condition	-	Ensure the accessible route is maintained in operable working condition. (Remove sand.)	1	Labor	\$0

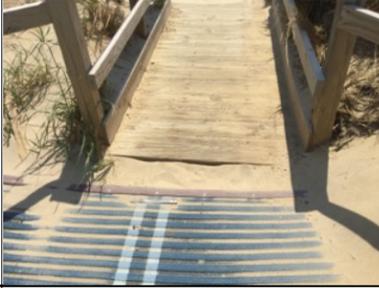
ID	Location	Floor	Room	Element	Type	Photo	Issues	Current Measure	Recommendations	Quantity	Price	Cost Estimation
16	Accessible Beach at Lower Parking Lot	Ext.		Exterior Access Route	Exterior

Route not maintained in operable working condition Surface openings > 1/2"	7" -	Replace or reposition so that openings are 1/2" max. and the long opening dimension is perpendicular to the dominant direction of travel. Ensure the accessible route is maintained in operable working condition.	1	Labor	\$0
17	Walking Path to Gatehouse	Ext.		Exterior Access Route	Exterior

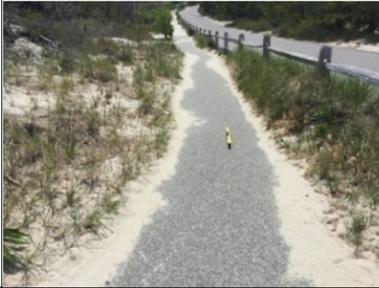
Route not maintained in operable working condition Running slope > 1:20 (5%)	8.1%	Reduce running slope to be no steeper than 1:20 (5%). Ensure the accessible route is maintained in operable working condition (clear sand). (Cost to correct excessive running slope not provided.)	1	-	\$0
18	Beach Access South Side	Ext.		Exterior Access Route	Exterior

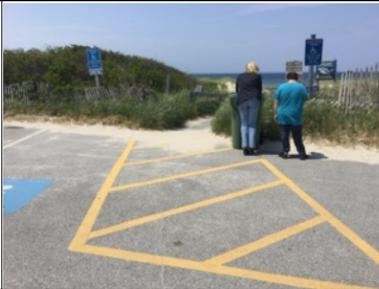
Route not maintained in operable working condition Directional sign to access beach not provided	-	Ensure the accessible route is maintained in operable working condition. Install a sign indicating the location of the nearest accessible beach.	1	346	\$346

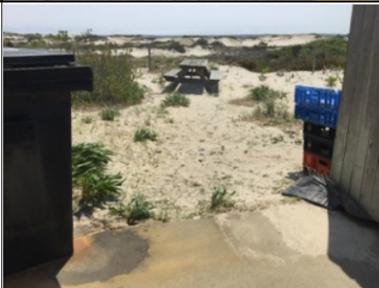
19	Path to Additional Picnic Tables	Ext.		Exterior Access Route	Exterior

Accessible route not provided	-	Ensure an accessible route is provided. (Cost estimate for a 4' wide by 12' long asphalt path to the accessible space at the accessible picnic table.)	1	600	\$600
Beach Access Routes												
20	Lower Parking Lot East Entrance Not Accessible	Ext.		Beach Access Routes	264

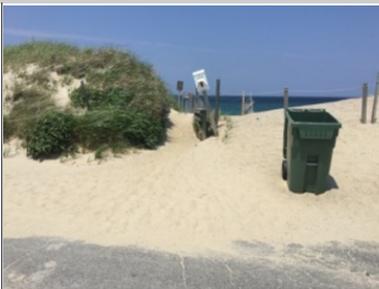
Beach route not provided	-	Provide a beach mat.	1		\$0

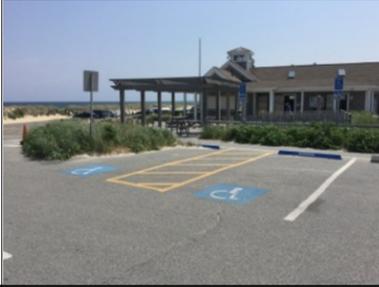
ID	Location	Floor	Room	Element	Type	Photo	Issues	Current Measure	Recommendations	Quantity	Price	Cost Estimation
Off-Street Parking Lot or Garage												
21	Parking Lot	Ext.		Off-Street Parking Lot or Garage	Visitor

Total # of parking Total # of designated accessible parking spaces Total # of designated van accessible spaces Access aisle < 96" wide at van space	58 4 2 60.5"	Provide a marked access aisle that is at least 96" wide.	1	300	\$300
22	Accessible Beach at Lower Parking Lot	Ext.		Off-Street Parking Lot or Garage	Parking Lot

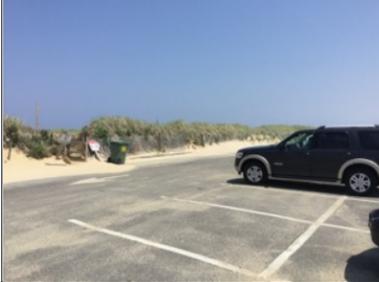
Total # of parking Total # of designated accessible parking spaces Total # of designated van accessible spaces Sign does not have the designation "Van Accessible"	86 0 0	Provide three (3) car accessible spaces that are at least 96" wide. Provide one (1) van accessible space that is at least 132" wide. Provide two (2) access aisles that are at least 60" wide. Provide four (4) accessible parking identification signs. Add one (1) designation "Van Accessible" to the sign located at the van accessible space.	4	1850	\$7400

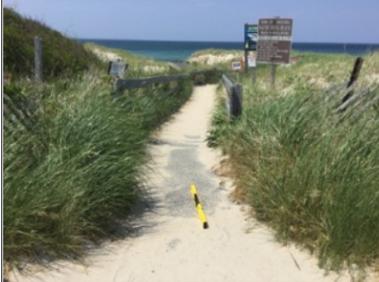
Access to Goods and Services												
Signage												
23	Parking Lot 1 Beach Entrance	Ext.		Signage	Directional

Directional sign to access. beach not provided	-	Provide a sign indicating the location of the nearest accessible beach access route.	1	346	\$346
Laboratory												
24	First Aid Room	Ext.		Laboratory	Other

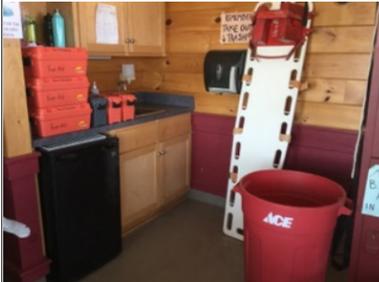
At least one (or 5%) accessible sink not provided Accessible route obstructed by protruding object	- -	Provide at least one sink with the rim no higher than 34" with knee and toe clearance positioned for a forward approach. Relocate trash and stretcher.	1	3480	\$3480

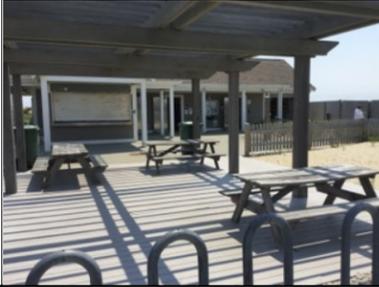
ID	Location	Floor	Room	Element	Type	Photo	Issues	Current Measure	Recommendations	Quantity	Price	Cost Estimation
Picnic Tables												
25	Path to Bathhouse and Concession Stand	Ext.		Picnic Tables	N/A

At least 5% accessible spaces not provided	-	Ensure that at least one (1) accessible picnic table is provided in this area.	1	1400	\$1400
26	Path to Picnic Table	Ext.		Picnic Tables	N/A

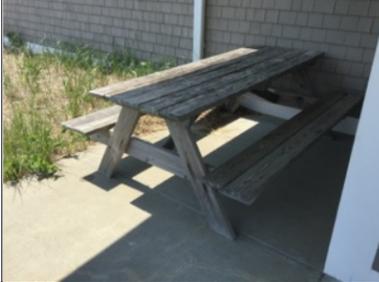
At least 5% accessible spaces not provided	-	Ensure that at least one (1) accessible picnic table is provided in this area.	1	1400	\$1400
27	Path to Additional Picnic tables	Ext.		Picnic Tables	N/A

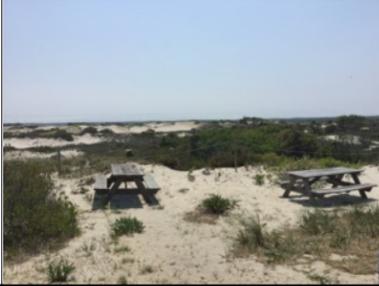
Toe or knee clearance at tables not provided		Ensure that at least one (1) accessible picnic table is provided in this area.	1	1400	\$1400
Toilet & Bathing Rooms												
Overall Access												
28	Women's Toilet Room	1		Overall Access	Toilet Room

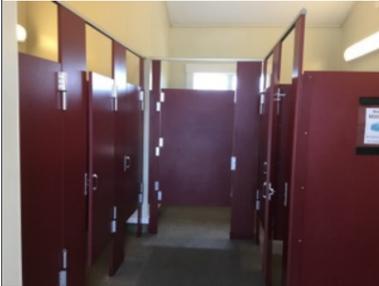
6 fixtures, but no ambulatory compartment provided	-	Provide one ambulatory accessible compartment.	1	3012	\$3012

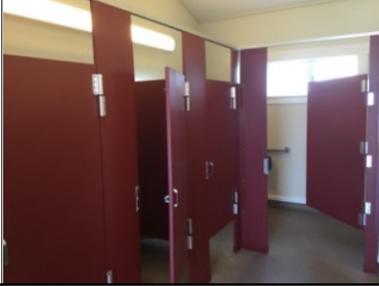
29	Men's Toilet Room	1		Overall Access	Toilet Room

6 fixtures, but no ambulatory compartment provided	-	Provide one ambulatory accessible compartment.	1	3012	\$3012

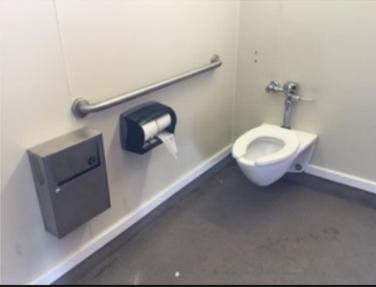
ID	Location	Floor	Room	Element	Type	Photo	Issues	Current Measure	Recommendations	Quantity	Price	Cost Estimation
Toilet Compartment												
30	Women's Toilet Room	1		Toilet Compartment	Accessible Compartment

Grab bars not provided	-	Provide one grab bar on the rear wall.	1	898	\$898
31	Women's Toilet Room	1		Toilet Compartment	Accessible Compartment

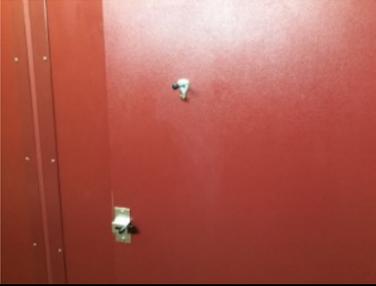
Door pull not provided		Provide a door pull on both sides of the door near the latch.	1	70	\$70
32	Men's Toilet Room	1		Toilet Compartment	Accessible Compartment

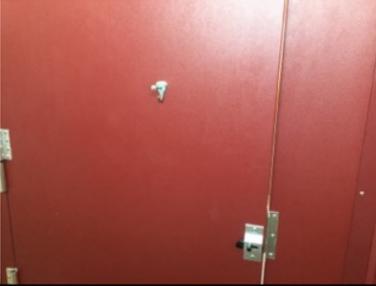
Door pull not provided	-	Provide a door pull on both sides of the door near the latch.	1	70	\$70
Urinal												
33	Men's Toilet Room	1		Urinal	N/A

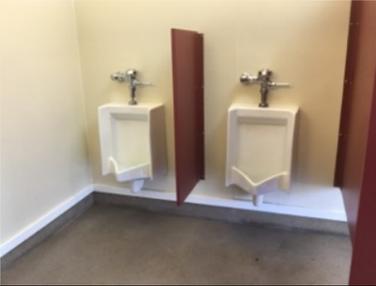
Rim > 17" high	19.25"	Provide at least one urinal with the rim no higher than 17" above the finished floor.	1	3248	\$3248
Dispensers												
34	Women's Toilet Room	1		Dispensers	Other

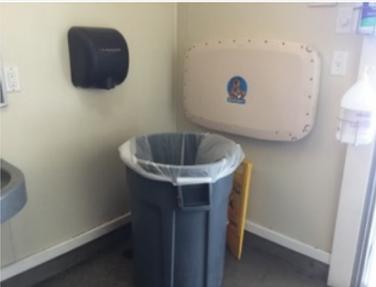
Clear floor space not provided at accessory	-	Remove trash can to maintain clear floor space at changing table.	1	Labor	\$0

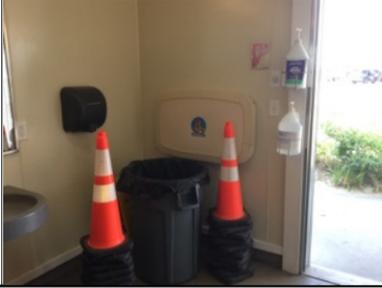
ID	Location	Floor	Room	Element	Type	Photo	Issues	Current Measure	Recommendations	Quantity	Price	Cost Estimation
35	Men's Toilet Room	1		Dispensers	Other

Clear floor space not provided at accessory		Remove trash can to maintain clear floor space at changing table.	1	Labor	\$0
Portable Toilet												
36	Portable Toilet at Lower Parking Lot	Ext.		Portable Toilet	N/A

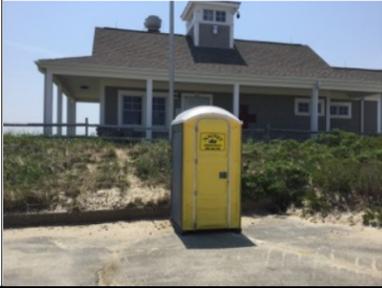
60" by 72" clear space not provided	-	Provide an accessible portable toilet that has 60" wide and 72" deep clear floor space at the toilet.	1	-	\$0
Additional Access												
Drinking Fountains												
37	Drinking Fountain Between Toilet Rooms	Ext.		Drinking Fountains	Hi-Lo

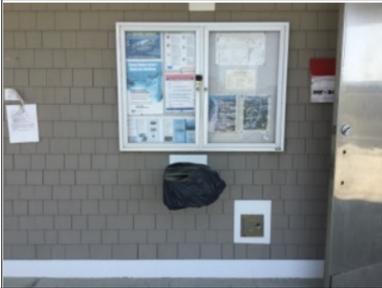
Spout > 36" high (wheelchair users) No drinking fountain provided for standing users	38" -	Lower drinking fountain so that the spout is 36" max. above the finished floor or ground. Provide an additional drinking fountain for standing users or install a Hi-Lo drinking fountain.	1	6056	\$6056

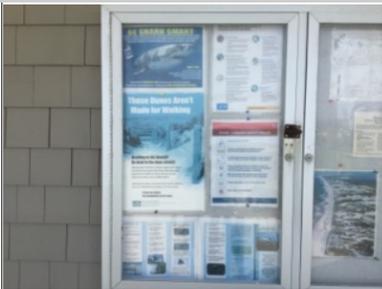
Best Practice												
38	Information Between Toilet Rooms	Ext.			N/A

Recommend duplicating beach information located on signs on the beach website.	1	-	\$0

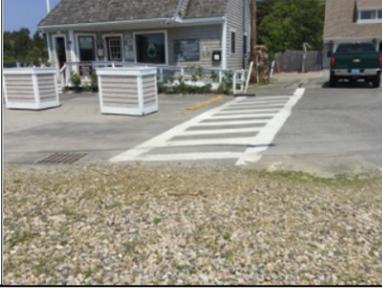
ID	Location	Floor	Room	Element	Type	Photo	Issues	Current Measure	Recommendations	Quantity	Price	Cost Estimation
39	Gatehouse	Ext.			N/A

Recommend providing a sign at the gatehouse indicating the pedestrian path to the beach has steep run slopes.	1	-	\$0
