# Kalmus Beach, Bathhouse and Parking Lot

## ADA Transition Plan

October 2021

Institute for Human Centered Design

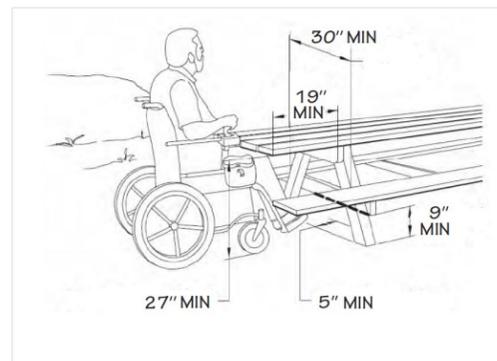
**Note:** The pavilion has newer picnic tables but they lack the required 19" knee clearance. See fig. below.

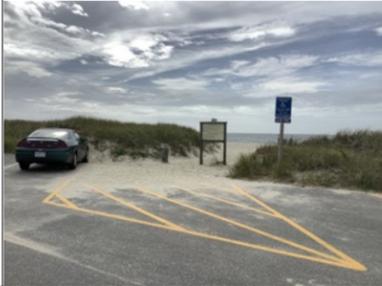
ID	Location	Floor	Room	Element	Type	Photo	Issues	Current Measure	Recommendations	Quantity	Price	Cost Estimation
<b>Approach and Entrance</b>												
<b>Exterior Access Route</b>												
1	Near Parking Entry - West Side	Ext.		Exterior Access Route	Exterior

Route obstructed by protruding objects	-	Relocate sign so it is not on the circulation path.	1	Labor	\$0
2	Beach Path to North of Snack Bar	Ext.		Exterior Access Route	Walkway

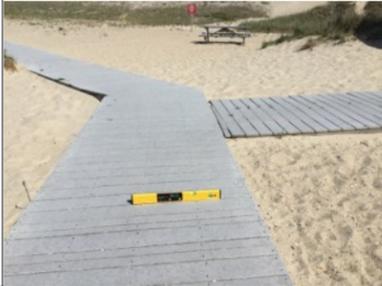
Cross slope > 1:50 (2.00%)	4.6%	Reduce cross slope to be no steeper than 1:50 (2.00%).	1	-	\$0
3	Beach Path to North of Snack Bar	Ext.		Exterior Access Route	Walkway

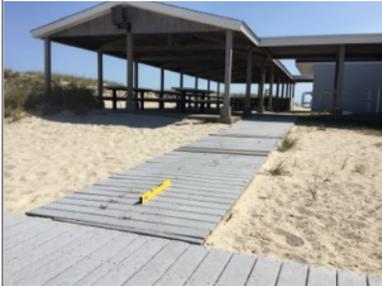
Cross slope > 1:50 (2.00%) Running slope > 1:20 (5%)	3.2% 6.7%	Reduce cross slope to be no steeper than 1:50 (2.00%). Reduce running slope to be no steeper than 1:20 (5%).	1	-	\$0
4	Beach Path to North of Snack Bar	Ext.		Exterior Access Route	Walkway

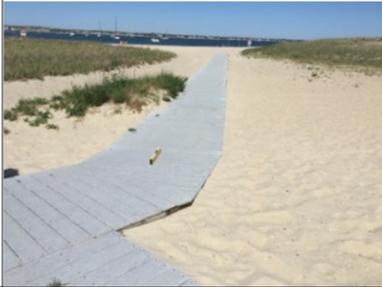
Running slope > 1:20 (5%)	6.8%	Reduce running slope to be no steeper than 1:20 (5%).	1	-	\$0

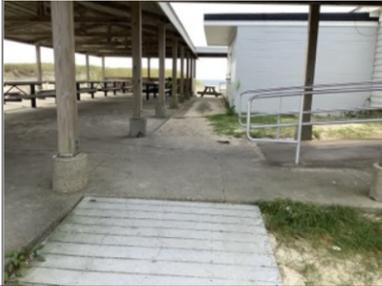
5	Near Snack Bar	Ext.		Exterior Access Route	Walkway

Level changes > 1/4"	1.75"	Alter change in level to be 1/4" high max.	1	256	\$256

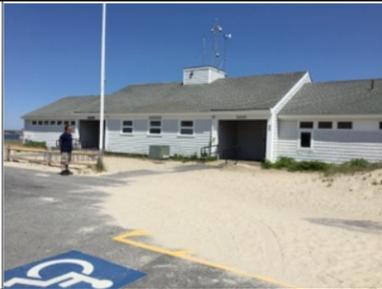
ID	Location	Floor	Room	Element	Type	Photo	Issues	Current Measure	Recommendations	Quantity	Price	Cost Estimation
6	Route From Accessible Parking to Toilet Room	Ext.		Exterior Access Route	Exterior

Route not maintained in operable working condition	-	Remove sand to ensure the accessible route is maintained in operable working condition.	1	Labor	\$0
<b>Beach Access Routes</b>												
7		Ext.		Beach Access Routes	Removable

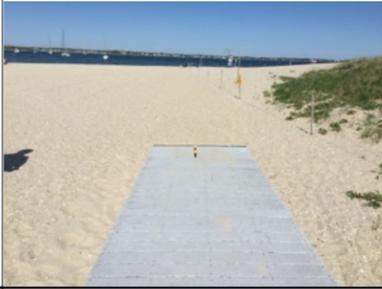
Beach route not provided		Provide an accessible route that is firm and stable. Ensure the accessible route extends to the high tide level.  (Cost for a beach mat that is 100 ft. long by 5 ft. wide.)	1	3699	\$3699
8	Beach Path to North of Snack Bar	Ext.		Beach Access Routes	Permanent

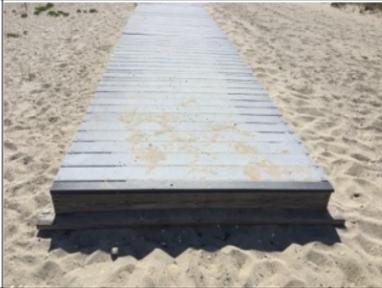
Level changes > 1/4"	8"	Alter change in level to provide a 1:12 (8.33%) max. slope that connects to a beach mat.  See ID # 7.	1	-	\$0
9	Beach Path to North of Snack Bar	Ext.		Beach Access Routes	Permanent

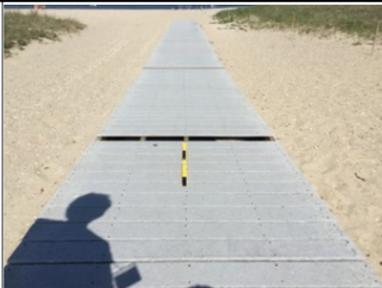
Surface openings > 1/2" Route not maintained in operable working condition	6.75" -	See ID #10.	1	-	\$0

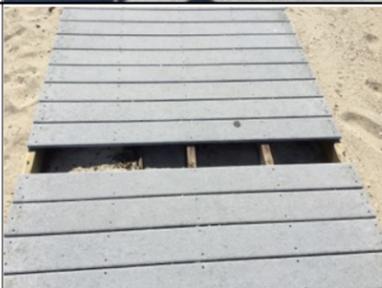
10	Beach Path to North of Snack Bar	Ext.		Beach Access Routes	4

Surface openings > 1/2" Route not maintained in operable working condition	6.75" -	Ensure the accessible route is maintained in operable working condition.	1	-	\$0

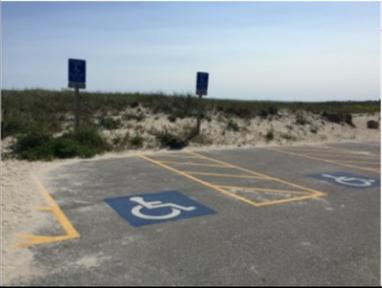
ID	Location	Floor	Room	Element	Type	Photo	Issues	Current Measure	Recommendations	Quantity	Price	Cost Estimation
<b>Off-Street Parking Lot or Garage</b>												
11	Accessible Parking Next to Toilet Rooms	Ext.		Off-Street Parking Lot or Garage	Visitor

Sign bottom < 60" above finished grade	57.5"	Locate identification signs with the bottom of the signs 60" above the ground.	2	Labor	\$0
12	Accessible Parking Next to Parking Hut	Ext.		Off-Street Parking Lot or Garage	Visitor

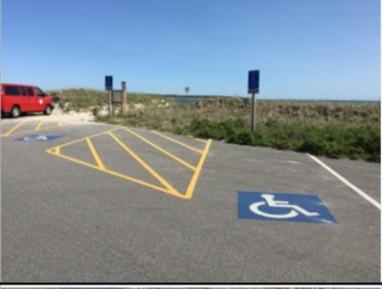
Sign bottom < 60" above finished grade	57.5"	Locate identification sign with the bottom of the sign 60" above the ground (right side).	1	Labor	\$0
13	Accessible Parking Next to Snack Bar	Ext.		Off-Street Parking Lot or Garage	Visitor

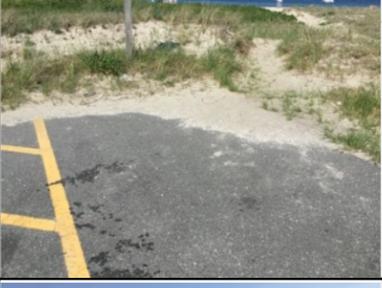
Not maintained in operable working condition	-	See ID #15.	1	Labor	\$0
14	Accessible Parking Space Next to Toilet Rooms	Ext.		Off-Street Parking Lot or Garage	Visitor

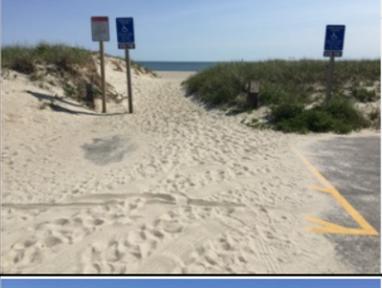
Not maintained in operable working condition	-	Ensure the accessible parking space is maintained in operable working condition.	1	Labor	\$0

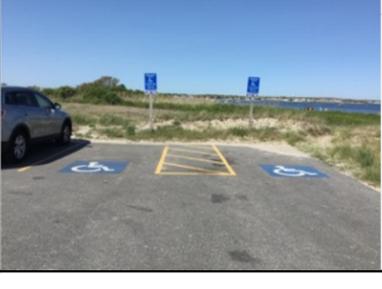
15	Accessible Parking Spaces Next to Snack Bar	Ext.		Off-Street Parking Lot or Garage	Visitor

Not maintained in operable working condition	-	Ensure the accessible parking space is maintained in operable working condition.	1	Labor	\$0

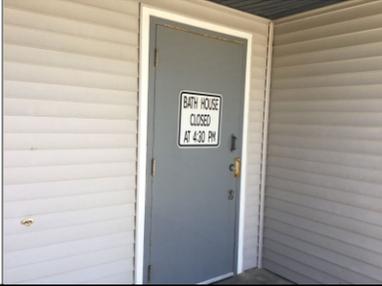
ID	Location	Floor	Room	Element	Type	Photo	Issues	Current Measure	Recommendations	Quantity	Price	Cost Estimation
<b>Entrance</b>												
16	Toilet Room Entrance/Exit	Ext.		Entrance	Main Entrance

Maneuvering clearance(s) not provided	15.5"	Ensure door is kept open during business hours.	1	Labor	\$0
17	Snack Bar Entrance/Exit	Ext.		Entrance	Main Entrance

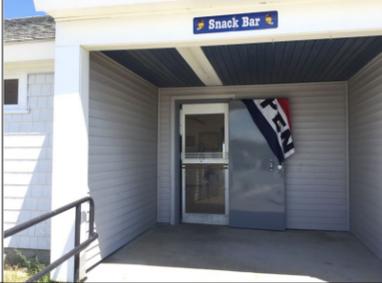
Maneuvering clearance(s) not provided	14.8"	Ensure door is kept open during business hours.	1	Labor	\$0
<b>Access to Goods and Services</b>												
<b>Ramps</b>												
18	Snack Bar Entrance	Ext.		Ramps	Exterior

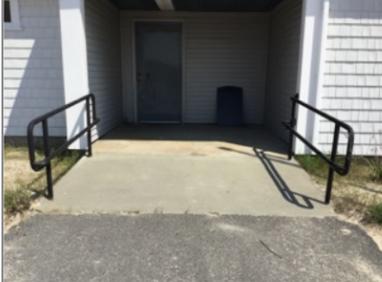
Handrails do not extend 12" past top & bottom	-	Alter handrails to extend horizontally above the landing for 12" min. beyond the top and bottom of ramp runs.	2	800	\$1600
19	Toilet Rooms	Ext.		Ramps	Exterior

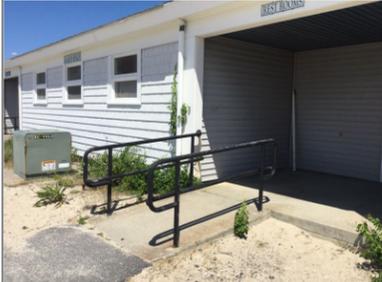
Handrails do not extend 12" past top & bottom	-	Alter handrails to extend horizontally above the landing for 12" min. beyond the top and bottom of ramp runs.	2	800	\$1600

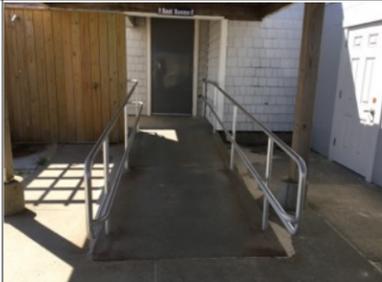
20	Route From Entry Hall Door Into Pavilion and Shower	Ext.		Ramps	Exterior

Edge protection < 4" high	-	Provide edge protection that prevents the passage of a 4" diameter sphere, where any portion of the sphere is within 4" of the finished floor or ground surface.	1	2520	\$2520

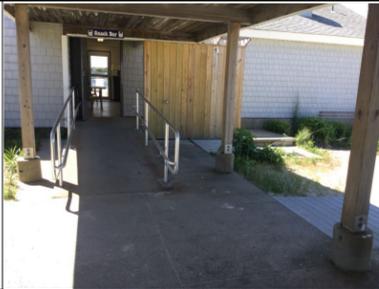
ID	Location	Floor	Room	Element	Type	Photo	Issues	Current Measure	Recommendations	Quantity	Price	Cost Estimation
21	Shower Right of Ramp - Northeast Side	Ext.		Ramps	Exterior

Edge protection < 4" high		Provide edge protection that prevents the passage of a 4" diameter sphere, where any portion of the sphere is within 4" of the finished floor or ground surface.	1	2520	\$2520
<b>Stairways</b>												
22	Route From Snack Bar to Pavilion and Shower	Ext.		Stairways

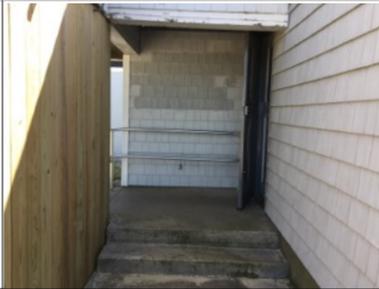
Handrails not provided	-	Provide handrails.	1	-	\$0
<b>Signage</b>												
23	Toilet Room Entrance	1		Signage	Egress

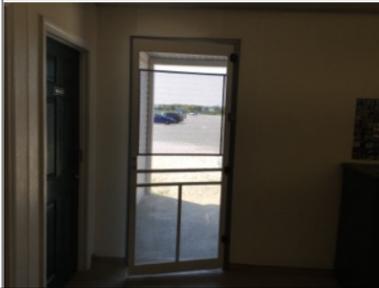
Not provided	-	Ensure a tactile exit sign with raised characters and braille is provided at exit door. Mount sign between 48"- 60" above the finished floor located on the latch side of the door.  If an illuminated exit sign is provided, ensure it has the illuminated International Symbol of Accessibility (ISA).	1	232	\$232

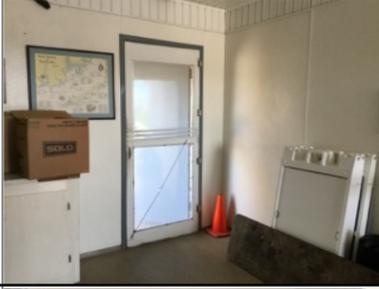
24	Snack Bar Door Towards Pavilion	1		Signage	Egress

Not provided	-	Ensure a tactile exit sign with raised characters and braille is provided at exit door. Mount sign between 48"- 60" above the finished floor located on the latch side of the door.  If an illuminated exit sign is provided, ensure it has the illuminated International Symbol of Accessibility (ISA).	1	232	\$232
25	Snack Bar Entrance/Exit	1		Signage	Egress

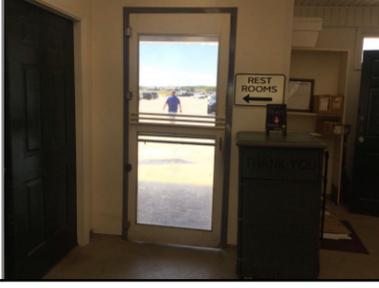
Not provided	-	Ensure a tactile exit sign with raised characters and braille is provided at exit door. Mount sign between 48"- 60" above the finished floor located on the latch side of the door. If an illuminated exit sign is provided, ensure it has the illuminated International Symbol of Accessibility (ISA). Relocate trash container to maintain the maneuvering clearance at the door.	1	232	\$232

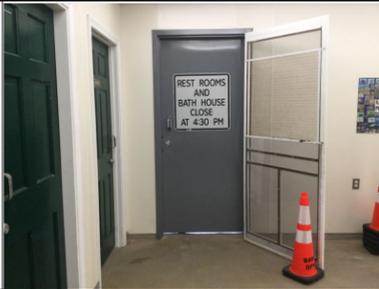
ID	Location	Floor	Room	Element	Type	Photo	Issues	Current Measure	Recommendations	Quantity	Price	Cost Estimation
26	Toilet Room Entrance/Exit	1		Signage	Egress

Not provided		Ensure a tactile exit sign with raised characters and braille is provided at exit door. Mount sign between 48"- 60" above the finished floor located on the latch side of the door.  If an illuminated exit sign is provided, ensure it has the illuminated International Symbol of Accessibility (ISA).	1	232	\$232
27	Towards Outdoor Shower	1		Signage	Egress

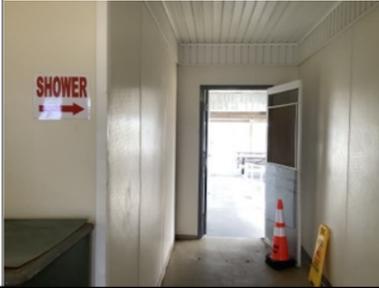
Not provided	-	Ensure a tactile exit sign with raised characters and braille is provided at exit door. Mount sign between 48"- 60" above the finished floor located on the latch side of the door.  If an illuminated exit sign is provided, ensure it has the illuminated International Symbol of Accessibility (ISA).	1	232	\$232
28	Entry Hall	1		Signage	Designation

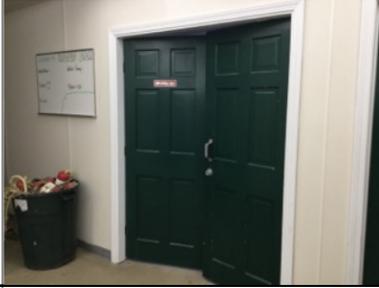
Raised characters not provided Braille not provided	- -	Provide text with raised characters duplicated in braille.	1	232	\$232

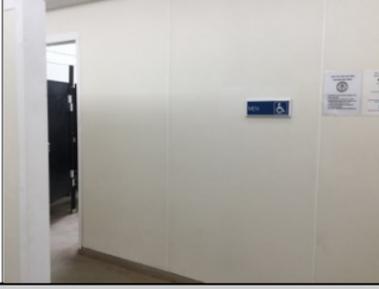
29	Men's Toilet Room	1		Signage	Designation

Raised characters not provided Braille not provided	- -	Provide text with raised characters duplicated in braille.	1	232	\$232
<b>Service Counter</b>												
30	Snack Bar Area	1		Service Counter	N/A

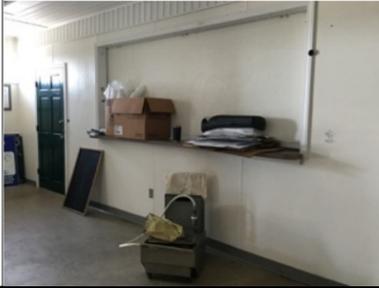
Counter > 36" high	42"	Provide a counter that is 36" max. above the ground.	1	880	\$880

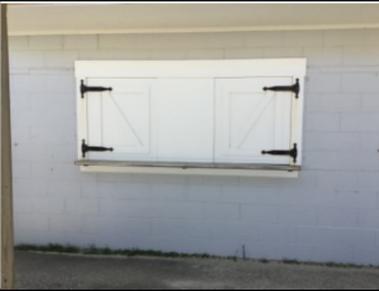
ID	Location	Floor	Room	Element	Type	Photo	Issues	Current Measure	Recommendations	Quantity	Price	Cost Estimation
31	Ice Cream Counter	Ext.		Service Counter	N/A

Counter > 36" high	42.25"	Provide a counter that is 36" max. above the ground.	1	880	\$880
<b>Work Surface</b>												
32	Snack Bar	1		Work Surface	N/A

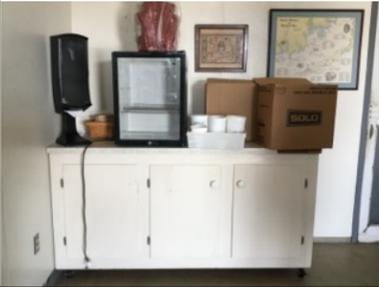
Top of dining/work surface < 28" or > 34"	38.5"	Provide a table with additional utensils and napkins as needed.	1	Labor	\$0
<b>Picnic Tables</b>												
33	Pavilion	Ext.		Picnic Tables	N/A

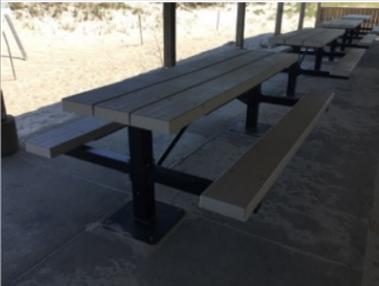
Number of accessible seating spaces	-	Provide at least one picnic table with 19" min. depth in this area.	1	1400	\$1400
34	Pavilion Beach Access Towards South	Ext.		Picnic Tables	N/A

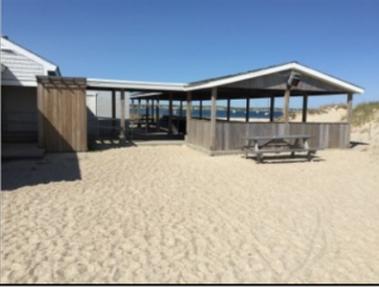
Picnic table not on an accessible route	-	Ensure that the picnic table is on an accessible route. Ensure picnic table is accessible.	1	Labor	\$0
<b>Benches</b>												
35	Route From Accessible Parking Next to Parking Hut to Shoreline	Ext.		Benches

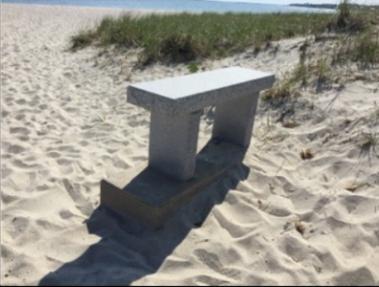
No accessible route to one bench in this area	-	Locate bench on an accessible route.	1	Labor	\$0

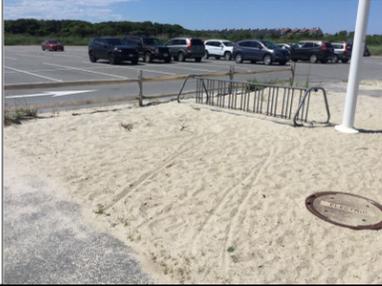
ID	Location	Floor	Room	Element	Type	Photo	Issues	Current Measure	Recommendations	Quantity	Price	Cost Estimation
<b>Bike Racks</b>												
36	Near Parking Lot	Ext.		Bike Racks	N/A

Not connected to an accessible route	-	Ensure bike racks are on an accessible route.	1	Labor	\$0
<b>Toilet &amp; Bathing Rooms</b>												
<b>Lavatory</b>												
37	Women's Toilet Room	1		Lavatory	N/A

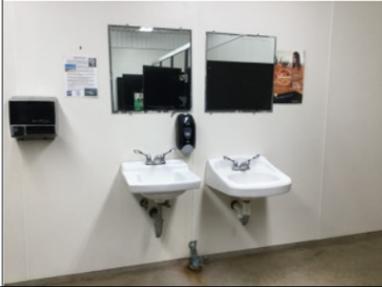
Toe or knee clearances not provided Exposed plumbing underneath Mirror above lavatory w/reflective surface > 40"	25.75" - 49"	Provide at least one lavatory with knee and toe clearance positioned for a forward approach. Insulate or otherwise configure pipes to prevent contact for at least one lavatory. Lower mirror so that the bottom surface is at 40" max. above the finished floor.	1	1942	\$1942
38	Men's Toilet Room	1		Lavatory	N/A

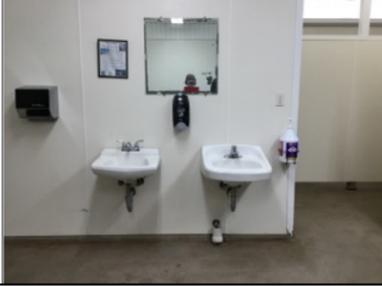
Exposed plumbing underneath Mirror above lavatory w/reflective surface > 40"	- 52"	Insulate or otherwise configure pipes to prevent contact for at least one lavatory. Lower mirror so that the bottom surface is at 40" max. above the finished floor.	1	348	\$348

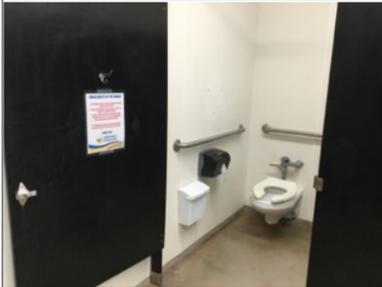
<b>Toilet Compartment</b>												
39	Women's Toilet Room	1		Toilet Compartment	Accessible Compartment

Door with malfunctioning self-closing hinge Door pull not provided	- - -	Repair hinge. Provide a door pull on both sides of the door near the latch.	1	70	\$70
40	Men's Toilet Room	1		Toilet Compartment	Accessible Compartment

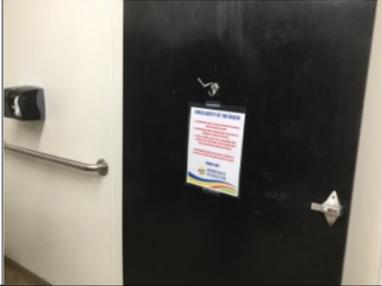
Door with malfunctioning self-closing hinge Door pull not provided	- -	Repair hinge. Provide a door pull on both sides of the door near the latch.	1	70	\$70

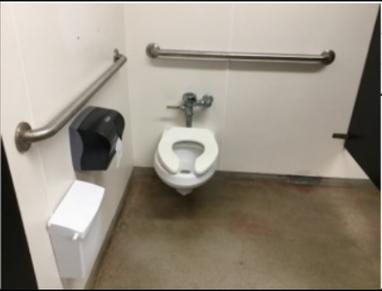
ID	Location	Floor	Room	Element	Type	Photo	Issues	Current Measure	Recommendations	Quantity	Price	Cost Estimation
41	Women's Toilet Room	1		Toilet Compartment	Accessible Compartment

Flush control not on open side Clearance at toilet < 60" clear width Clearance at toilet < 72" clear depth (MAAB)	- 58.75" 61"	Provide the flush control on the open side of the toilet (transfer side). Provide a wheelchair accessible compartment that is 60" wide min. Provide a wheelchair accessible compartment that is 60" wide and 72" deep.  (Cost is for the flush control.)	1	374	\$374
42	Men's Toilet Room	1		Toilet Compartment	Accessible Compartment

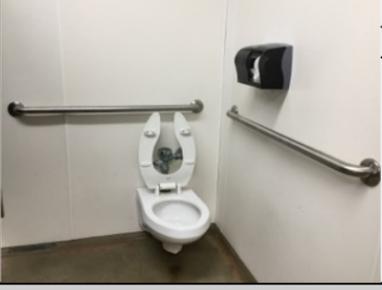
Non-compliant toilet paper dispenser Clearance at toilet < 72" clear depth (MAAB)	- 61"	Relocate toilet paper so that it is located under the grab bar and higher than 15" above the finished floor; and between 7" and 9" from the front of the toilet. Or replace dispenser if it does not allow continuous paper flow. Provide a wheelchair accessible compartment that is 60" wide and 72" deep.  (Cost is to relocate the toilet paper dispenser.)	1	256	\$256

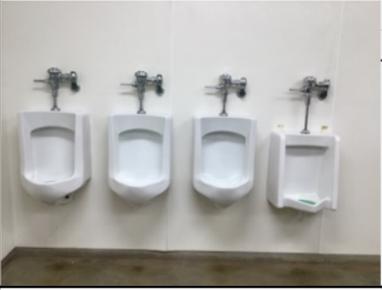
<b>Urinal</b>												
43	Men's Toilet Room	1		Urinal	N/A

Rim > 17" high Flush control too high or not properly located	24" 55"	Provide at least one urinal with the rim no higher than 17" above the finished floor. Mount flush control at 44" max. above the finished floor.	1	3248	\$3248
44	Men's Toilet Room	1		Urinal	N/A

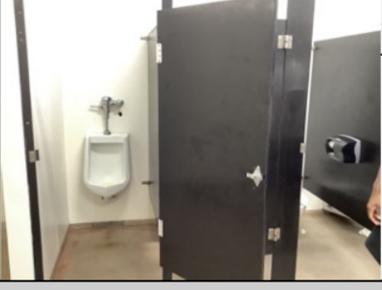
Rim > 17" high Urinal recessed > 24" has > 36" clear width	20.5" 31"	If this toilet room is intended to be the accessible urinal, an accessible route that is at least 36" wide must be provided.	1	-	\$0
<b>Dispensers</b>												
45	Women's Toilet Room	1		Dispensers	N/A

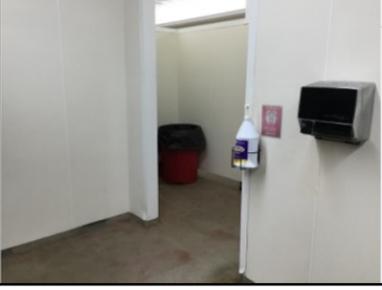
Dispenser acts as a protruding object		Relocate paper dispenser so it does not protrude into the circulation path.	1	256	\$256

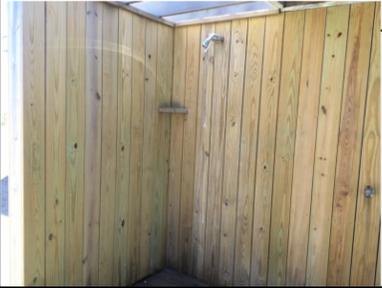
ID	Location	Floor	Room	Element	Type	Photo	Issues	Current Measure	Recommendations	Quantity	Price	Cost Estimation
<b>Outdoor Rinsing Showers</b>												
46	Outdoor Shower Near Men's Toilet Room - South Side	Ext.		Outdoor Rinsing Showers	N/A

2 fixed showerheads not provided	-	Provide two showerheads located 48" and 72" min. above the ground. Provide shower controls that do not require tight grasping, pinching or twisting of the wrist.	1	2719	\$2719
47	Outdoor Shower Near Snack Bar - North Side	Ext.		Outdoor Rinsing Showers	N/A

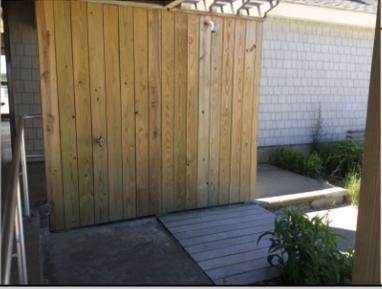
2 fixed showerheads not provided	-	Provide two showerheads located 48" and 72" min. above the ground. Provide shower controls that do not require tight grasping, pinching or twisting of the wrist.	1	2719	\$2719
<b>Portable Toilet</b>												
48	Parking Lot	Ext.		Portable Toilet	N/A

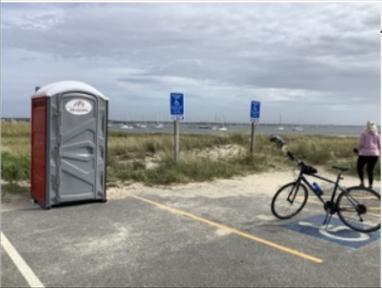
60" by 72" clear space not provided	-	Provide an accessible portable toilet that has 60" wide and 72" deep at the toilet.	1	-	\$0

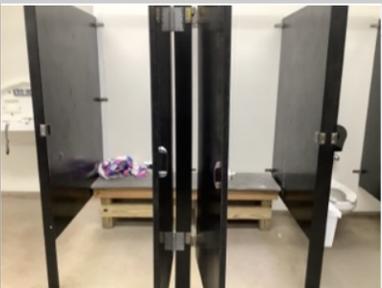
<b>Changing Room</b>												
49	Women's Toilet Room	1		Changing Room	N/A

Room is < 78" x 72"	49"x25"	Provide an accessible changing room that is 78" by 72" minimum.	1	5866	\$5866
50	Men's Toilet Room	1		Changing Room	N/A

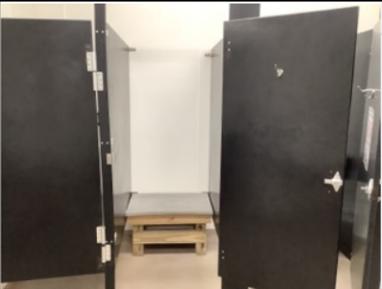
Room is < 78" x 72"	49"x29.25"	Provide an accessible changing room that is 78" by 72" minimum.	1	5866	\$5866

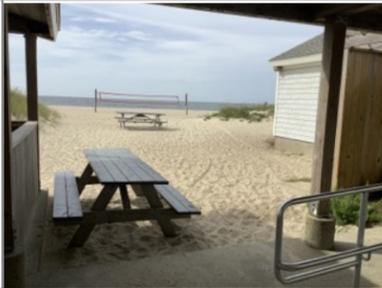
ID	Location	Floor	Room	Element	Type	Photo	Issues	Current Measure	Recommendations	Quantity	Price	Cost Estimation
<b>Accessible Route</b>												
51	Entrance Left of Ramp Near Shower - Southeast Side	Ext.		Accessible Route	N/A

Recommend providing a beach mat at this location to provide an accessible route to the beach from this side.	1	-	\$0
<b>Signage</b>												
52	Route From Accessible Parking Next to Toilet Rooms to Beach	Ext.		Signage	N/A

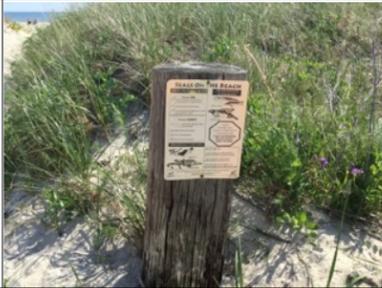
Recommend locating this information on an accessible route mounted 40" min. above the ground.	1	-	\$0
53	Entry Hall Towards Outdoor Showers	1		Signage	N/A

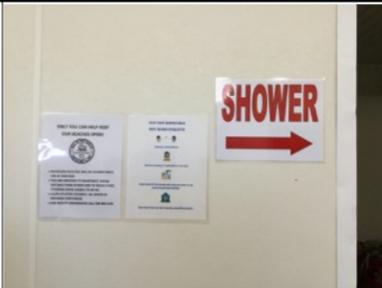
Recommend relocating signs to avoid glare.	1	-	\$0
54	Entry Hall	1		Signage	N/A

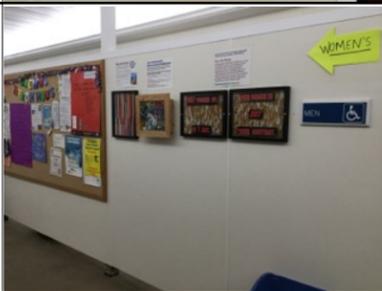
Recommending providing a permanent directional sign.	1	-	\$0
