Hathaway's Pond

ADA Transition Plan

October 2021

Institute for Human Centered Design

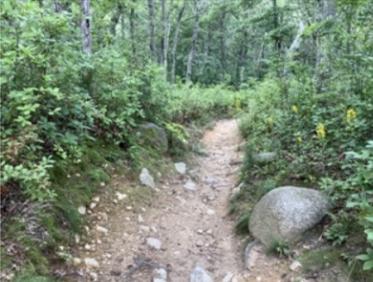
Exterior route < 36" wide Cross slope > 1:50 (2.00%) Running slope > 1:20 (5%) Level changes > 1/4" Surface is not stable, firm, and slip-resistant Accessible route not provided	30" - - - -	Ensure that a clear width of 36" min. is maintained at the accessible route. Reduce cross slope to be no steeper than 1:50 (2.00%). Reduce running slope to be no steeper than 1:20 (5%). Alter change in level to be 1/4" high max. Note: Providing an accessible route is impractical.	1	-	\$0
2	Path Prior to First Viewing Area	Ext.		Exterior Access Route	Exterior

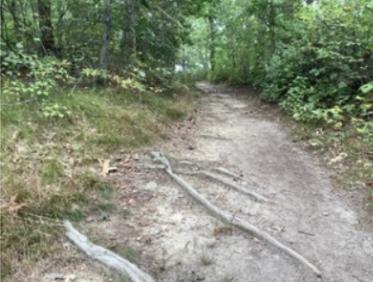
Cross slope > 1:50 (2.00%) Running slope > 1:20 (5%) Level changes > 1/4" Surface is not stable, firm, and slip-resistant Accessible route not provided	- - - - -	Reduce cross slope to be no steeper than 1:50 (2.00%). Reduce running slope to be no steeper than 1:20 (5%). Alter change in level to be 1/4" high max. Repair surface. Ensure an accessible route is provided. Note: Providing an accessible route is impractical.	1	-	\$0

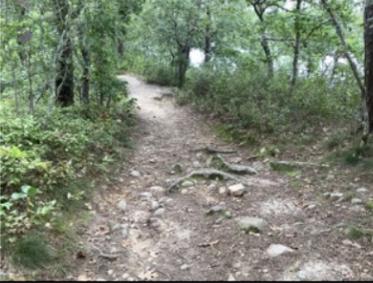
3	Path Prior to First Viewing Area	Ext.		Exterior Access Route	Exterior

Cross slope > 1:50 (2.00%) Running slope > 1:20 (5%) Level changes > 1/4" Surface is not stable, firm, and slip-resistant Accessible route not provided	- - - - -	Reduce cross slope to be no steeper than 1:50 (2.00%). Reduce running slope to be no steeper than 1:20 (5%). Alter change in level to be 1/4" high max. Repair surface. Ensure an accessible route is provided. Note: Providing an accessible route is impractical.	1	-	\$0
4	Between First and Second Viewing Area	Ext.		Exterior Access Route	Exterior

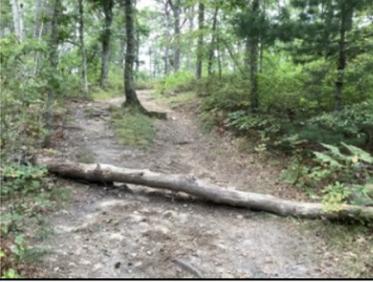
Cross slope > 1:50 (2.00%) Running slope > 1:20 (5%) Level changes > 1/4" Surface is not stable, firm, and slip-resistant Accessible route not provided	- - - - -	Reduce cross slope to be no steeper than 1:50 (2.00%). Reduce running slope to be no steeper than 1:20 (5%). Alter change in level to be 1/4" high max. Repair surface. Ensure an accessible route is provided. Note: Providing an accessible route is impractical.	1	-	\$0

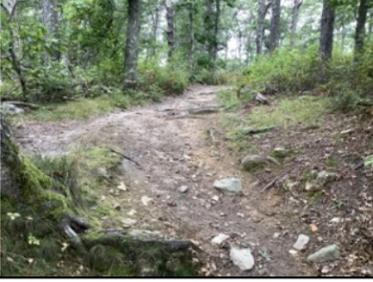
5	Between First and Second Viewing Area	Ext.		Exterior Access Route	Exterior

Cross slope > 1:50 (2.00%) Running slope > 1:20 (5%) Level changes > 1/4" Surface is not stable, firm, and slip-resistant Accessible route not provided	- - - - -	Reduce cross slope to be no steeper than 1:50 (2.00%). Reduce running slope to be no steeper than 1:20 (5%). Alter change in level to be 1/4" high max. Repair surface. Ensure an accessible route is provided. Note: Providing an accessible route is impractical.	1	-	\$0

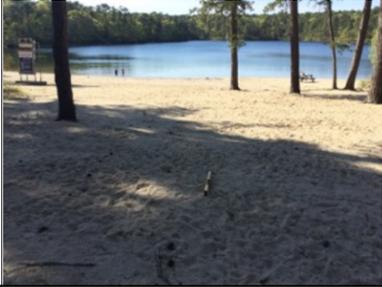
Beach route not provided Surface is not firm and stable	- -	Provide an accessible route that is firm and stable. Ensure the accessible route extends to the recreation water level (for lake, pond and reservoir beach). (Cost based on an 82' long beach mat extending to the recreation water level.)	1	4575	\$4575
Off-Street Parking Lot or Garage												
7	Accessible Parking	Ext.		Off-Street Parking Lot or Garage	Visitor

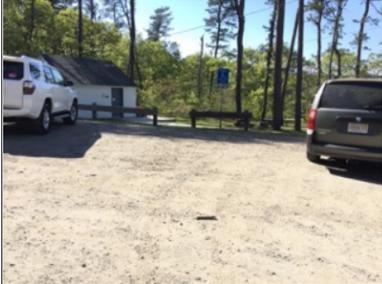
Total # of designated accessible parking spaces Total # of designated van accessible spaces Access aisle not provided Sign does not have the designation "Van Accessible" Total # of parking	50 1 - - -	Provide a compliant van accessible parking space with a ISA identification sign. Include a marked access aisle that is at least 96" wide at the van space and at least 60" wide at the car space. Add the designation "Van Accessible" to the sign located at the van accessible space. (See the report for a graphic showing how to designate accessible parking spaces in unpaved parking lots.)	2	500	\$1000

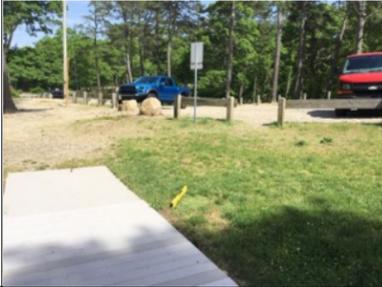
No top or bottom landing provided Edge protection < 4" high Handrails not provided	- - -	Provide landing at bottom of ramp. Provide edge protection that prevents the passage of a 4" diameter sphere, where any portion of the sphere is within 4" of the finished floor or ground surface. Provide handrails with 1-1/4" to 1-1/2" circular cross section.	1	2900	\$2900
Signage												
9	Men's Toilet Room	Ext.		Signage	Designation

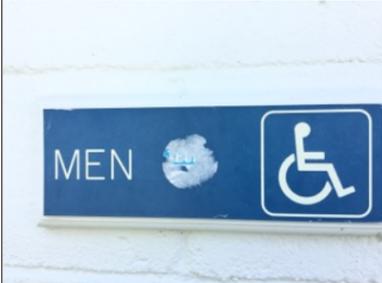
Raised characters not provided Braille not provided	- -	Provide text with raised characters duplicated in braille at the entry to the men's toilet room.	1	232	\$232

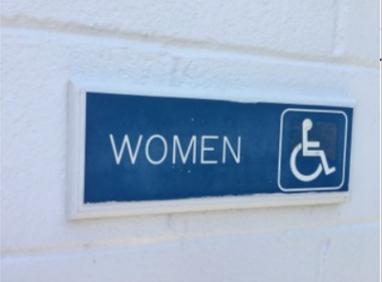
Raised characters not provided Braille not provided	- -	Provide text with raised characters duplicated in braille at the entry to the women's toilet room.	1	232	\$232
Picnic Tables												
11	Fishing Point - North East Side	Ext.		Picnic Tables	N/A

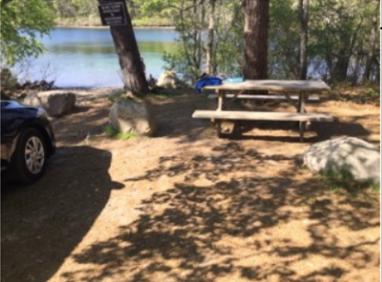
Toe or knee clearance at table not provided	-	Provide at least one picnic table with top between 28"- 34" above the ground and 27" clear height underneath.	1	1400	\$1400
12	Beach	Ext.		Picnic Tables	N/A

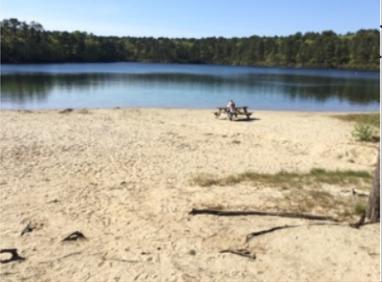
Toe or knee clearance at table not provided Picnic table not on an accessible route	- -	Provide at least 5% but not less than one picnic table with top between 28"- 34" above the ground and 27" clear height underneath in each distinct area where picnic tables are provided. Ensure that the dining surface is connected to an accessible route. (Cost based on an accessible picnic table and a 33' long beach mat to the picnic table.)	1	3309	\$3309

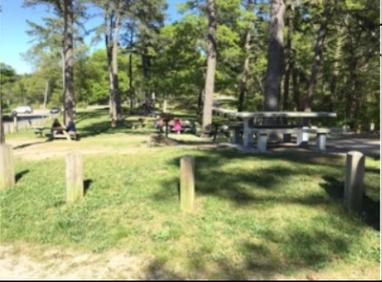
13	Picnic Area	Ext.		Picnic Tables	N/A

Toe or knee clearance at table not provided Picnic table not on an accessible route	- -	Provide at least one picnic table in this picnic area with top between 28"- 34" above the ground and 27" clear height underneath. Ensure that the dining surface is connected to an accessible route. (Cost based on an accessible picnic table and a 48" wide min. x 30' long stone dust path to, under and around the picnic table.)	1	2360	\$2360
14	Picnic Area Right of Toilet Room	Ext.		Picnic Tables	N/A

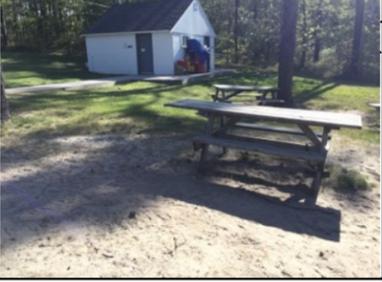
Toe or knee clearance at table not provided Picnic table not on an accessible route	- -	Provide at least one picnic table in this area with top between 28"- 34" above the ground and 27" clear height underneath. Ensure that the dining surface is connected to an accessible route. (Cost based on an accessible picnic table and a stone dust accessible route to and around the accessible picnic table in this area.)	1	1400	\$1400

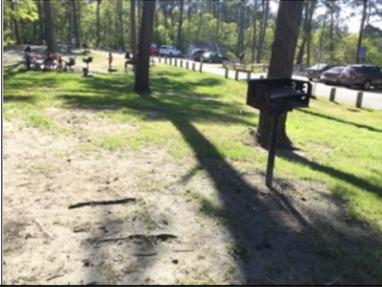
Not on a accessible route Surface not firm and stable Clear floor space not provided	- - -	Ensure at least 5% of grills but not less than one grill is located on an accessible route. Ensure surface is firm and stable. Ensure that a stable and firm surface and at least a 30" by 48" clear floor space is provided on all usable sides of grills. (Cost based on a 48" wide min. stone dust route from the parking area to and around the grill.)	2	960	\$1920
Benches												
16	First Viewing Area About 900' From Start of Path	Ext.		Benches	N/A

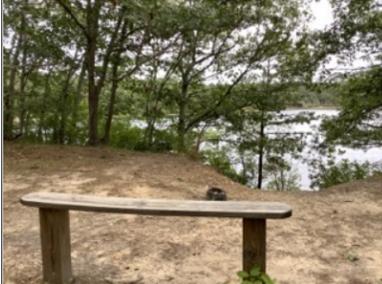
No accessible route to one bench in this area	-	Provide an accessible route to at least one bench in this area.	1	-	\$0
Toilet & Bathing Rooms												
Lavatory												
17	Women's Toilet Room	1		Lavatory	N/A

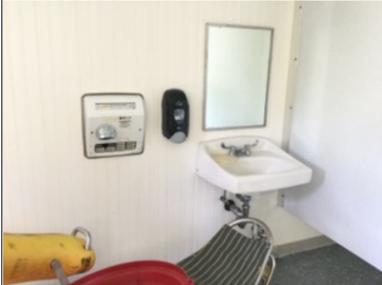
Exposed plumbing underneath	-	Insulate pipes to prevent contact at lavatory.	1	92	\$92

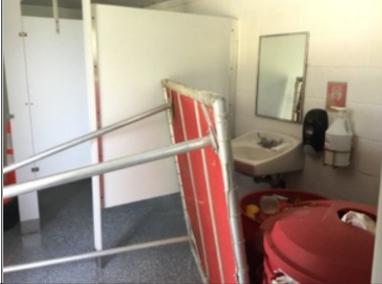
18	Men's Toilet Room	1		Lavatory

Exposed plumbing underneath Mirror above lavatory w/reflective surface > 40"	- 42.6"	Insulate pipes to prevent contact at lavatory. Lower mirror so that the bottom surface is at 40" max. above the finished floor.	1	348	\$348

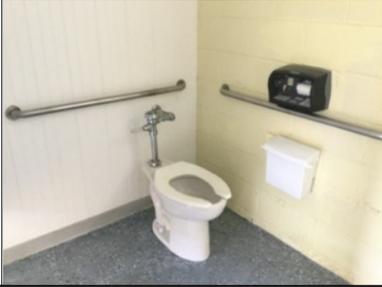
Centerline < or > 18" (MAAB)	19.2" -	Relocate toilet so that the centerline is 18" from the side wall.	1	2828	\$2828
Toilet Compartment												
20	Women's Toilet Room	1		Toilet Compartment	Accessible Compartment

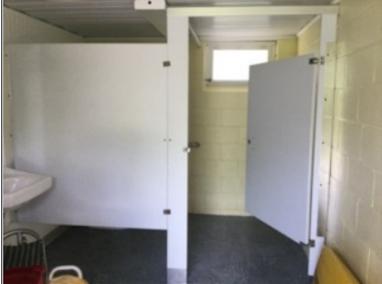
Door with non-compliant hardware Door with malfunctioning self-closing hinge	- -	Provide hardware that can be operable with one hand and not require tight grasping, pinching, or twisting of the wrist. Repair hinge.	1	70	\$70
21	Men's Toilet Room	1		Toilet Compartment	Accessible Compartment

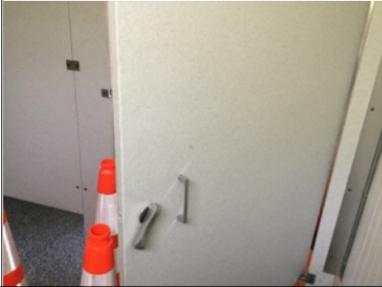
Door with malfunctioning self-closing hinge	-	Repair hinge.	1	Labor	\$0
22	Men's Toilet Room	1		Toilet Compartment	Accessible Compartment

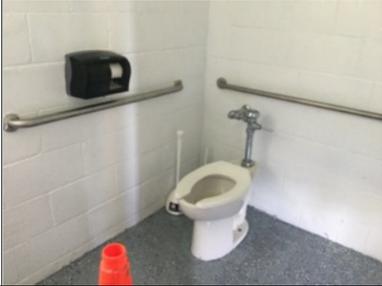
Non-compliant toilet paper dispenser	-	Relocate toilet paper so that it is located under the grab bar and higher than 15" above the finished floor; and between 7" and 9" from the front of the toilet.	1	353	\$353

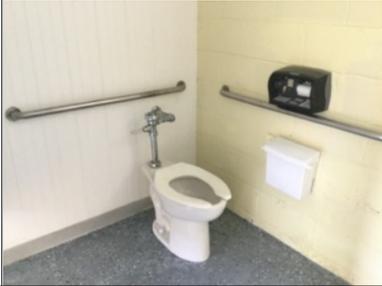
23	Women's Toilet Room	1		Toilet Compartment	Accessible Compartment

Non-compliant toilet paper dispenser	-	Relocate toilet paper so that it is located under the grab bar and higher than 15" above the finished floor; and between 7" and 9" from the front of the toilet. Or replace dispenser if it does not allow continuous paper flow.	1	353	\$353

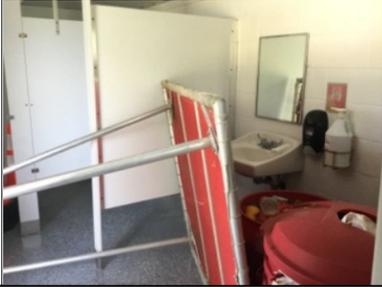
Dispenser acts as a protruding object	7.5"	Provide a cane-detectible barrier 27" max. above the finished floor under the suntan lotion dispenser.	1	306	\$306
Best Practice												
Lifeguard Stations												
25	View Towards Life Guard Stations	Ext.		Lifeguard Stations	N/A

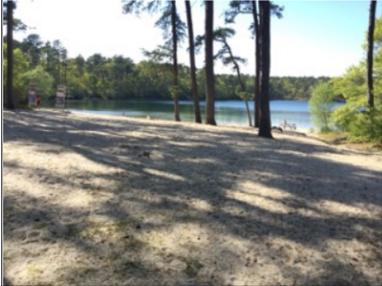
Recommend providing a stable and firm surface such as a beach mat connecting from the beach access route to at least one of the lifeguard stations so a visitor with a mobility disability could navigate to a life guard station should the need to do so arise.	1	-	\$0
Viewing Area												
26	Second Viewing Area About 2000' from Start of Path	Ext.		Viewing Area	Exterior

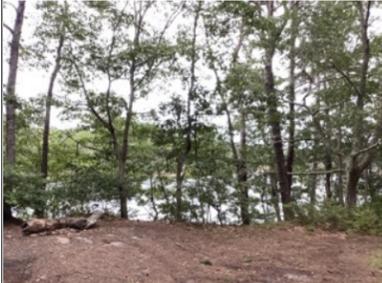
Recommend providing one bench with a back and one bench with arms at both viewing areas.	1	-	\$0
