Hyannis Village Green

ADA Transition Plan

Institute for Human Centered Design

**Barnstable
Hyannis Village Green**

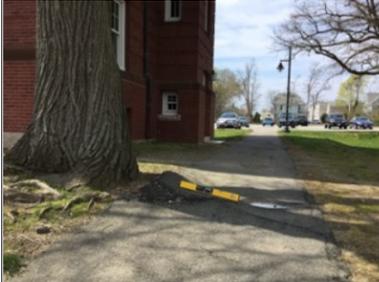
ID	Location	Floor	Room	Element	Type	Photo	Issues	Current Measure	Recommendations	Quantity	Price	Cost Estimation
Approach and Entrance												
Exterior Access Route												
1	Path to Town Hall Parking Lot	Ext.		Exterior Access Route	Walkway

Exterior route < 36" wide Route obstructed by protruding objects Cross slope > 1:50 (2.00%) Route not maintained in operable working condition	24" - 18.6% -	Ensure that a clear width of 36" min. is maintained at the accessible route. Reduce cross slope to be no steeper than 1:50 (2.00%). Ensure the accessible route is maintained in operable working condition. (Cost based on an asphalt patch to extend the accessible width of the walkway to a at least 36" min. (preferable 48" min.) adjacent to the raised tree root.)	1	240	\$240
2	Memorial to Village Green Pathway to Memorial, Both Sides	Ext.		Exterior Access Route	Walkway

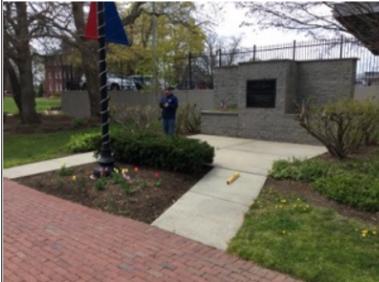
Surface openings > 1/2" Running slope > 1:20 (5%)	1" 10.5%	At right-side walkway (with level in photo) reduce gap between sections of cement. Reduce running slope to be no steeper than 1:20 (5%) at left walkway to the memorial (side that does not show the level). (Cost based on 4'x6' of cement to correct running slope (left side) and repair gap in cement (right side)).	1	384	\$384

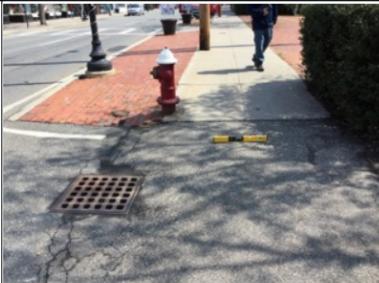
3	Hyannis Village Green by Main Street	Ext.		Exterior Access Route	Walkway

Cross slope > 1:50 (2.00%)	4.4%	Reduce cross slope to be no steeper than 1:50 (2.00%). (Cost based on asphalt to reduce cross slope.)	1	240	\$240
4	Near Chief Sachem Iyanough Sculpture	Ext.		Exterior Access Route	Walkway

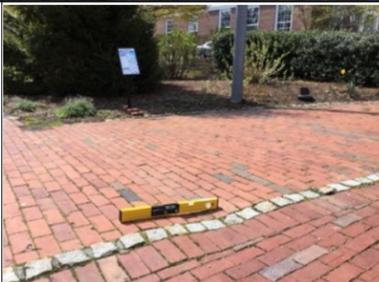
Cross slope > 1:50 (2.00%)	7.4%	Reduce cross slope to be no steeper than 1:50 (2.00%). (Cost based on a brick patch to reduce cross slope.)	1	416	\$416
5	Village Green Pathway by Chief Sachem Iyanough Sculpture	Ext.		Exterior Access Route	Walkway

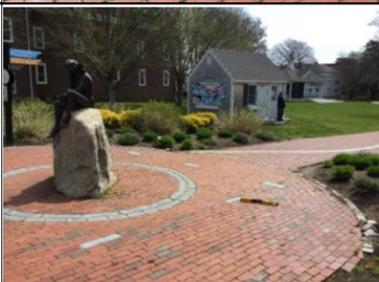
Cross slope > 1:50 (2.00%)	6.9%	Reduce cross slope to be no steeper than 1:50 (2.00%). (Cost based on a brick patch to reduce cross slope.)	1	416	\$416

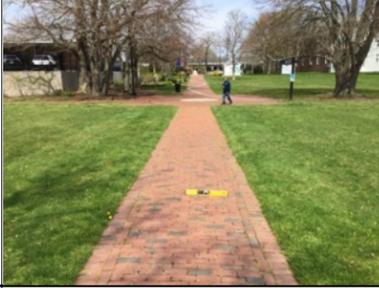
ID	Location	Floor	Room	Element	Type	Photo	Issues	Current Measure	Recommendations	Quantity	Price	Cost Estimation
6	Pathway From Town Hall to Village Green Center	Ext.		Exterior Access Route	Walkway

Cross slope > 1:50 (2.00%)	5.3%	Reduce cross slope to be no steeper than 1:50 (2.00%). (Cost based on a brick patch to correct cross slope.)	1	812	\$812
7	Near Chief Sachem Iyanough Sculpture	Ext.		Exterior Access Route	Walkway

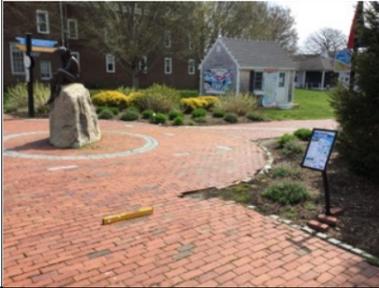
Cross slope > 1:50 (2.00%) Level changes > 1/4"	4% 1.5"	Reduce cross slope to be no steeper than 1:50 (2.00%). (Cost based on a brick patch to reduce cross slope.)	1	416	\$416
8	Village Green Entrance Facing Main Street	Ext.		Exterior Access Route	Walkway

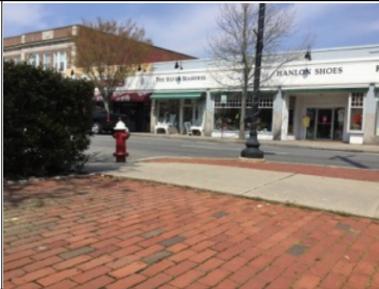
Level changes > 1/4"	1.5"	Alter change in level to be 1/4" high max. (Cost based on a brick patch to correct change in level between the brick and the cement.)	1	832	\$832
9	Village Green Entrance at Main Street	Ext.		Exterior Access Route	Walkway

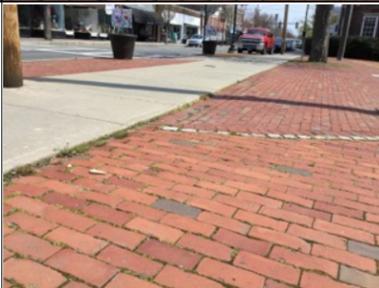
Level changes > 1/4"	1"	Alter change in level to be 1/4" high max. (Cost based on a brick patch to correct change in level between the brick and the cement.)	1	832	\$832

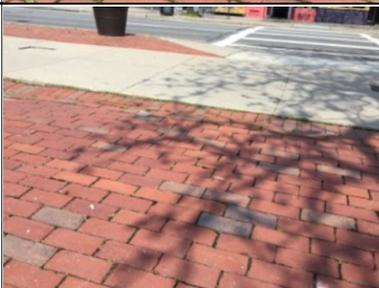
10	Village Green Entrance Facing Main Street	Ext.		Exterior Access Route	Walkway

Level changes > 1/4"	1"	Alter change in level to be 1/4" high max. Ensure bricks and transition from bricks to cement have a change in level that does not exceed 1/4".	1	416	\$416

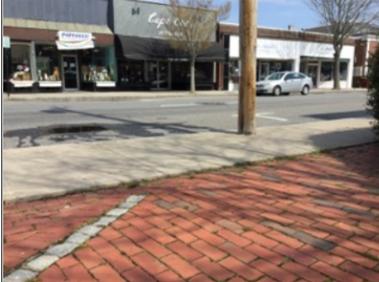
ID	Location	Floor	Room	Element	Type	Photo	Issues	Current Measure	Recommendations	Quantity	Price	Cost Estimation
11	Village Green Entrance by Main Street	Ext.		Exterior Access Route	Walkway

Level changes > 1/4"	1.5"	Alter change in level to be 1/4" high max. (Cost based on a brick patch by the Belgian block and concrete.)	1	832	\$832
12	Pathway by Information Center	Ext.		Exterior Access Route	Walkway

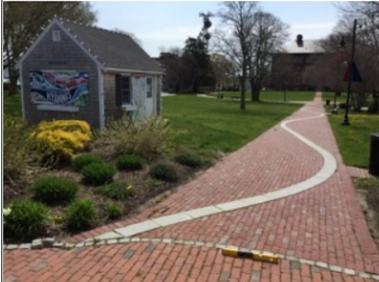
Level changes > 1/4"	1.5"	Alter change in level to be 1/4" high max. (Cost based on a brick patch to correct change in level and on the relaying of the Belgian block.)	1	416	\$416
13	Pathway From Town Hall to Village Green Center	Ext.		Exterior Access Route	Walkway

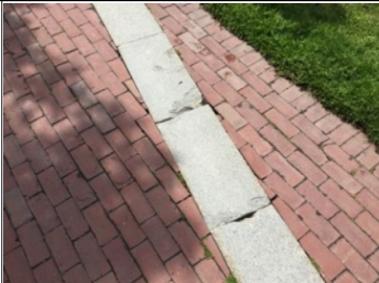
Level changes > 1/4"	1"	Alter change in level to be 1/4" high max.	1	256	\$256
14	Village Green Pathway Near Town Hall	Ext.		Exterior Access Route	Walkway

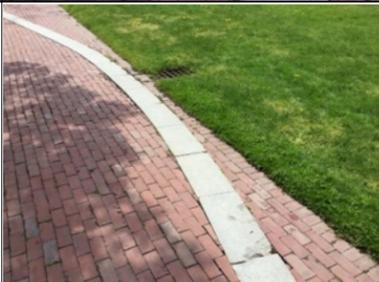
Level changes > 1/4"	1"	Alter change in level to be 1/4" high max.	1	256	\$256

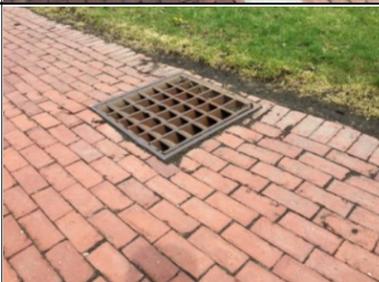
15	Grate on Village Green Near Town Hall	Ext.		Exterior Access Route	Walkway

Level changes > 1/4"	1	Alter change in level to be 1/4" high max. (Cost based on a brick patch at drain.)	1	416	\$416

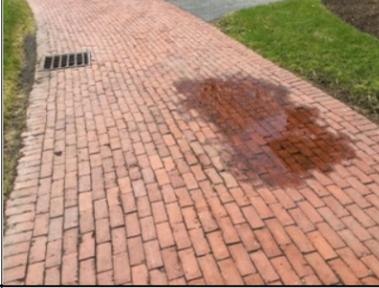
ID	Location	Floor	Room	Element	Type	Photo	Issues	Current Measure	Recommendations	Quantity	Price	Cost Estimation
16	Village Green Pathway by School Administration	Ext.		Exterior Access Route	Walkway

Level changes > 1/4" Does not prevent accumulation of water	0.75" -	Alter change in level to be 1/4" high max. Repair surface. (Cost based on a brick patch to correct recess in walkway.)	1	416	\$416
17	Information Center by Village Green Pathway	Ext.		Exterior Access Route	Exterior

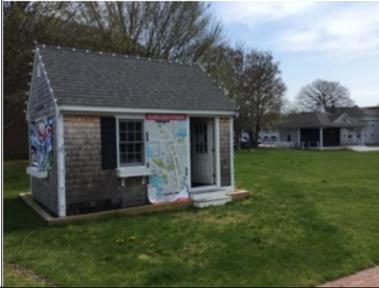
Accessible route not provided	-	Ensure an accessible route is provided. (Cost based on a brick surface from the existing walkway to the exterior area when information for the public is made available.)	1	832	\$832
18	Near Memorial	Ext.		Exterior Access Route	Exterior

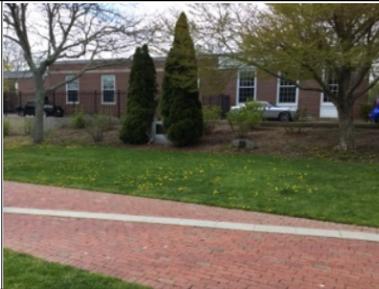
Accessible route not provided	-	Ensure an accessible route is provided. (Cost based on a 4' wide x 20" long brick walkway to the base of the memorial.)	1	2080	\$2080

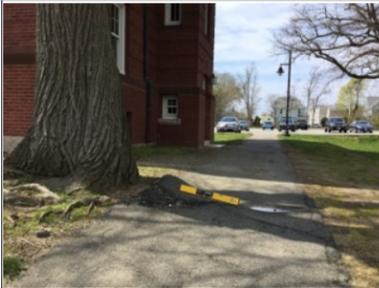
Tree Root												
19	Path to Town Hall Parking Lot	Ext.		Tree Root	N/A

Recommend providing highly visible fencing or some other type of barrier where the tree root significantly rises to prevent a tripping hazard.	1		\$0
Best Practice												
Bench												
20	Bench by Village Green Pathway	Ext.		Bench	N/A

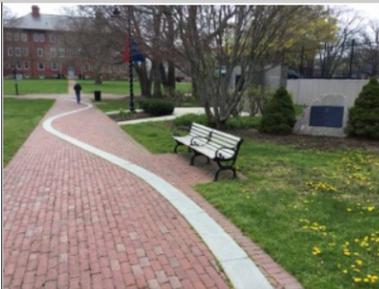
Recommend providing a 36" by 48" firm, stable and slip-resistant area alongside one bench in each area of the park where benches are provided so that a person using a wheelchair or other mobility device is able to sit alongside someone seated on the bench with her/his shoulders aligned.	1	-	\$0

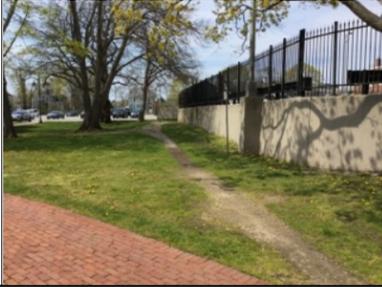
ID	Location	Floor	Room	Element	Type	Photo	Issues	Current Measure	Recommendations	Quantity	Price	Cost Estimation
Desire Line												
21	Desire Line to Town Hall Parking Lot	Ext.		Desire Line	N/A

Recommend providing a 48" wide min. stable, firm and slip-resistant accessible walkway from the existing walkway in Hyannis Village Green along the desire line running across the grass to the Town Hall parking lot.	1	-	\$0
Open Space												
22	Village Green Walkway	Ext.		Open Space	Grass Area by Walkway

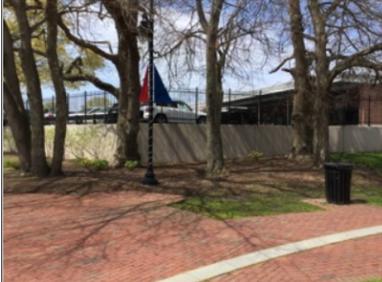
Recommend inserting plants or filling in grassy area with bricks or some other stable, firm and slip-resistant surface to prevent a tripping hazard where the bricks and grass border each other.	1		\$0
