McKeon Park

Town of Barnstable ADA Transition Plan

Institute for Human Centered Design

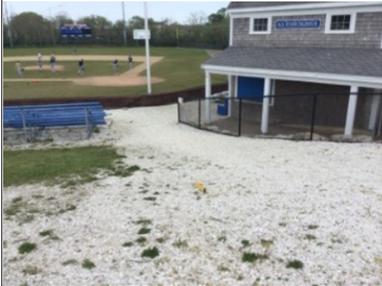
Running slope > 1:20 (5%) Surface is not stable, firm, and slip-resistant Accessible route not provided	23.9% - -	Due to excessive slopes, providing an accessible route from the parking area to the field level on the first base side of the field is not feasible. There is also no other feasible accessible route to the field.	1	-	\$0
2	Path From Parking to Third Base Side of Baseball Field	Ext.		Exterior Access Route	Exterior

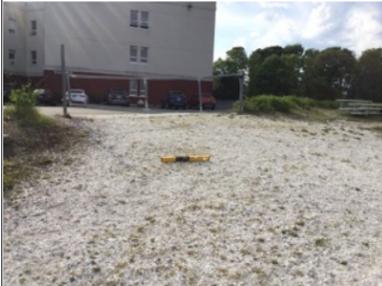
Running slope > 1:20 (5%) Surface is not stable, firm, and slip-resistant Accessible route not provided	16.9% - -	Due to excessive slopes, providing an accessible route from the parking area to the field level on the third base side of the field is not feasible. There is also no other feasible accessible route to the field.	1	-	\$0

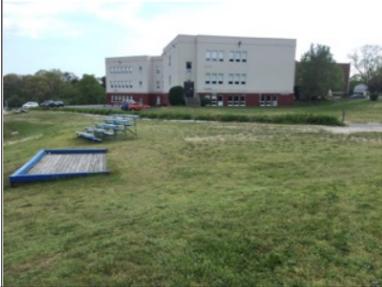
3	Accessible Seating Area	Ext.		Exterior Access Route

Accessible route not provided	-	Ensure an accessible route is provided from the northwest parking area to the visiting team side accessible seating area and to a new comparable home team side accessible seating area with a running slope of !:20 (5.00%) max. and a cross slope of 1:50 (2.00%) max.) (Cost based on two 4' wide min. x 60' stone dust paths to each accessible seating area.)	2	1920	\$3840
Off-Street Parking Lot or Garage												
4	Unpaved Accessible Parking on Northwest Side of Field Near Accessible Seating	Ext.		Off-Street Parking Lot or Garage	N/A

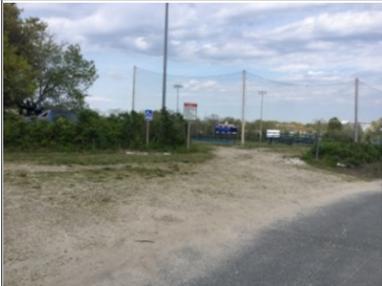
Access aisle not provided Sign does not have the designation "Van Accessible" Sign bottom < 60" above finished grade	- - 55"	Provide a marked access aisle that is at least 96" wide. Add the designation "Van Accessible" to the sign located at the van accessible space. Locate sign with the bottom of the sign 60" min. and the top of the sign 96" max. above the ground. (See figure in report narrative for example of how to mark an accessible parking space in an unpaved lot.)	1	800	\$800

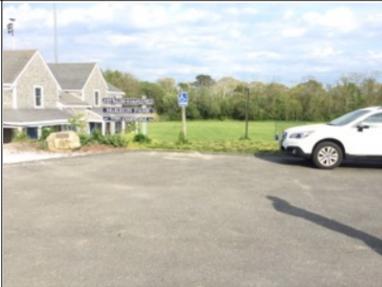
5	Near Path to Press Box	Ext.		Off-Street Parking Lot or Garage	N/A

Access aisle not provided Sign bottom < 60" above finished grade	- 37"	Provide a marked access aisle that is at least 60" wide. Locate sign with the bottom of the sign 60" above the ground.	1	300	\$300

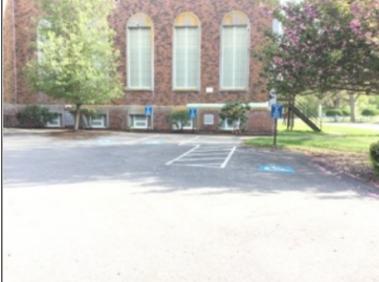
Access aisle not provided Sign bottom < 60" above finished grade	- 46"	Provide a marked access aisle that is at least 60" wide at the accessible space that lacks an access aisle. Locate each sign with the International Symbol of Accessibility (ISA) with the bottom of the sign 60" min. and the top of the sign 96" max. above the ground.	1	300	\$300
7	Near Parking Spot 96	Ext.		Off-Street Parking Lot or Garage	N/A

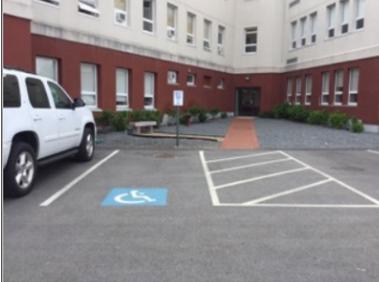
Sign does not have the designation "Van Accessible" Sign bottom < 60" above finished grade	- 52.5"	Add a sign with the International Symbol of Accessibility (ISA) and the designation "Van Accessible". Locate sign with the bottom of the sign 60" min. above the ground. Note: If you choose to keep the space for emergency vehicles, provide another compliant van accessible space and recommend removing the ISA from the ground at the emergency vehicle space.	1	500	\$500

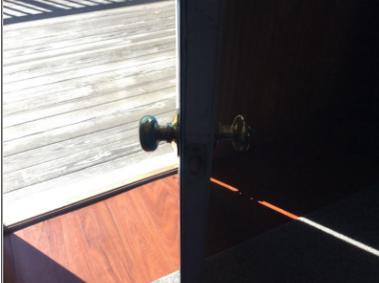
Hardware not operable with a closed fist	-	Provide hardware that can be operable with one hand and not require tight grasping, pinching, or twisting of the wrist.	1	484	\$484
9	To Press Box	Ext.		Doors, Doorways, & Gates	N/A

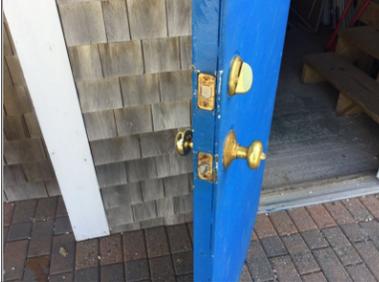
Hardware not operable with a closed fist	-	Provide hardware that can be operable with one hand and not require tight grasping, pinching, or twisting of the wrist.	1	484	\$484
Stairways												
10	Stair To and From Press Box	G		Stairways	Interior

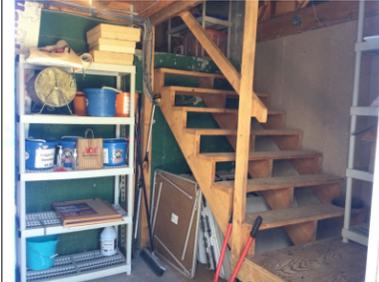
Handrails do not extend 12" from stairs Handrails have non-compliant cross section Handrails not provided Stair has open risers	- - - -	Bottom: Ensure that the sloped bottom extension extends one tread depth minimum beyond last riser nosing in same direction as stair flight. Provide handrails with a 1 1/4" - 2" circular cross section. Provide handrails on one side. Ensure stairs have closed risers. (Cost based on two compliant handrails and closing risers.)	1	1576	\$1576

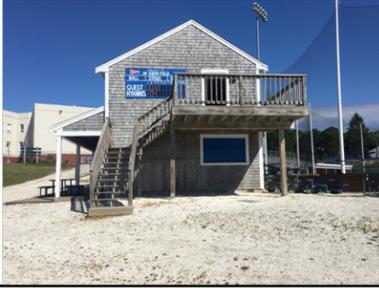
Handrails do not extend 12" from stairs Handrails have non-compliant cross section Handrails not provided Stair has open risers	- - - -	Bottom: Ensure that the sloped bottom extension extends one tread depth minimum beyond last riser nosing in same direction as stair flight. Provide handrails with a 1 1/4" - 2" circular cross section. Provide handrails on one side. Ensure stairs have closed risers. (Cost based on two compliant handrails and closing risers.)	1	1576	\$1576
Play and Sport Areas												
Bleachers												
12	Accessible Seating Area	Ext.		Bleachers	N/A

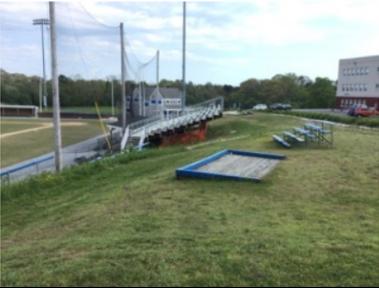
Total number of seats in the facility Min. # of designated wheelchair spaces not provided	3000 -	In order to provide program accessibility for accessible seating, double the width and depth of the accessible seating platform on the visitors side of the field and provide a comparable seating platform located on an accessible route on the home side of the field. Have portable companion seats available for each location. (Cost dependent of chosen method of construction.)	2	-	\$0
