# Olde Barnstable Fairgrounds Golf Course

## ADA Transition Plan

October 2021

Institute for Human Centered Design

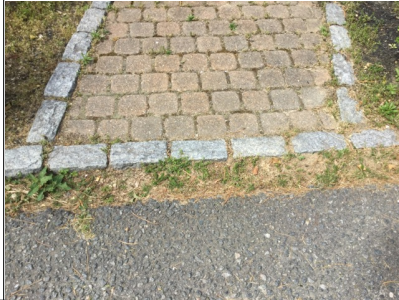
ID	Location	Floor	Room	Element	Type	Photo	Issues	Current Measure	Recommendations	Quantity	Price	Cost Estimation
<b>Approach and Entrance</b>												
<b>Exterior Access Route</b>												
1	Pro Shop Back Garden	Ext.		Exterior Access Route	Walkway

Surface openings > 1/2" Level changes > 1/4"	6.75" 1"	Reduce openings to 1/2" max. Alter change in level to be 1/4" high max.  (Cost based on an asphalt patch.)	1	160	\$160
2	Route From Lower Parking Lot to Pro Shop	Ext.		Exterior Access Route	Exterior

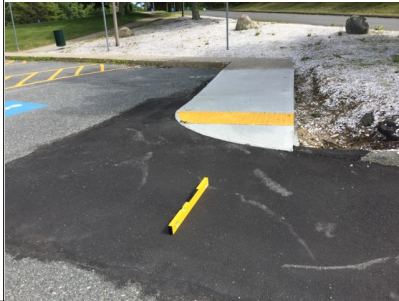
Running slope > 1:20 (5%)	13.4%	Reduce running slope to be no steeper than 1:20 (5%).  (Cost based on asphalt to reduce slope.)	1	256	\$256
3	Driving Range	Ext.		Exterior Access Route	Exterior

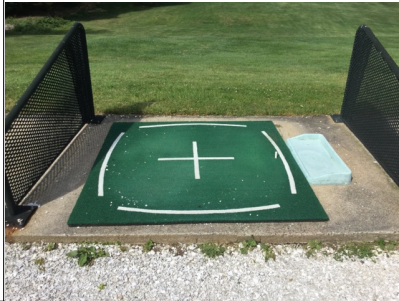
Level changes > 1/4" Surface is not stable, firm, and slip-resistant Accessible route not provided	3.25" - -	Alter change in level to be 1/4" high max. Ensure an accessible route is provided.  (Cost based on an asphalt patch connected to the new accessible route at at least one driving range bay.)	1	256	\$256

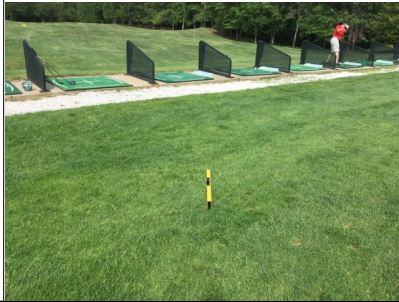
4	Route From Lower Parking Lot to Driving Range	Ext.		Exterior Access Route	Exterior

Surface is not stable, firm, and slip-resistant Accessible route not provided	- -	Ensure an accessible route is provided from the lower parking lot to the driving range.  (Cost based on an 4' wide min. x 30 asphalt route to the driving range with a maximum running slope of 1:20 (5.00%) and a maximum cross slope of 1:50 (2.00%).)	1	1200	\$1200
5	Route From Parking to Pro Shop	Ext.		Exterior Access Route	Walkway

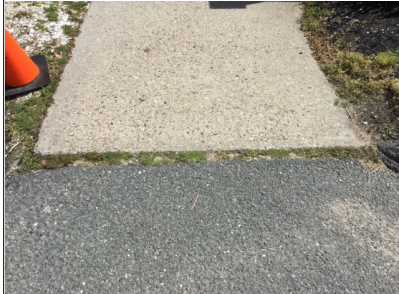
Route not maintained in operable working condition	2.5"	Ensure the accessible route is maintained in operable working condition.  (Cost based on a 4'x4' concrete patch to repair 2.5" gap.)	1	256	\$256

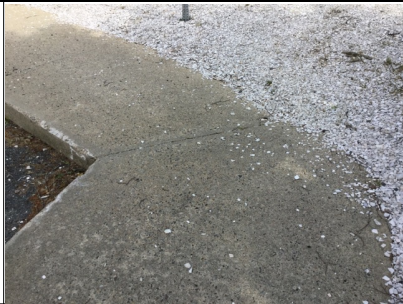
ID	Location	Floor	Room	Element	Type	Photo	Issues	Current Measure	Recommendations	Quantity	Price	Cost Estimation
6	Route From Lower Parking Lot to Pro Shop	Ext.		Exterior Access Route	Walkway

Route not maintained in operable working condition	-	Ensure the accessible route is maintained in operable working condition. (Remove debris from path.)	1	Labor	\$0
7	Near Hole 10	Ext.		Exterior Access Route

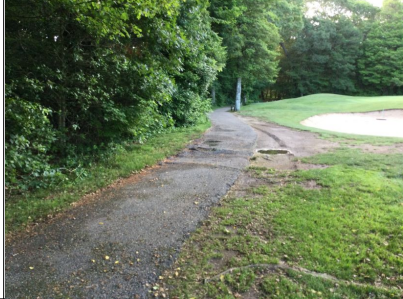
Route not maintained in operable working condition	-	Ensure the accessible route is maintained in operable working condition.  (Cost based on an asphalt patch at area damaged by a tree root.)	1	256	\$256
8	Tee 2	Ext.		Exterior Access Route	Exterior

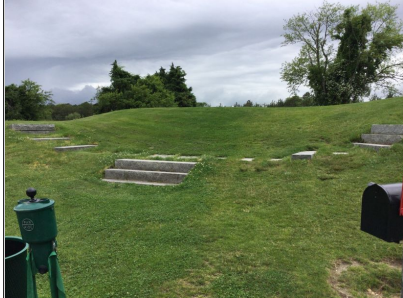
Accessible route not provided	-	Ensure an accessible route is provided. (Ensure a route is provided such that a golf cart can reach each of the teeing grounds at the second hole.)	1	Labor	\$0
<b>Off-Street Parking Lot or Garage</b>

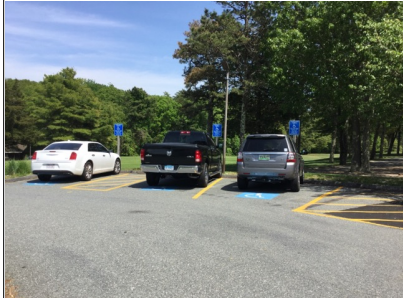
9	Parking Next to Pro Shop	Ext.		Off-Street Parking Lot or Garage	N/A

Total # of parking Total # of designated accessible parking spaces Total # of designated van accessible spaces Running or cross slope at space > 1:50 (2.00%)	130 2 1 3.5%	Provide two additional compliant car accessible parking spaces with a sign including the International Symbol of Accessibility (ISA) and marked access aisle. Reduce running or cross slope at existing accessible spaces to be no steeper than 1:50 (2.00%) in all directions. (Cost for 2 new spaces and for asphalt to correct slope at existing space.)	1	5140	\$5140
10	Lower Parking Lot Near Driving Range	Ext.		Off-Street Parking Lot or Garage	N/A

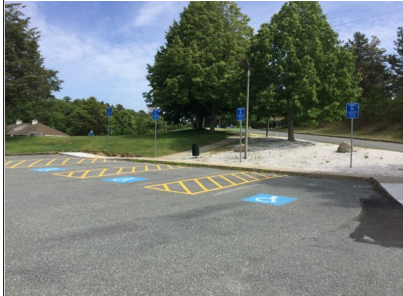
Running or cross slope at access aisle > 1:50 (2.00%)	3.9%	Reduce running or cross slope to be no steeper than 1:50 (2.00%).  (Cost based on asphalt to reduce slope.)	1	900	\$900

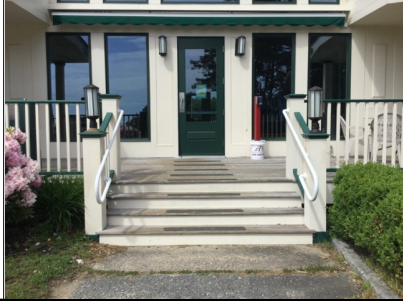
ID	Location	Floor	Room	Element	Type	Photo	Issues	Current Measure	Recommendations	Quantity	Price	Cost Estimation
<b>Entrance</b>												
11	Back Deck Stairs to Golf Course	Ext.		Entrance	N/A

Directional sign to accessible entrance not provided	-	Provide a directional sign indicating the location of the nearest accessible entrance.	1	346	\$346
12	Door From Back Deck to Pro Shop Lobby	Ext.		Entrance	Secondary Entrance

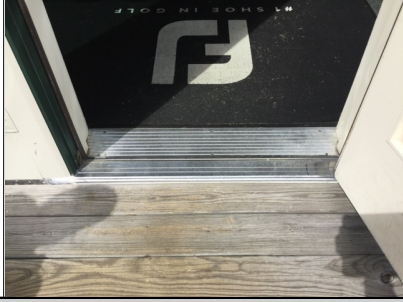
Threshold is > 1/2" high	1"	Alter threshold to be 1/2" high max.	1	150	\$150
<b>Emergency Exit</b>												
13	Pro Shop	1		Emergency Exit	N/A

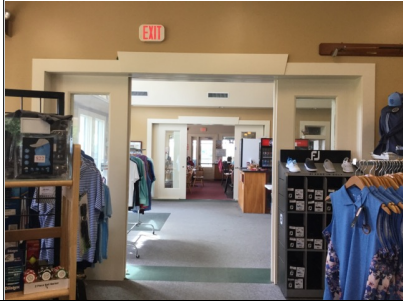
Tactile sign not provided at emergency exit	-	Provide a sign with raised characters ad braille at the emergency exit.	1	232	\$232
14	Restaurant Door Facing Back Deck	1		Emergency Exit	N/A

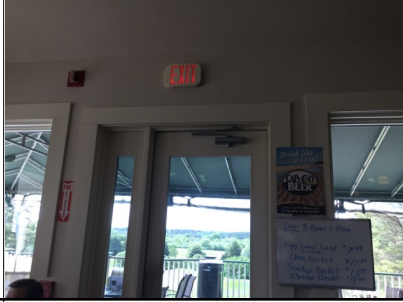
Tactile sign not provided at emergency exit Directional sign to accessible emergency exit not provided	- -	Provide a sign with raised characters ad braille at the emergency exit. Provide a directional sign indicating the location of the nearest accessible emergency exit.	1	232	\$232

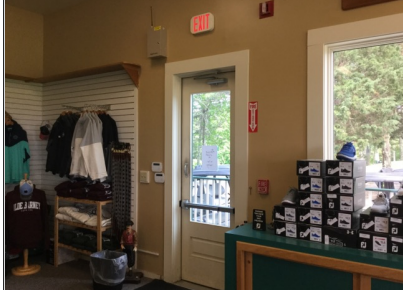
15	Door From Pro Shop to Back Deck	1		Emergency Exit	N/A

Tactile sign not provided at emergency exit Directional sign to accessible emergency exit not provided	- -	Provide a sign with raised characters ad braille at the emergency exit. Provide a directional sign indicating the location of the nearest accessible emergency exit.	1	232	\$232

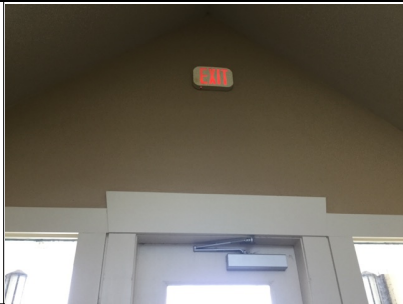
ID	Location	Floor	Room	Element	Type	Photo	Issues	Current Measure	Recommendations	Quantity	Price	Cost Estimation
16	Pro Shop Entrance	1		Emergency Exit	N/A

Tactile sign not provided at emergency exit Illuminated International Symbol of Acc. not provided (MAAB)	- -	Provide a sign with raised characters and braille at the emergency exit. If the exit sign is replaced with a new illuminated exit sign, provide an illuminated International Symbol of Accessibility (ISA).	1	232	\$232
<b>Access to Goods and Services</b>												
<b>Interior Access Route</b>												
17	Route to Men's Toilet Room	1		Interior Access Route	Interior

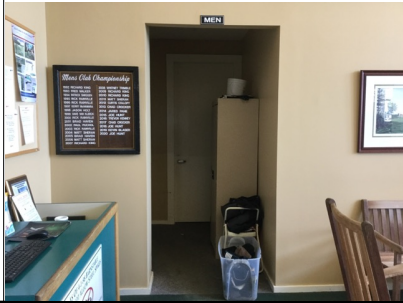
Route < 36" wide	25"	Ensure that a clear width of 36" min. is maintained at the accessible route.	1	Labor	\$0
18	Restaurant	1		Interior Access Route	Interior

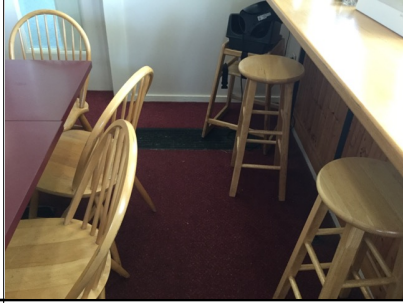
Route < 36" wide	30"	Ensure that a clear width of 36" min. is maintained at the accessible route.	1	Labor	\$0

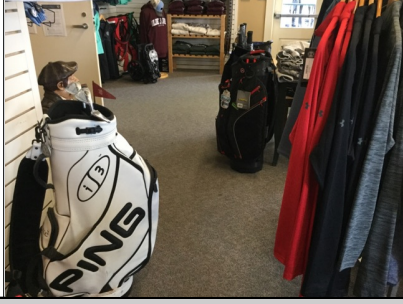
19	Pro Shop	1		Interior Access Route	Interior

Route < 36" wide	24"	Ensure that a clear width of 36" min. is maintained at the accessible route.	1	Labor	\$0
<b>Ramps</b>												
20	Drink Vending Machine Shed Near Tee 7	Ext.		Ramps	Exterior

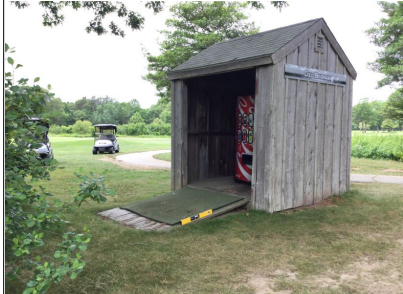
Running slope >1:12 (8.33%) Edge protection < 4" high Handrails not provided	14.2% - -	Reduce running slope to be no steeper than 1:12 (8.33%). Provide edge protection. Provide handrails with 1-1/4" to 1-1/2" circular cross section.  (Cost based on a 4' wide min. x 7.5' long compliant pressure treated wood straight ramp into the vending machine shed.)	1	980	\$980

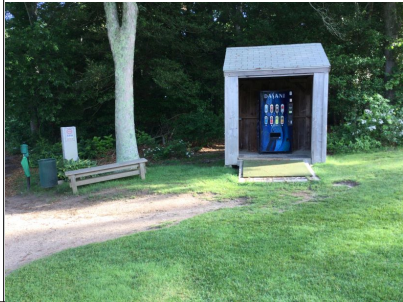
ID	Location	Floor	Room	Element	Type	Photo	Issues	Current Measure	Recommendations	Quantity	Price	Cost Estimation
21	Drink Vending Machine Shed Near Tee 13	Ext.		Ramps	Exterior

Running slope >1:12 (8.33%) Edge protection < 4" high Handrails not provided	9.5% - -	Reduce running slope to be no steeper than 1:12 (8.33%). Provide edge protection. Provide handrails with 1-1/4" to 1-1/2" circular cross section.  (Cost based on a 4' wide min. x 7.5' long compliant pressure treated wood straight ramp into the vending machine shed.)	1	980	\$980
22	Route From Parking to Pro Shop	Ext.		Ramps	Exterior

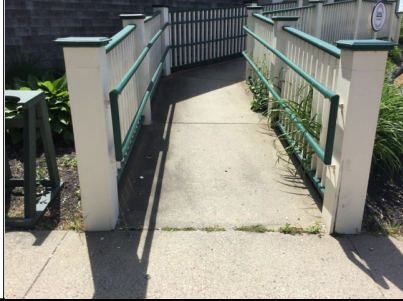
Handrails do not extend 12" past top & bottom	-	Alter handrails to extend horizontally above the landing for 12" min. beyond the top and bottom of ramp runs.  (Cost based on welding extensions to existing pipe.)	1	568	\$568
<b>Stairways</b>												
23	Route From Parking to Pro Shop	Ext.		Stairways	Exterior

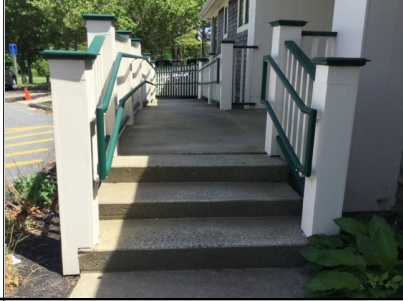
Handrails do not extend 12" from stairs	-	Alter handrails to extend horizontally above the landing for 12" min. beyond the bottom of ramp runs.  (Cost based on welding extensions to existing pipe.)	1	284	\$284

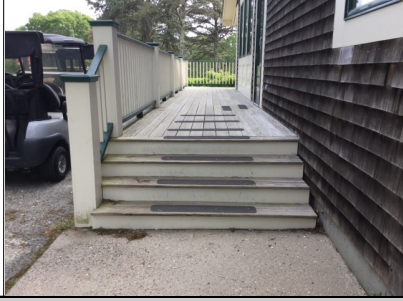
24	Stairs to Pro Shop Deck	Ext.		Stairways	Exterior

Handrails do not extend 12" from stairs Handrails have non-compliant cross section Handrails not provided	- - -	Ensure that the sloped bottom extension extends one tread depth minimum beyond last riser nosing in same direction as stair flight. Provide handrails with a 1 1/4" - 2" circular cross section. Provide handrails on one side.  (Cost based on two 10' long wall mounted metal handrails with a compliant cross section.)	1	1480	\$1480
<b>Signage</b>												
25	Men's Toilet Room	1		Signage	Designation

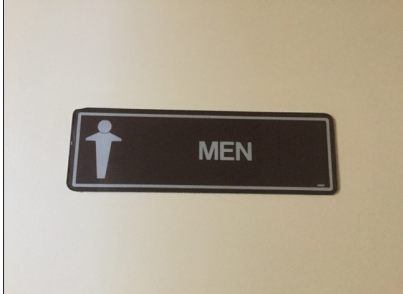
Raised characters not provided Braille not provided Sign not located on the latch side of the door	- - -	Provide text with raised characters duplicated in braille. Locate sign at permanent rooms alongside the door on the latch side.	1	232	\$232

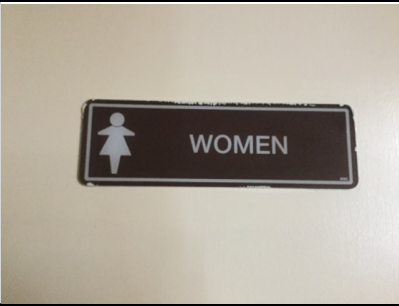
ID	Location	Floor	Room	Element	Type	Photo	Issues	Current Measure	Recommendations	Quantity	Price	Cost Estimation
26	Women's Toilet Room	1		Signage	Designation

Raised characters not provided Braille not provided Sign not located on the latch side of the door	- - -	Provide text with raised characters duplicated in braille. Locate sign at permanent rooms alongside the door on the latch side.	1	232	\$232
<b>Service Counter</b>												
27	Snack Bar	1		Service Counter	N/A

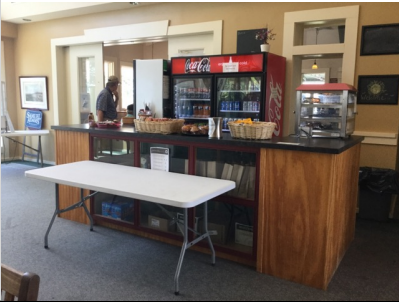
Counter > 36" high	42"	Provide a counter that is 36" max. above the ground.	1	880	\$880
<b>Operable Parts</b>												
28	Route From Lower Parking Lot to Pro Shop	Ext.		Operable Parts	Trash can

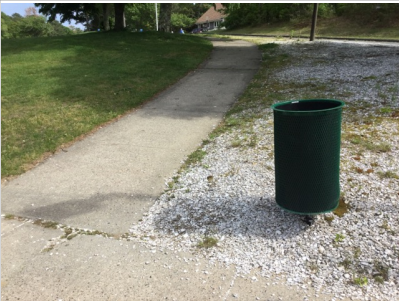
Element not on an accessible route	-	Ensure trash receptacle is located on an accessible route.	1	Labor	\$0
29	Snack Bar	1		Operable Parts	N/A

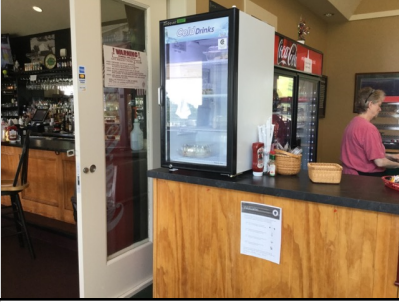
Reach < 15" or > 48"(forward/side approach)	60"	Relocate the refrigerator so that controls are between 15"- 48" above the finished floor.	1	Labor	\$0

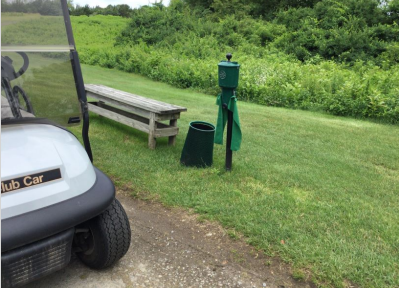
30	Tee 8	Ext.		Operable Parts	N/A

Not operable with a closed fist	-	Operation of the golf ball cleaner requires tight grasping, pinching or twisting of the wrist and therefore is not accessible. However, IHCD is not aware of any golf ball cleaner design or hardware that is accessible.	1	-	\$0

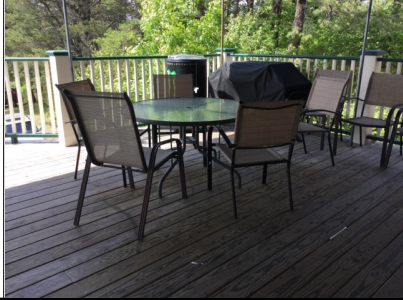
ID	Location	Floor	Room	Element	Type	Photo	Issues	Current Measure	Recommendations	Quantity	Price	Cost Estimation
<b>Picnic Tables</b>												
31	Restaurant Deck	Ext.		Picnic Tables	Dining Table

Toe or knee clearance at table not provided	25"	Provide at least one dining surface with top between 28"- 34" above the ground and 27" clear height underneath.	1	700	\$700
<b>Benches</b>												
32	Route From Lower Parking Lot to Pro Shop	Ext.		Benches	N/A

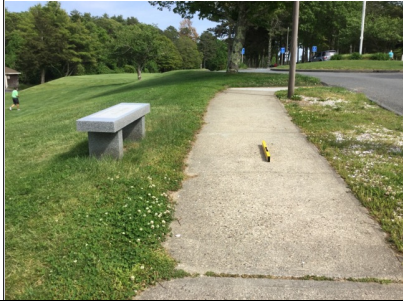
No accessible route to one bench in this area	-	Provide an accessible route to at least one bench in this area and locate at least one bench in other areas with benches on an accessible route. (Cost based on a 4' wide min. x 6' long asphalt path to one end of bench extending 12" min. beyond the back of the bench so someone using a wheeled mobility device could sit with shoulders aligned with someone on the bench.)	1	240	\$240
<b>Toilet &amp; Bathing Rooms</b>

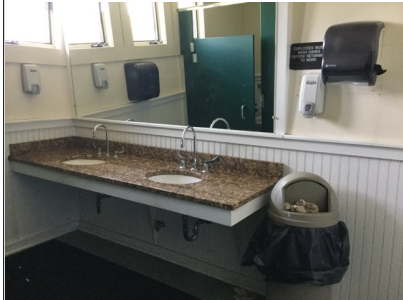
<b>Lavatory</b>												
33	Men's Toilet Room	1		Lavatory	N/A

Exposed plumbing underneath Mirror above lavatory w/reflective surface > 40" Dispensers not within reach range	- 42.25" 58"	Insulate or otherwise configure pipes to prevent contact for at least one lavatory. Lower mirror so that the bottom surface is at 40" max. above the finished floor. Lower dispensers to 48" max. above the floor.	1	604	\$604
34	Women's Toilet Room	1		Lavatory	N/A

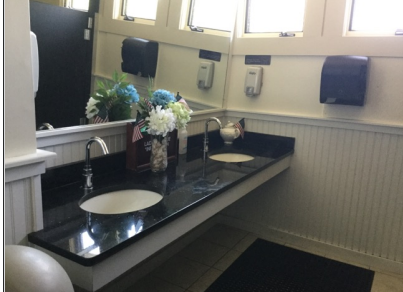
Exposed plumbing underneath Mirror above lavatory w/reflective surface > 40" Dispensers not within reach range	- 44" 57"	Insulate or otherwise configure pipes to prevent contact for at least one lavatory. Lower mirror so that the bottom surface is at 40" max. above the finished floor. Lower dispensers to 48" max. above the floor.	1	604	\$604

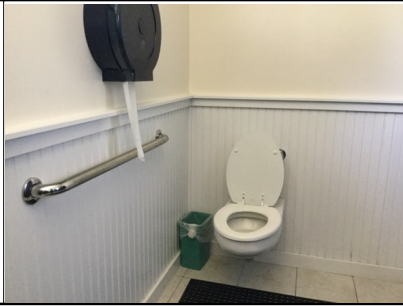
Grab bars not provided Non-compliant toilet paper dispenser	- -	Provide one grab bar on the rear wall. Relocate toilet paper so that it is located under the grab bar and higher than 15" above the finished floor; and between 7" and 9" from the front of the toilet. Or replace dispenser if it does not allow continuous paper flow.	1	705	\$705

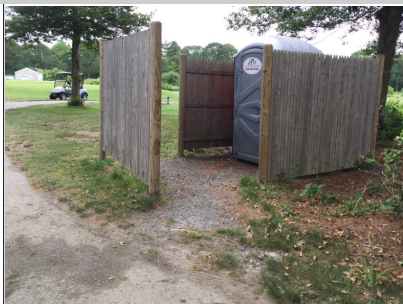
Not located on an accessible route Accessible portable toilets not provided	- -	Provide an accessible portable toilet that has 60" wide and 72" deep clear floor space at the toilet. Ensure that at least 5% of portable toilets (at least 1 where portable toilets are provided) are accessible. (Cost for a 4' wide min. x 6' long asphalt path from existing path to toilet entry. Cost for portable toilet not provided.)	1	240	\$240
39	Portable Toilet Near Hole 14	Ext.		Portable Toilet	N/A

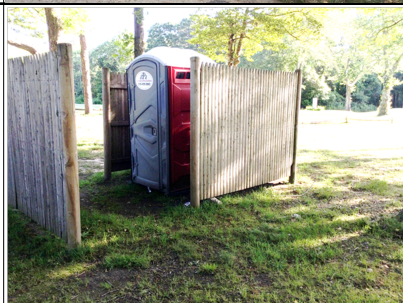
Not located on an accessible route Accessible portable toilets not provided	- -	Provide an accessible portable toilet that has 60" wide and 72" deep clear floor space at the toilet. Ensure that at least 5% of portable toilets (at least 1 where portable toilets are provided) are accessible. (Cost for a 4' wide min. x 6' long asphalt path from existing path to toilet entry. Cost for portable toilet not provided.)	1	240	\$240

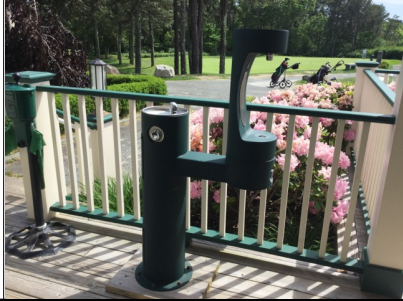
ID	Location	Floor	Room	Element	Type	Photo	Issues	Current Measure	Recommendations	Quantity	Price	Cost Estimation
<b>Drinking Fountains</b>												
40	Restaurant Deck	Ext.		Drinking Fountains	Standing

No drinking fountain provided for seated users	-	Provide an additional drinking fountain for seated users or install a Hi-Lo drinking fountain.	1	4028	\$4028
<b>Best Practice</b>												
<b>Bench</b>												
41	Tee 8	Ext.		Bench	N/A

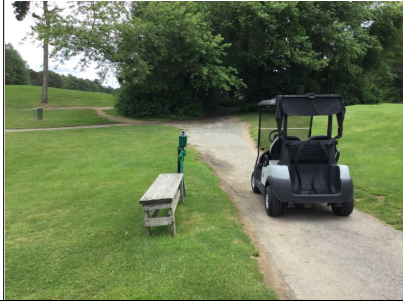
Recommend providing a 36" wide by 48" deep stable, firm and slip resistant surface such as asphalt or stone dust at one end of the benches on the golf course so a person with a wheeled mobility device could sit at one end of the bench with his or her shoulders aligned with someone seated on the bench.	1	-	\$0
<b>Exterior Step</b>												
42	Route From Parking to Pro Shop	Ext.		Exterior Step	N/A

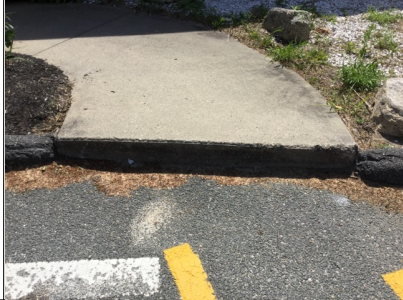
Recommend providing color contrast to alert about the 5.5" change in level.	1	-	\$0

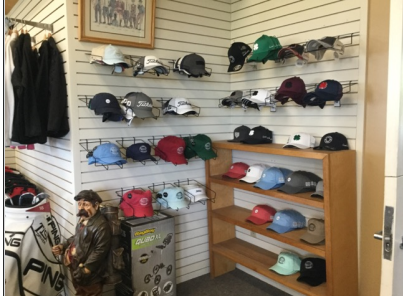
<b>Pro Shop</b>												
43	Pro Shop	1		Pro Shop	Hat Racks

Ensure assistance is provided to customers for whom some merchandise is out of reach range.	1		\$0

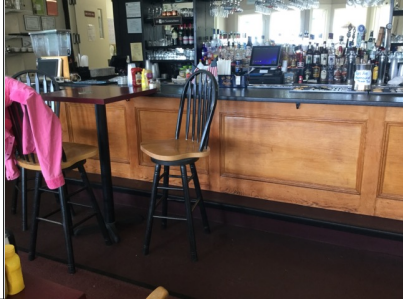
ID	Location	Floor	Room	Element	Type	Photo	Issues	Current Measure	Recommendations	Quantity	Price	Cost Estimation
<b>Restaurant</b>												
44	Restaurant	1		Restaurant	Bar Counter

Recommend providing a 36" high max. portion of the bar for guests using a wheeled mobility or similar device or guests of short stature.	1		\$0
