# Adult Community Center

## Town of Barnstable ADA Transition Plan

August 2021

Institute for Human Centered Design

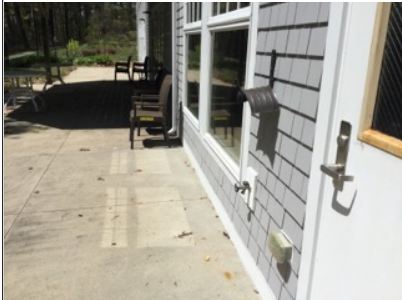
Obstructed by protruding objects	8"	Relocate water hose holder so it does not protrude into the circulation path.	1	Labor	\$0
3	Upper Level Garden	Ext.		Exterior Access Route	Exterior

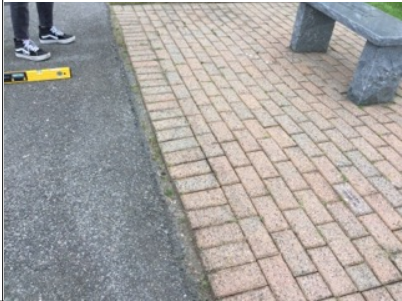
Surface openings > 1/2"	3.5"	Repair surface.	1	-	\$0
4	Path From Lower Level to Upper Level - Garden	Ext.		Exterior Access Route	Walkway

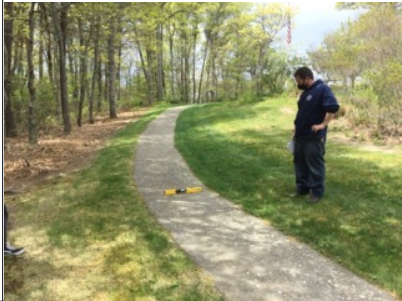
Cross slope > 1:50 (2.00%)	3.4%	Reduce cross slope to be no steeper than 1:50 (2.00%).	1	-	\$0
5	Path Near Upper Level From Lower Level - Garden	Ext.		Exterior Access Route	Walkway

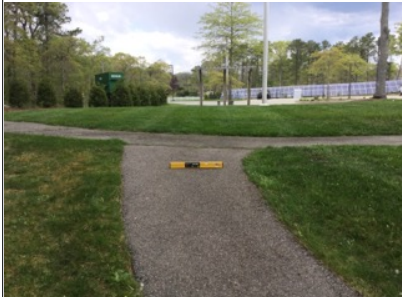
Cross slope > 1:50 (2.00%)	8.1%	Reduce cross slope to be no steeper than 1:50 (2.00%).	1	-	\$0

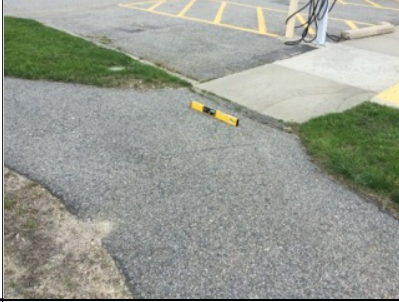
Cross slope > 1:50 (2.00%)	4.3%	Reduce cross slope to be no steeper than 1:50 (2.00%).	1	-	\$0
7	Upper Level Garden	Ext.		Exterior Access Route	Exterior

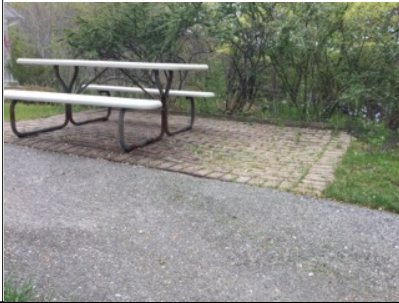
Surface is not stable, firm, and slip-resistant	-	Repair surface.	1	-	\$0
8	Upper Level Garden	Ext.		Exterior Access Route	Walkway

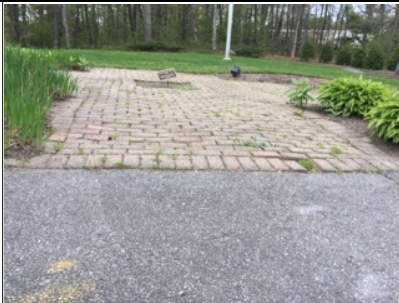
Surface is not stable, firm, and slip-resistant	-	Repair surface.	1	-	\$0
9	Garden	Ext.		Exterior Access Route	Walkway

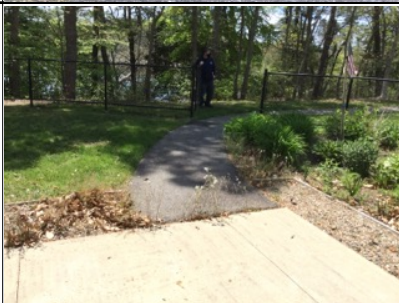
Route not maintained in operable working condition	-	Ensure the accessible route is maintained in operable working condition.	1	Labor	\$0
10	Path From Lower Level to Upper Level - Garden	Ext.		Exterior Access Route	Walkway

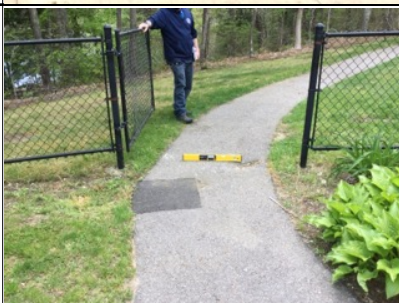
Route not maintained in operable working condition	-	Ensure the accessible route is maintained in operable working condition.	1	-	\$0

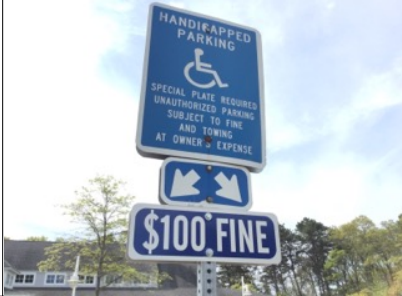
Identification sign not compliant	-	An identification sign is needed at each accessible parking space.	6	500	\$3000
<b>Entrance</b>												
13	Main Entrance/Exit	Ext.		Entrance	Main Entrance

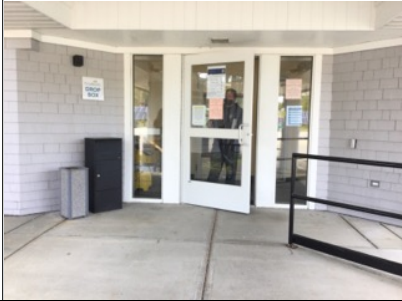
International Symbol of Accessibility not provided	-	Provide a sign with the International Symbol of Accessibility (ISA).	1	346	\$346
<b>Emergency Exit</b>

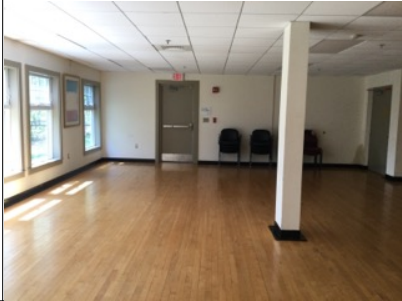
14	Exercise Room	1		Emergency Exit

Tactile sign not provided at exit Directional sign to accessible emergency exit not provided		Provide a tactile exit sign with raised characters and braille at exit door. Mount sign between 48"- 60" above the finished floor located on the latch side of the door. Provide a directional sign indicating the location of the nearest accessible emergency exit.	1	232	\$232
15	Exit - Exercise Room	Ext.		Emergency Exit	N/A

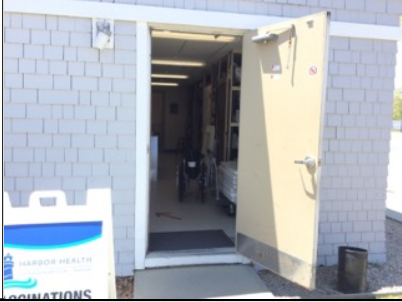
Threshold > 3/4" high	4.75"	Provide a temporary ramp as needed.	1	500	\$500
<b>Access to Goods and Services</b>												
<b>Means of Egress</b>												
17	Exit Through Storage - Multi - Purpose Room A	2		Means of Egress	N/A

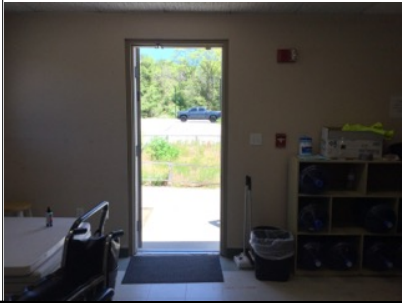
Tactile exit sign not provided	-	Ensure a tactile exit sign with raised characters and braille is provided at exit door. Mount sign between 48"- 60" above the finished floor located on the latch side of the door. Recommend providing a directional sign.	1	232	\$232
18	Main Entrance/Exit	2		Means of Egress	N/A

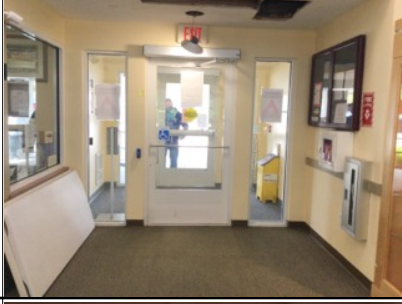
Tactile exit sign not provided Illuminated ISA symbol not provided (MAAB)	- -	Ensure a tactile exit sign with raised characters and braille is provided at exit door. Mount sign between 48"- 60" above the finished floor located on the latch side of the door. Provide an illuminated sign with the International Symbol of Accessibility.	1	432	\$432

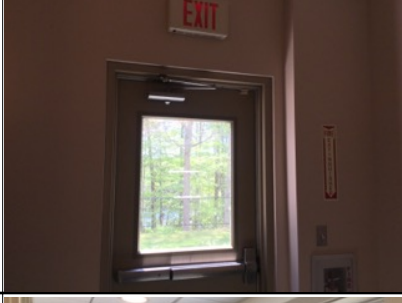
19	Exit Near Stair	1		Means of Egress	N/A

Tactile exit sign not provided Illuminated ISA symbol not provided (MAAB)	- -	Ensure a tactile exit sign with raised characters and braille is provided at exit door. Mount sign between 48"- 60" above the finished floor located on the latch side of the door. Provide an illuminated sign with the International Symbol of Accessibility.	1	432	\$432
20	Exit to Garden Opposite Classroom #1	1		Means of Egress	N/A

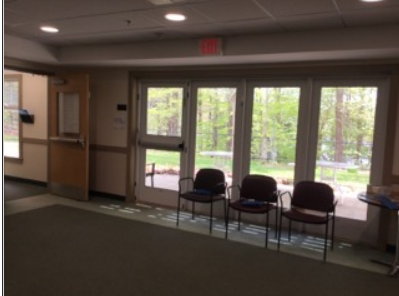
Tactile exit sign not provided Illuminated ISA symbol not provided (MAAB)	- -	Ensure a tactile exit sign with raised characters and braille is provided at exit door. Mount sign between 48"- 60" above the finished floor located on the latch side of the door. Provide an illuminated sign with the International Symbol of Accessibility.	1	432	\$432
22	Stair	2		Means of Egress	N/A

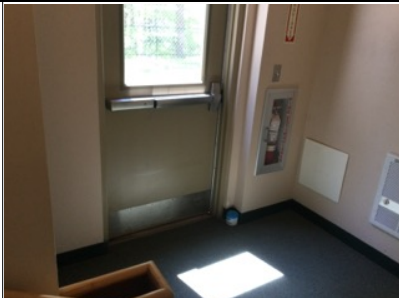
Door requires > 15 lbs. of force to open	18 lbs.	Adjust closers of exterior doors so doors do not require more than 15 pounds of force. Note: Fire doors shall have a minimum opening force allowable by the appropriate administrative authority.	1	Labor	\$0

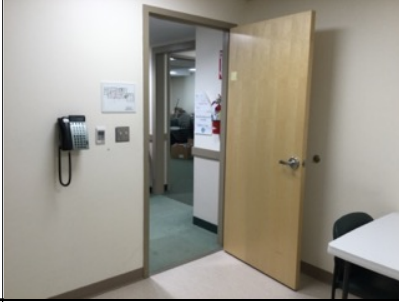
Obstructed by protruding objects	5.5"	Relocate telephone so it does not protrude into the circulation path.	1	Labor	\$0
27	Billiards Room	1		Interior Access Route	N/A

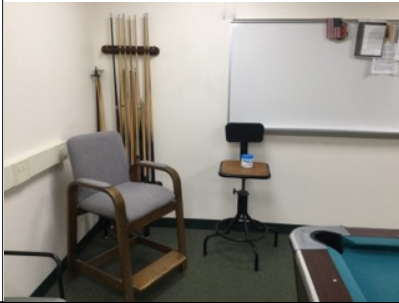
Accessible route not provided	-	Relocate chairs to maintain the accessible route to the pool sticks.	1	Labor	\$0
28	Near Stair	1		Interior Access Route	N/A

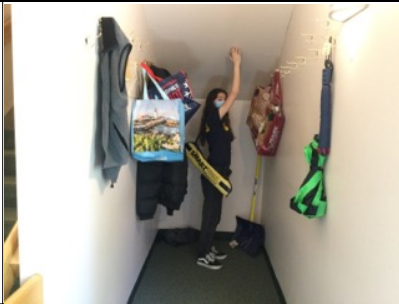
Vertical clearance < 80" above finished floor	66.5"	It may be technically infeasible to adjust the vertical clearance. Consider adding signage that says, "Low Headroom" or, "Low Ceiling".  Or relocate coat hooks and provide a cane-detectable barrier.	1	232	\$232
<b>Doors, Doorways, &amp; Gates</b>												
29	Activity Room C	2		Doors, Doorways, & Gates	Other

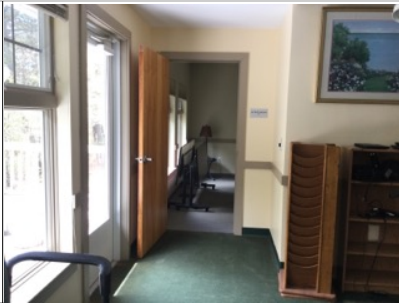
Maneuvering clearance(s) not provided	16.75"	Keep door open during business hours.	1	Labor	\$0

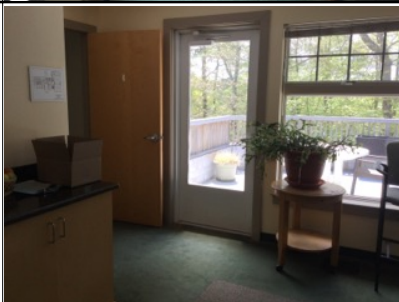
30	Lounge	2		Doors, Doorways, & Gates	Emergency Egress

Maneuvering clearance(s) not provided	-	Relocate plant to maintain the maneuvering clearance at the door.	1	Labor	\$0

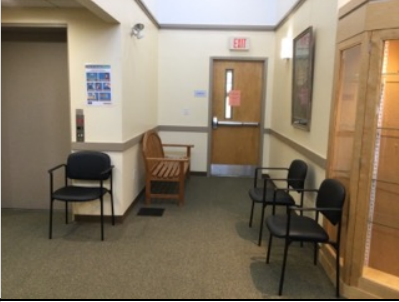
Maneuvering clearance(s) not provided		Relocate bench to maintain the required maneuvering clearance at the door.	1	Labor	\$0
32	Men's Toilet Room	1		Doors, Doorways, & Gates	Toilet Room

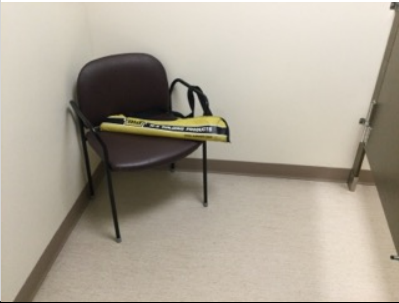
Maneuvering clearance(s) not provided	-	Relocate chair to maintain the maneuvering clearance at the toilet door compartment.	1	Labor	\$0
33	Entrance/ Exit - Multi - Purpose Room A	2		Doors, Doorways, & Gates	Emergency Egress

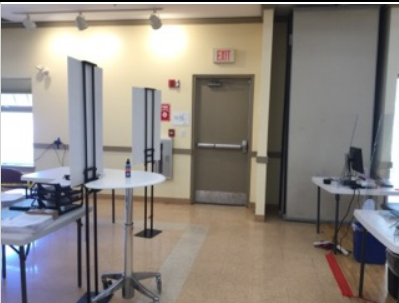
Maneuvering clearance(s) not provided	7"	Provide an automatic door opener.	1	3060	\$3060
34	Entrance/ Exit - Multi - Purpose Room B	2		Doors, Doorways, & Gates	Emergency Egress

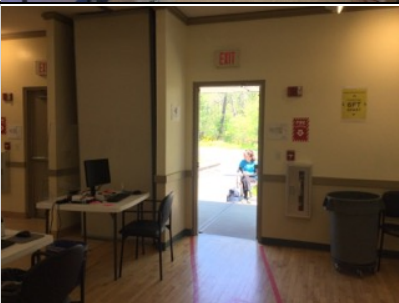
Maneuvering clearance(s) not provided	5.5"	Provide an automatic door opener.	1	3060	\$3060
35	Multi - Purpose Room B	2		Doors, Doorways, & Gates	Other

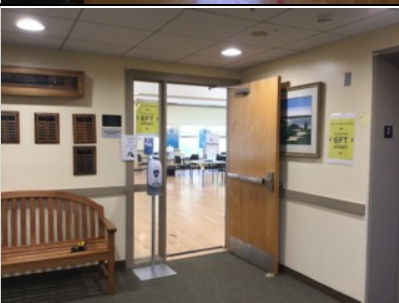
Maneuvering clearance(s) not provided	-	Relocate hand sanitizer to maintain the maneuvering clearance at the door.	1	Labor	\$0

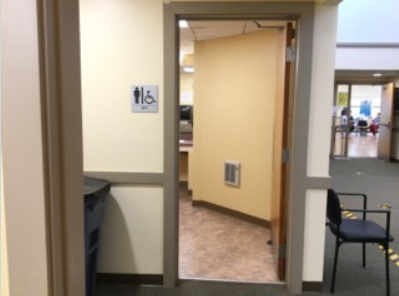
Door requires > 5 lbs. of force to open	15 lbs.	Adjust closers so doors do not require more than 5 pounds of force to open.	1	Labor	\$0
37	Women's Toilet Room	2		Doors, Doorways, & Gates	Toilet Room

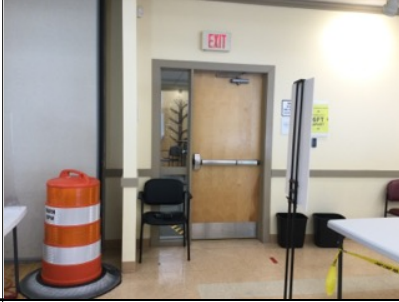
Door requires > 5 lbs. of force to open	10 lbs.	Adjust closers so doors do not require more than 5 pounds of force to open.	1	Labor	\$0
42	Multi - Purpose Room B	2		Doors, Doorways, & Gates	Other

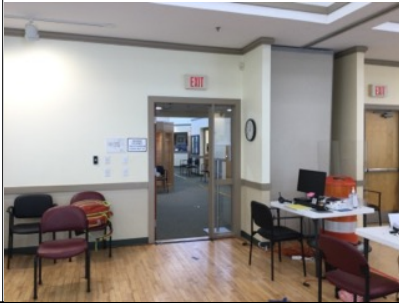
Door requires > 5 lbs. of force to open	11 lbs.	Adjust closers so doors do not require more than 5 pounds of force to open.	1	Labor	\$0
<b>Stairways</b>												
43	Stair	1.5		Stairways	Egress

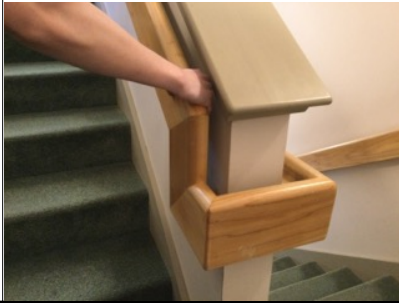
Handrails have non-compliant cross section	-	Provide handrails with 1 1/4" - 1-1/2" circular cross sections.	1	-	\$0
<b>Elevator</b>												
44	Elevator	2		Elevator	Interior

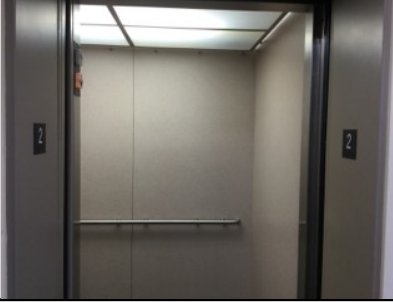
Tactile stars not provided at main entry level	-	Provide a tactile star on both sides of jambs at main floor.	2	96	\$192
<b>Signage</b>												
47	Lounge	2		Signage	Egress

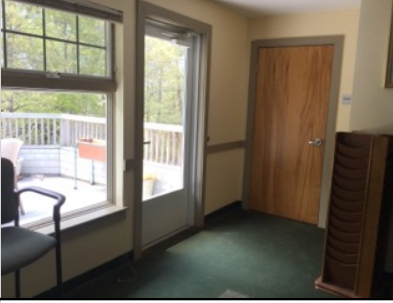
Signage is not provided	-	Locate compliant signage alongside the door on the latch side.	1	232	\$232
48	Classroom #1 Opposite Pool Room	1		Signage	Designation

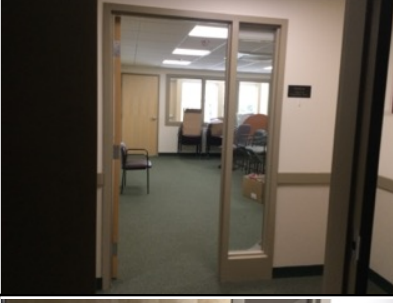
Signage is not provided	-	Locate compliant signage alongside the door on the latch side.	1	232	\$232
49	Exercise Room	1		Signage	Designation

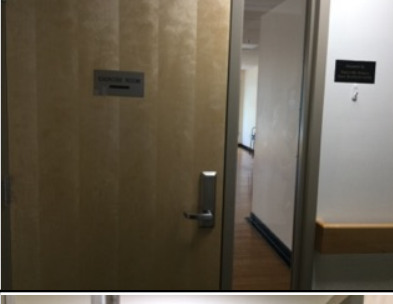
Raised characters not provided on sign Sign not located on the latch side of the door	- -	Provide text with raised characters duplicated in braille on sign. Locate sign alongside the door on the latch side.	1	232	\$232
50	Pool Room	1		Signage	Designation

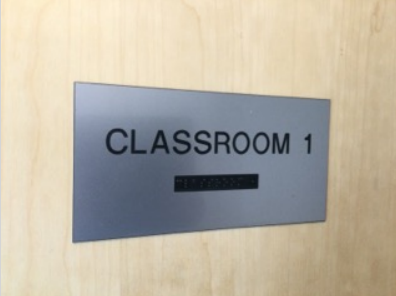
Raised characters not provided on sign Sign not located on the latch side of the door	- -	Provide text with raised characters duplicated in braille on sign. Locate sign alongside the door on the latch side.	1	232	\$232
52	Right of Main Entrance/Exit	Ext.		Signage	Informational

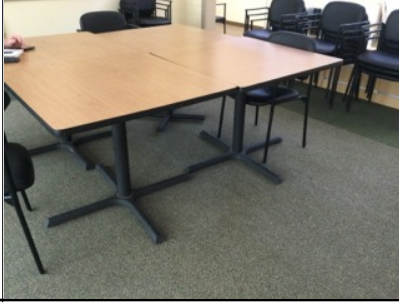
Knee or toe clearance not provided	-	Provide at least 1 dining or work surface with 27" min. knee and toe clearance.	1	700	\$700
57	Robert E. Cross Library	1		Dining or Work Surfaces	Work Surface

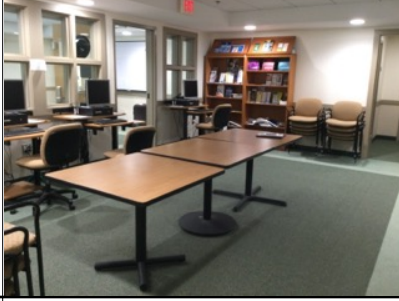
Knee or toe clearance not provided	-	Provide at least 1 work surface with 27" min. knee and toe clearance.	1	700	\$700
58	Robert E. Cross Library	1		Dining or Work Surfaces	Work Surface

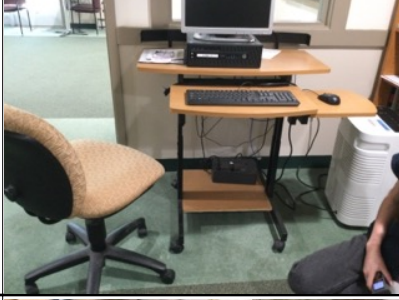
Knee or toe clearance not provided	-	Provide a computer table with 27" min. knee and toe clearance.	1	700	\$700
59	Classroom #1 Opposite Pool Room	1		Dining or Work Surfaces	Work Surface

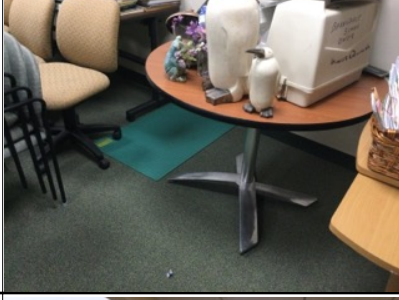
Knee or toe clearance not provided	-	Provide at least 1 work surface with 27" min. knee and toe clearance.	1	700	\$700

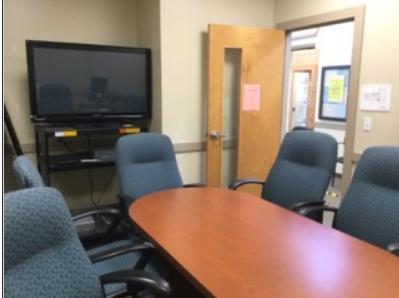
Assistive listening devices not provided	-	If audible communication is integral to the use of the space, provide an assistive listening system.	1	1214	\$1214
62	Activity Room A	2		Assembly Area	N/A

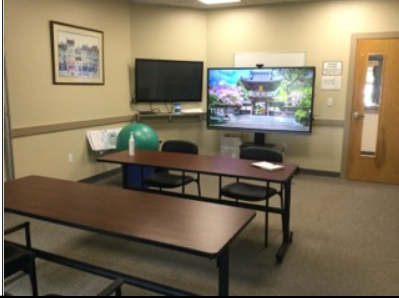
Assistive listening devices not provided	-	If audible communication is integral to the use of the space, provide an assistive listening system.	1	1214	\$1214
63	Multi - Purpose Room A	2		Assembly Area	N/A

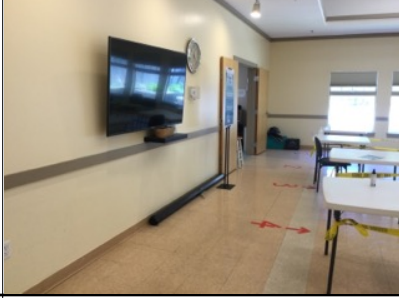
Assistive listening devices not provided	-	If audible communication is integral to the use of the space, provide an assistive listening system.	1	1214	\$1214
64	Multi - Purpose Room B	2		Assembly Area	N/A

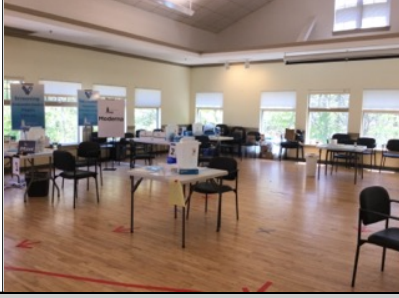
Assistive listening devices not provided	-	If audible communication is integral to the use of the space, provide an assistive listening system.	1	1214	\$1214

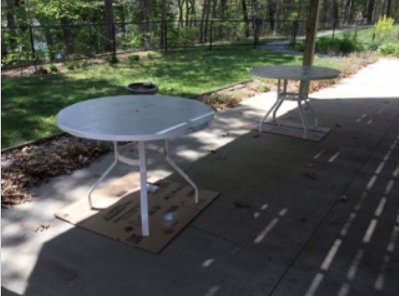
Toe or knee clearance at tables not provided	-	Provide at least 1 dining surface (or ensure that 5% of dining surfaces) have toe and knee clearance.	1	1400	\$1400
67	Upper Level Garden	Ext.		Picnic Tables	N/A

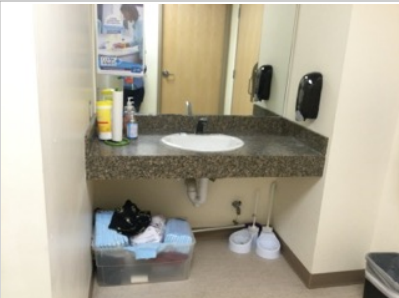
Toe or knee clearances not provided	-	Remove plastic bin container to maintain the required knee clearance.	1	Labor	\$0

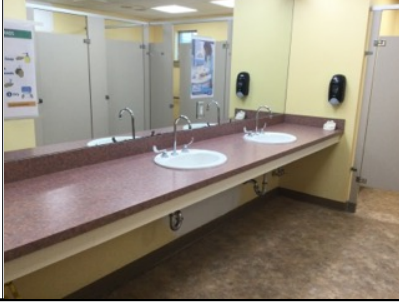
Plumbing underneath is exposed	-	Insulate or otherwise configure pipes to prevent contact for at least one lavatory.	1	92	\$92
<b>Toilet Compartment</b>												
72	Men's Toilet Room	2		Toilet Compartment	Accessible Compartment

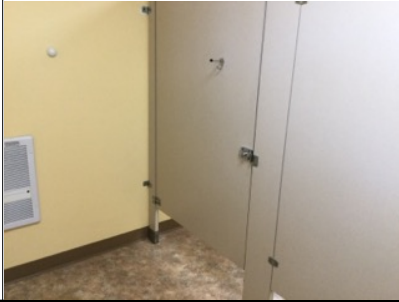
Door has malfunctioning self-closing hinge Door pull not provided	-	Repair hinge. Provide a door pull on both sides of the door near the latch.	1	70	\$70
73	Women's Toilet Room	2		Toilet Compartment	Accessible Compartment

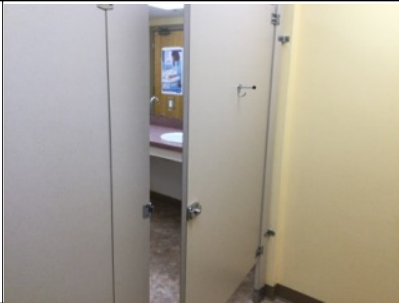
Door has malfunctioning self-closing hinge Door pull not provided	- -	Repair hinge. Provide a door pull on both sides of the door near the latch.	1	70	\$70
74	Men's Toilet Room	2		Toilet Compartment	Accessible Compartment

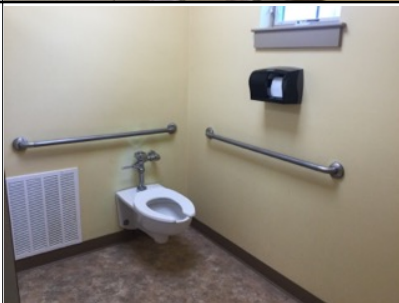
Non-compliant toilet paper dispenser	-	Relocate toilet paper so that it is 24" min. high, located under the grab bar, and between 7" and 9" from the front of the toilet.	1	256	\$256

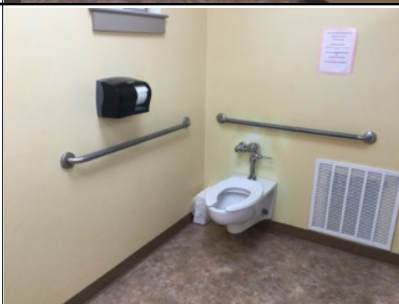
Non-compliant toilet paper dispenser	-	Relocate toilet paper so that it is 24" min. high, located under the grab bar, and between 7" and 9" from the front of the toilet.	1	256	\$256

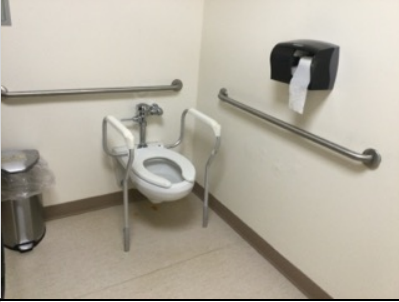
Non-compliant toilet paper dispenser Clearance at toilet < 60" clear width	- -	Relocate toilet paper so that it is 24" min. high, located under the grab bar, and between 7" and 9" from the front of the toilet. Remove railing to maintain the required 60" clear floor space at the toilet.	1	256	\$256
77	Women's Toilet Room	1		Toilet Compartment

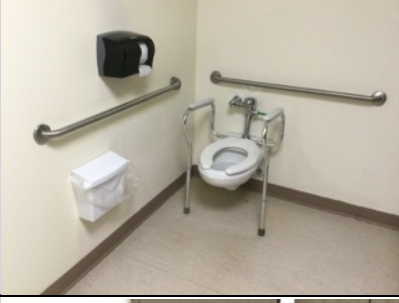
Non-compliant toilet paper dispenser Clearance at toilet < 60" clear width	- -	Relocate toilet paper so that it is 24" min. high, located under the grab bar, and between 7" and 9" from the front of the toilet. Remove railing to maintain the required 60" clear floor space at the toilet.	1	256	\$256
78	Men's Toilet Room	1		Toilet Compartment	Accessible Compartment

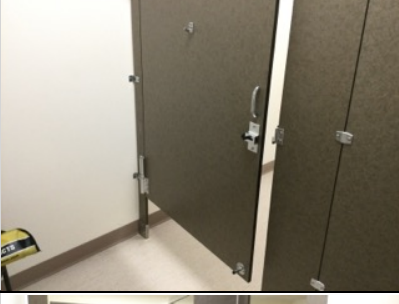
Door pull not provided	-	Provide a door pull on both sides of the door near the latch.	1	70	\$70

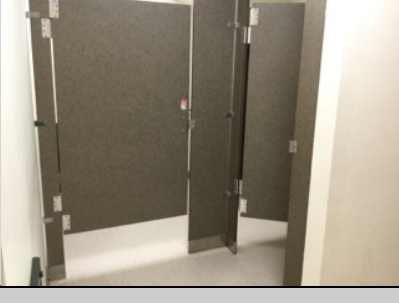
Door pull not provided	-	Provide a door pull on both sides of the door near the latch.	1	70	\$70
<b>Dispensers</b>												
80	Women's Toilet Room	2		Dispensers	Paper Towel Dispenser

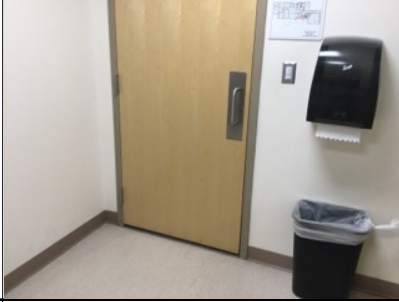
Dispenser acts as a protruding object	-	Relocate dispenser out of the circulation path.	1	256	\$256
82	Women's Toilet Room	1		Dispensers	Paper Towel Dispenser

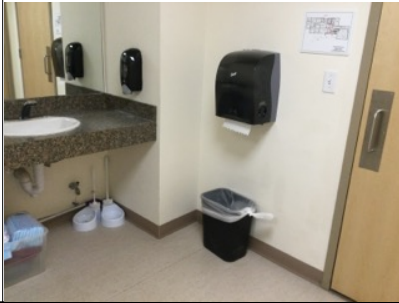
Dispenser acts as a protruding object	10"	Relocate dispenser out of the circulation path.	1	256	\$256
<b>Additional Access</b>												
<b>Drinking Fountains</b>												
83	Fountain Near Toilet Rooms	2		Drinking Fountains	Low

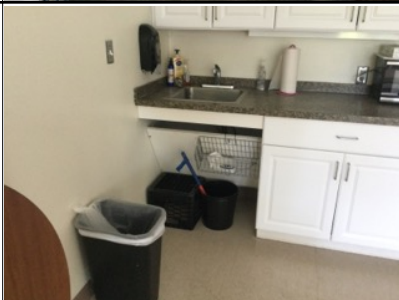
Toe and knee clearances not provided	-	Relocate items under the sink to maintain the maneuvering clearance.	1	Labor	\$0
