U.S. Custom House Old Jail

Town of Barnstable ADA Transition Plan

August 2021

**Town of Barnstable
U.S. Custom House Old Jail**

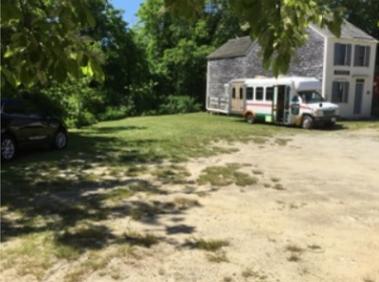
Total # of parking Total # of designated accessible parking spaces	10 0	Provide a van accessible parking space near the ramp that is 96" wide min. with a marked access aisle 96" wide min. Include an accessible parking identification sign. Add the designation "Van Accessible" to the sign. (Cost for a stone dust accessible parking space and path to ramp. See illustration in narrative report. Some additional material costs may be required.)	1	1850	\$1850
2	Main Entrance to the Jail	Ext.		Entrance	Main Entrance

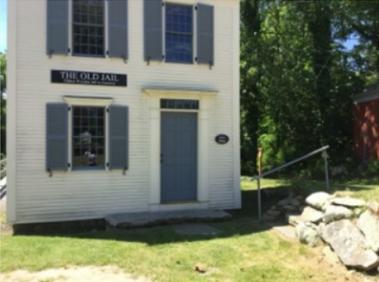
Entrance not on an accessible route Directional sign to accessible entrance not provided	- -	Provide a directional sign indicating the location of the nearest accessible entrance.	1	346	\$346
3	Cells Area	1		Interior Access Route	N/A

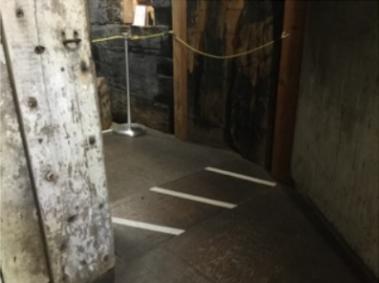
Running slope > 1:20 (5%)	12.3%	Staff should be available to assist wheelchair users up and down the ramp for safety purposes.	1	-	\$0

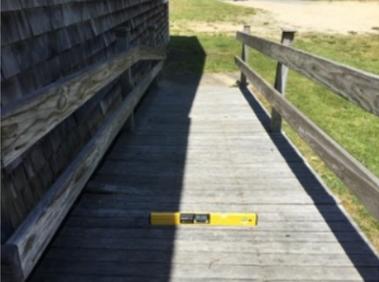
4	Accessible Entrance/Egress	Ext.		Exterior Ramp	N/A

Handrails have non-compliant cross section Landing has a slope > 1:50 in either direction Edge protection < 4" high	- 9.2% -	Provide handrails with 1-1/4" to 1-1/2" circular cross sections. Alter so that the slope in all directions is no greater than 1:50 (2.00%). Provide edge protection that prevents the passage of a 4" diameter sphere, where any portion of the sphere is within 4" of the finished floor or ground surface. (Cost based on 4 sets of 20 foot long handrails and edge protection on wide side.)	1	3520	\$3520
5	Accessible Entrance/Egress	Ext.		Exterior Access Route	Exterior

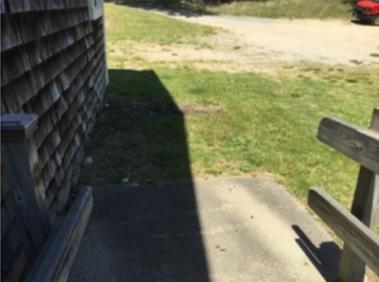
Accessible route not provided	-	Ensure an accessible route is provided to the ramp. (Cost provided in ID #1.)	1	-	\$0
