Department of Public Works

Commerce Road Flooding

September 12, 2018

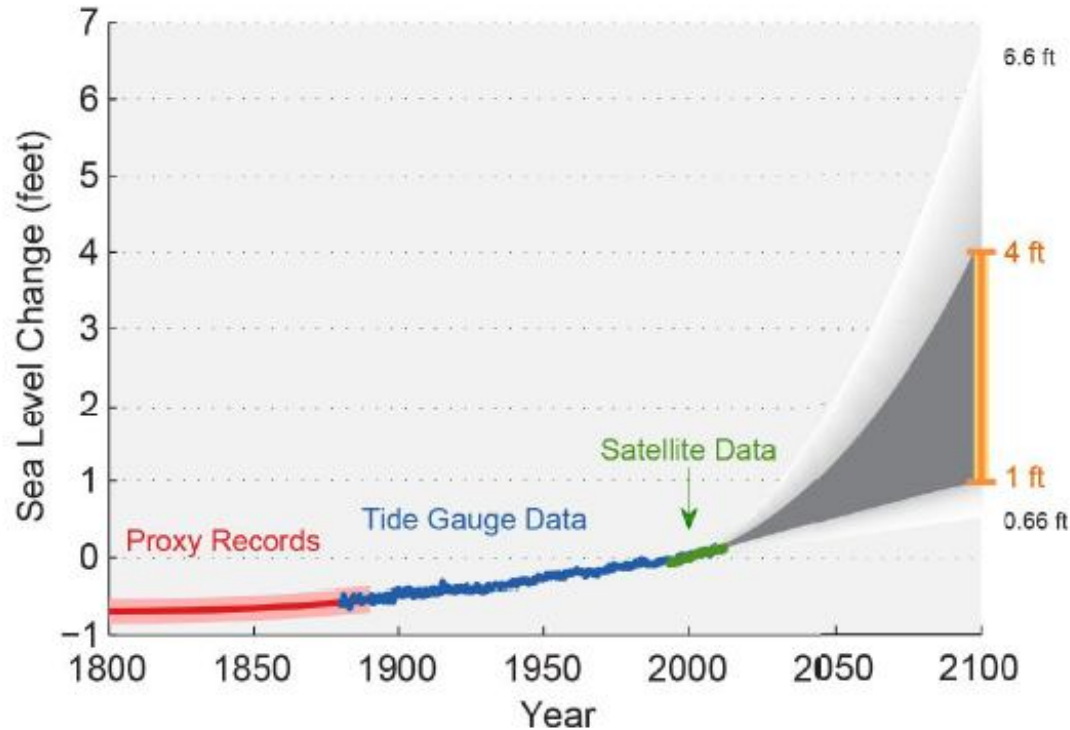
Past and Projected Changes in Global Sea Level

Figure 7: Estimated, observed, and possible future amounts of global sea level rise from 1800 to 2100, relative to the year 2000. The orange line at right shows the currently most likely range of sea level rise of 1 to 4 feet by 2100 based on an assessment of scientific studies, which falls within a larger possible range of 0.66 feet to 6.6 feet. Source: Melillo et al. 2014 and Parris et al. 2012.

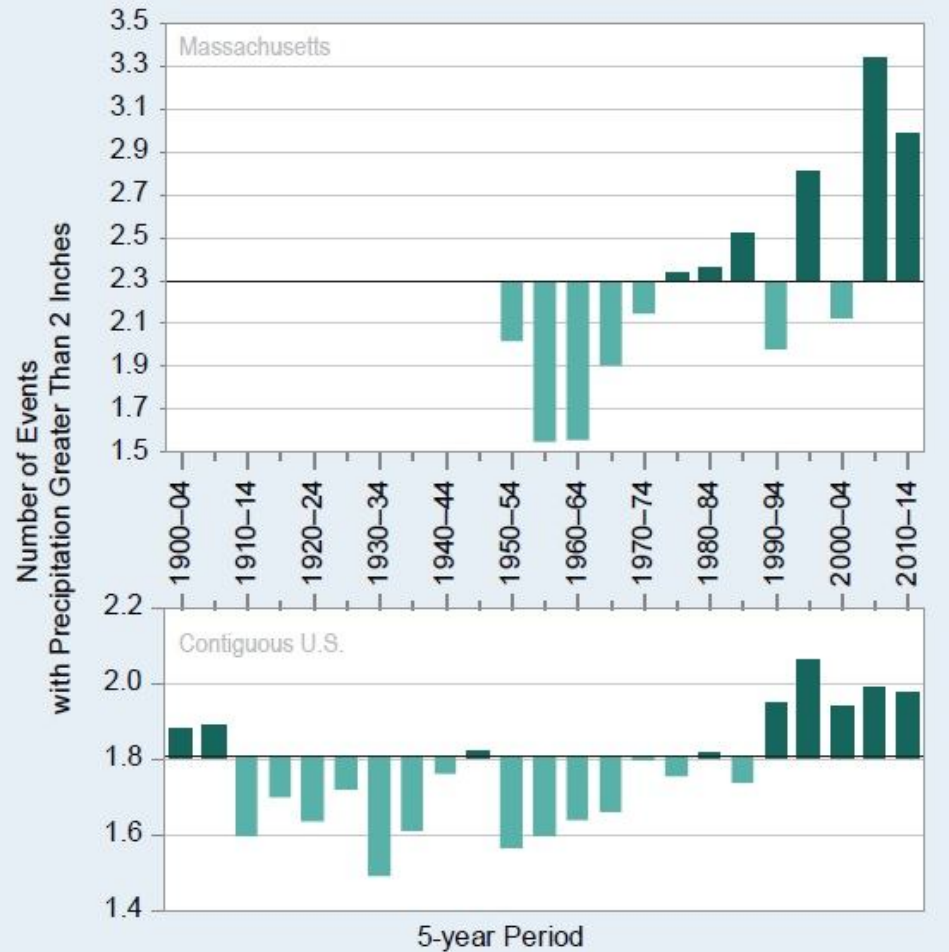
Observed Number of Extreme Precipitation Events

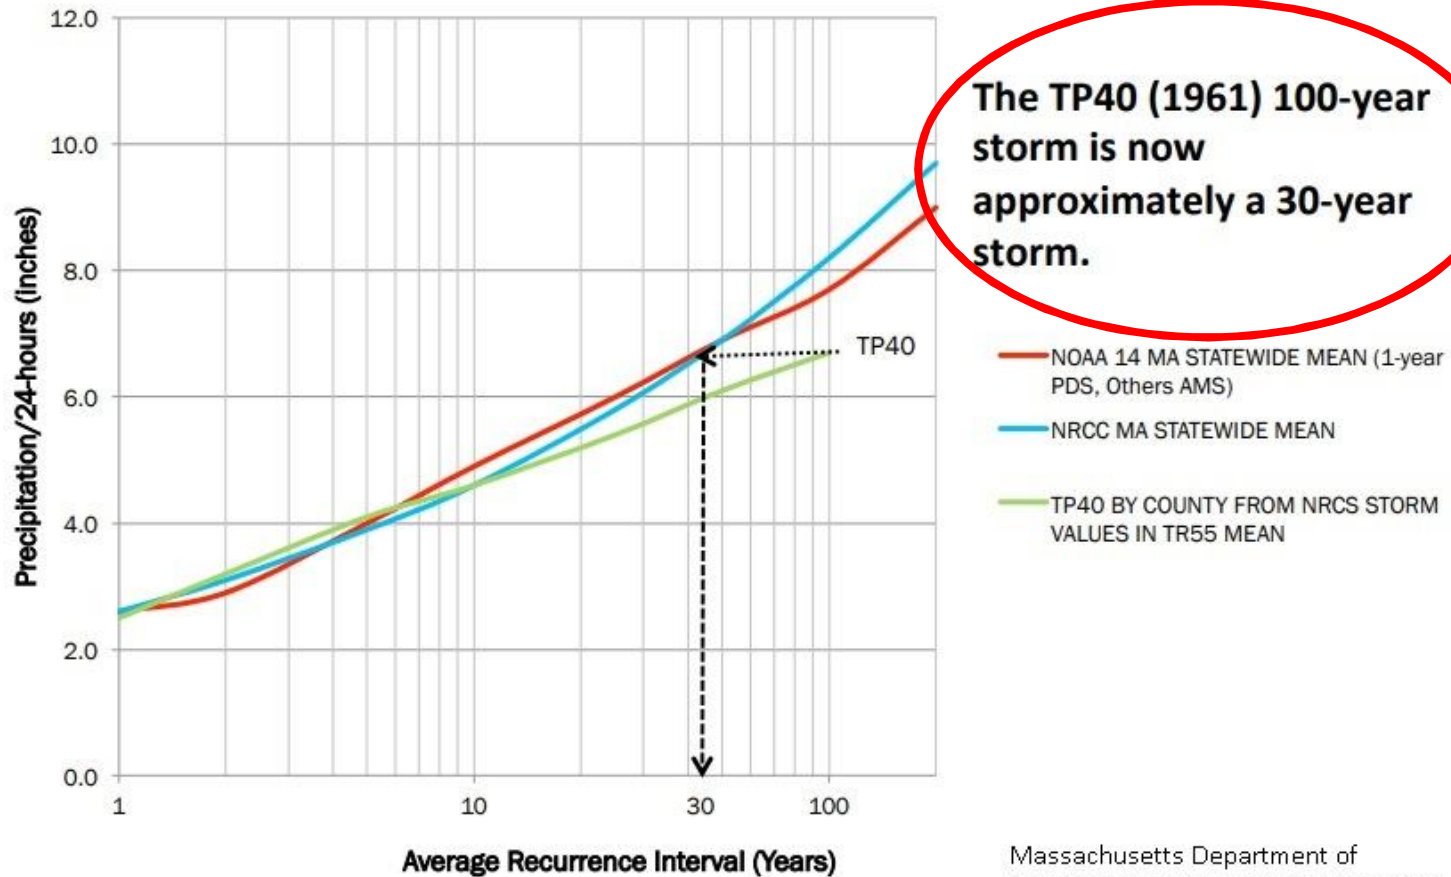
Massachusetts - Statewide Average
Change in 100-Year 24-hour Duration Storm (NOAA 14 vs TP40)

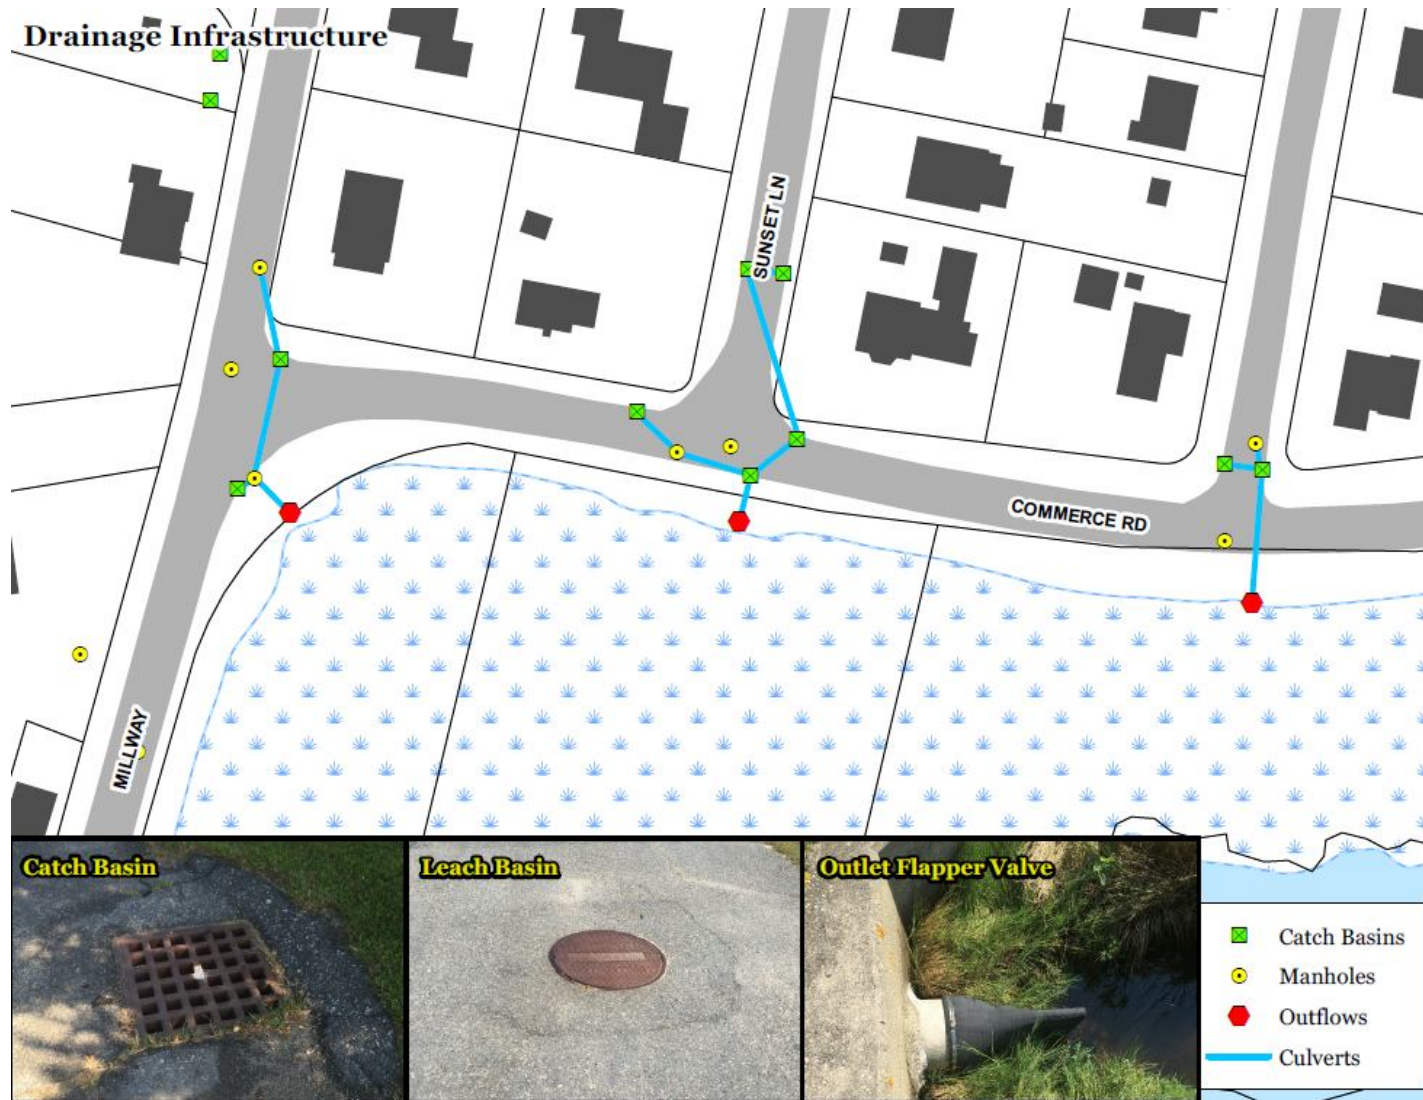
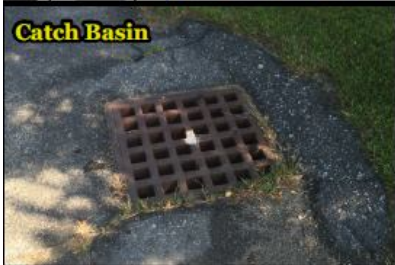
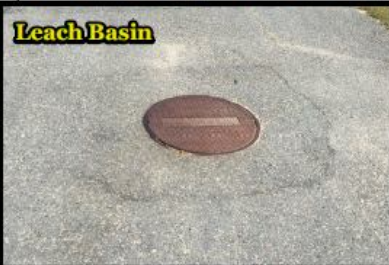
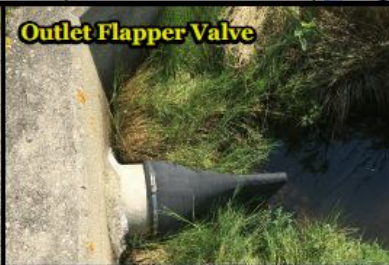
Exiting Conditions – Road Storm Drain System

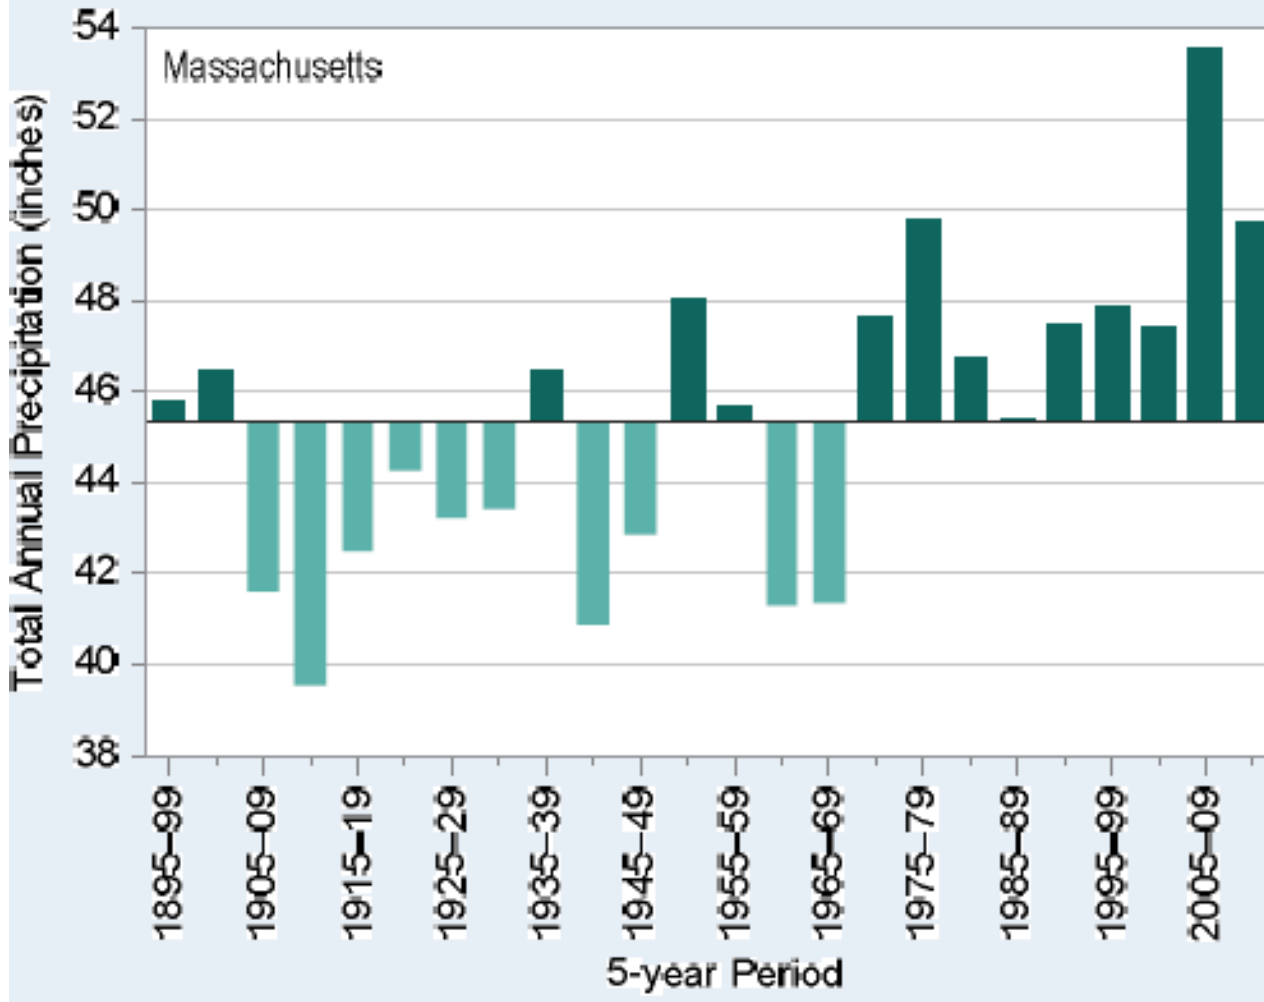
Observed Annual Precipitation

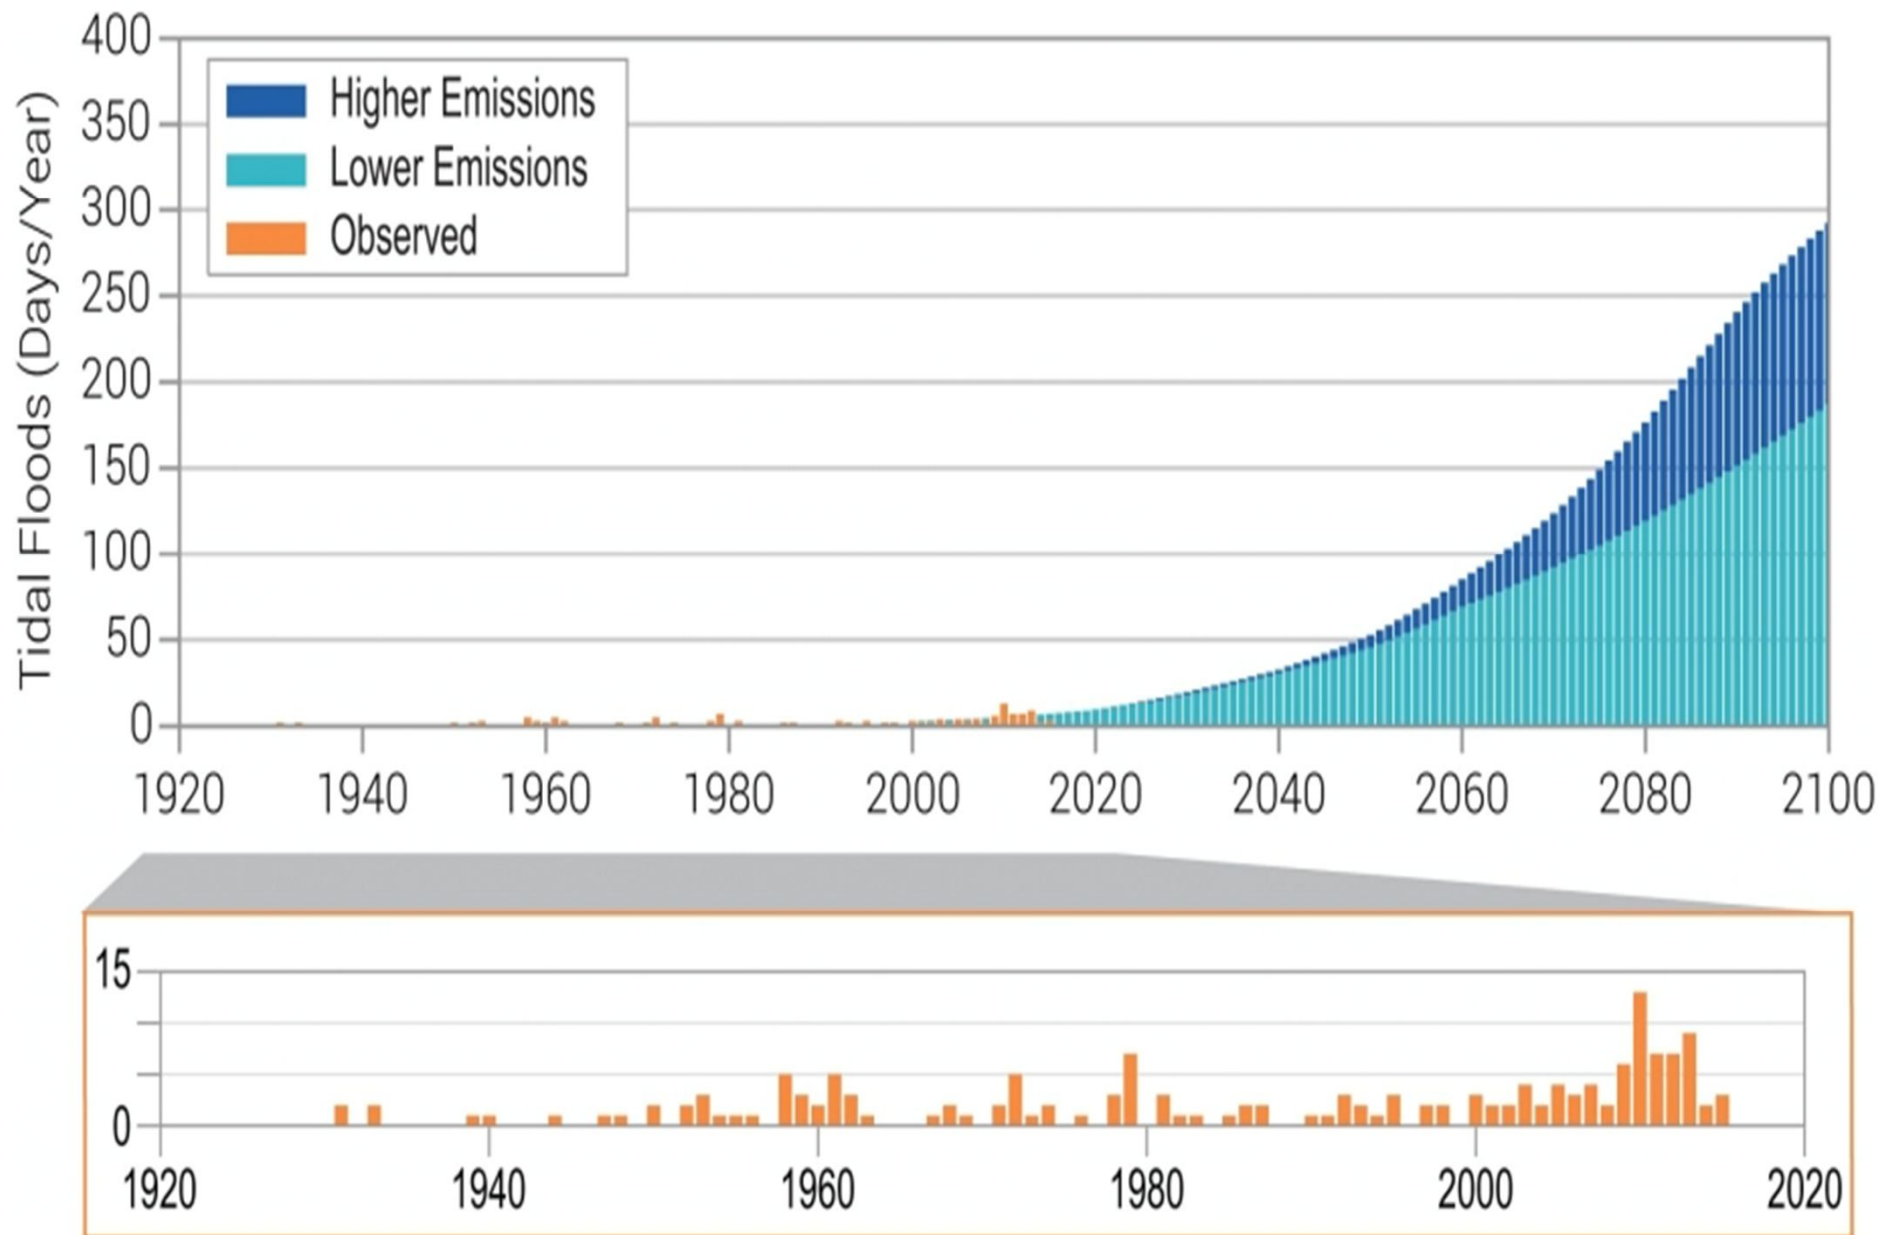
Observed and Projected Annual Number of Tidal Floods for Boston, MA

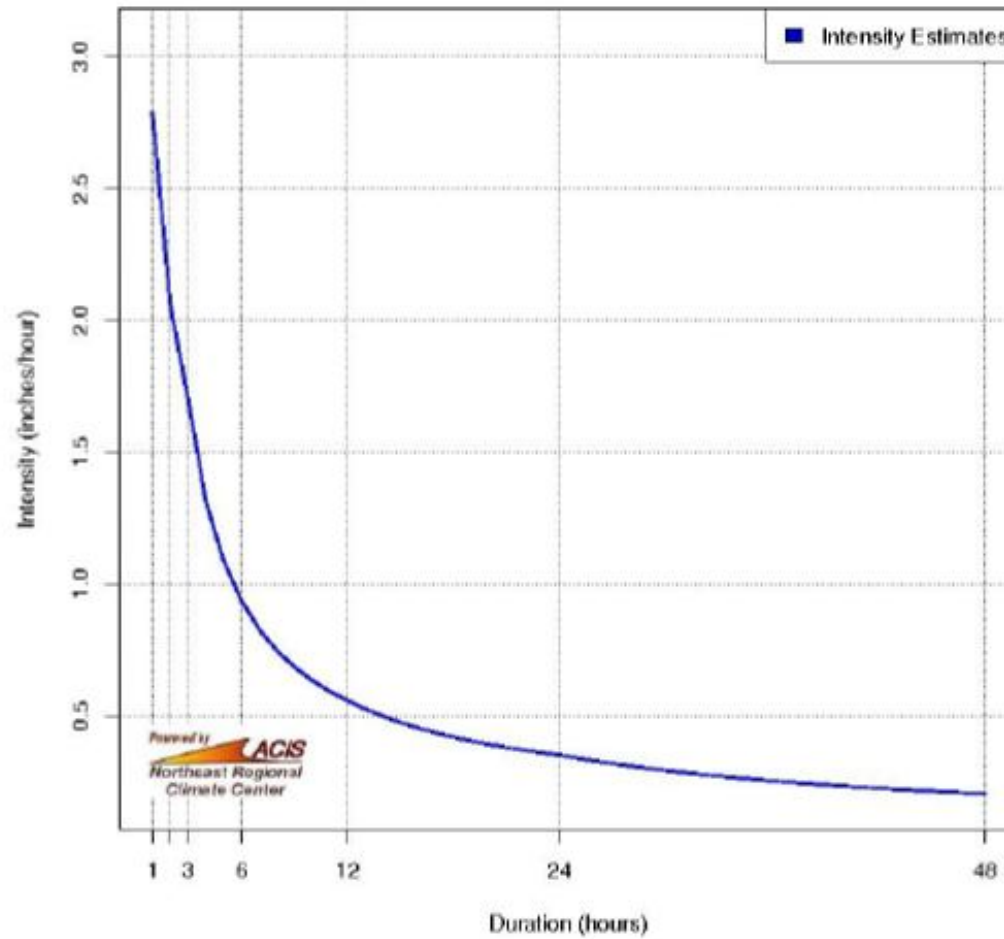
Intensity Frequency Duration - 100yr
(41.699N, -70.321W)
