Final Report

Stewart's Creek Year 5 Monitoring Report

March 2019

Prepared for:
Town of Barnstable
230 South Street
Hyannis, MA 02601

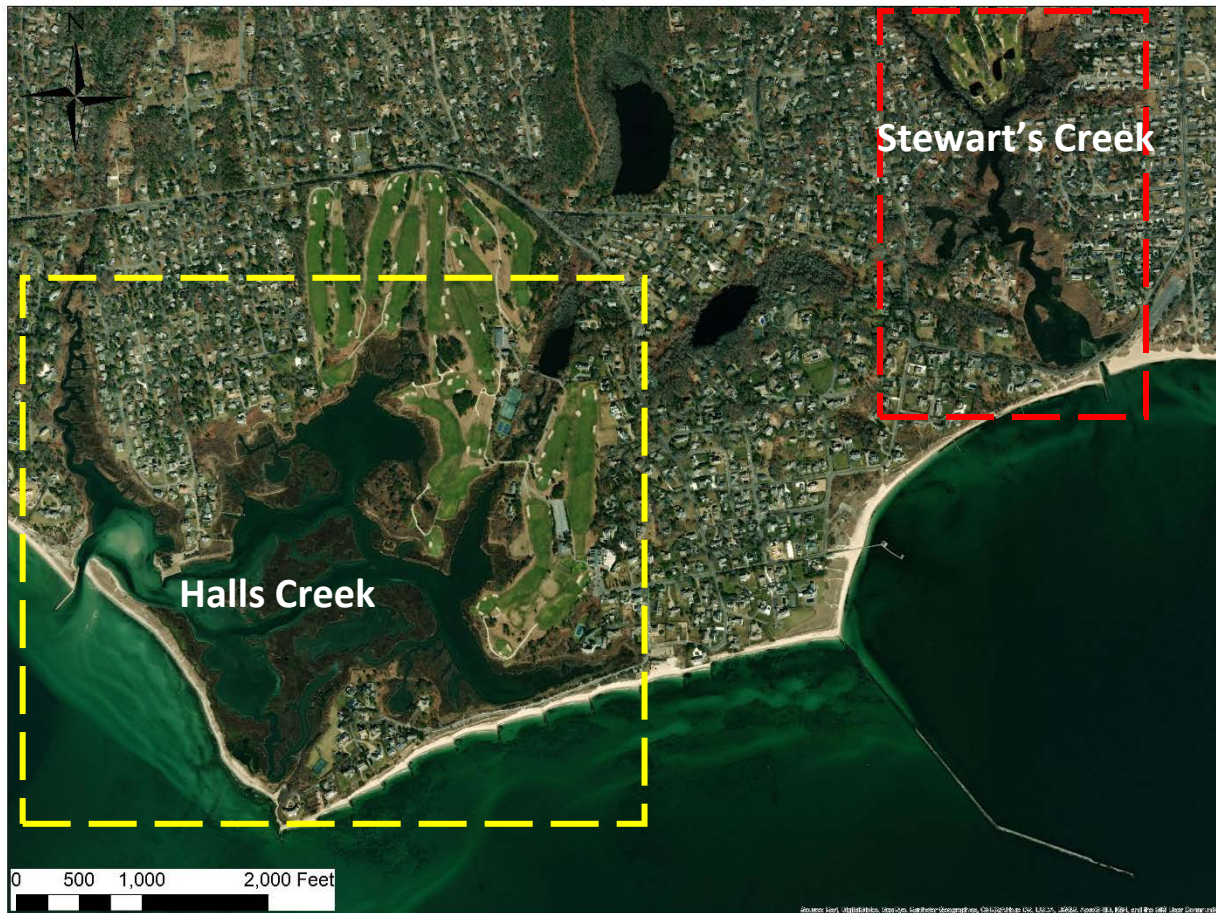
Figure 1. Overview of Stewart’s Creek (outlined red) and the reference site Hall’s Creek (outlined yellow).

A year-5 post-construction monitoring survey was conducted in 2018 at Stewart's Creek (Figure 1) to provide data for comparison against the 2013 pre-construction monitoring data, as well as the prior year-2 (2015) post-construction monitoring. The monitoring effort included measurements/sampling of tides, salinity, vegetation, topography, and benthic communities. The monitoring also included sampling at the reference site, Hall's Creek shown in Figure 1, originally established by the USACE and located about a mile west of Stewart's Creek.

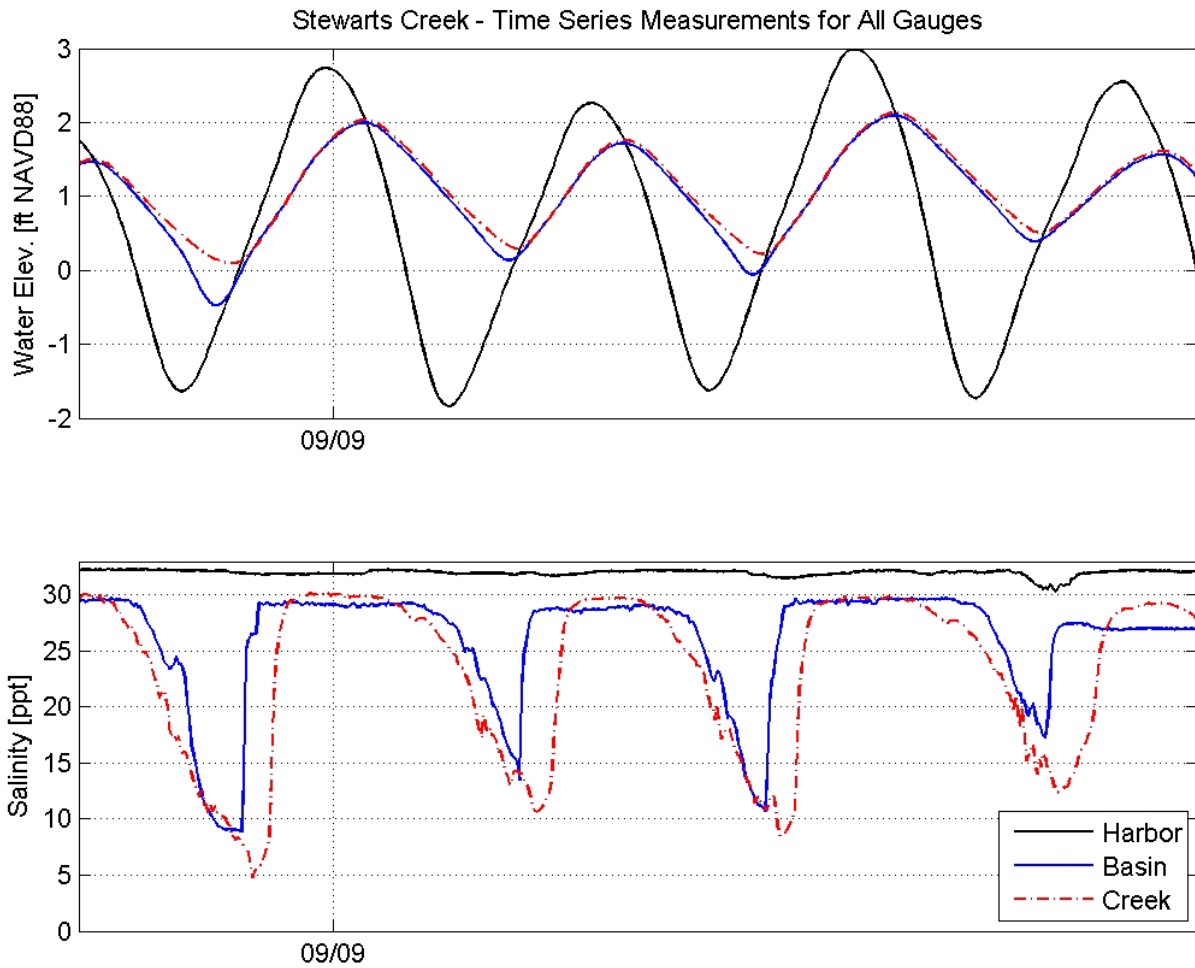
Greater insight into the tidal dynamics within the Stewart’s Creek system is revealed through examination of the measured time series data over a shorter period of time. Figures 4 and 5 illustrate a 2-day sample zoom view of the water surface elevation and salinity time series data during a representative spring and neap tide, respectively. Figures 4 and 5 show that during both spring and neap tides there is significant attenuation of the high tide from Lewis Bay (black line) to Stewart’s Creek (blue and red lines). There is a reduction of peak water surface elevation at high tides and a delay in the time high tide occurs (phase lag) within the system. Although the elevation of high tide matches well at the three locations within Stewart’s Creek, the elevation of low tide increases within the system. Salinity oscillates from nearly saltwater, 30 ppt, to brackish or even freshwater conditions with each change of the tide. During Spring tides, the salinity at low tide remains brackish (5-15 ppt), and becomes nearly fresh during neap tides.

Figure 4. Example of spring tide conditions for water surface elevation (top) and salinity (bottom) at Stewart's Creek.

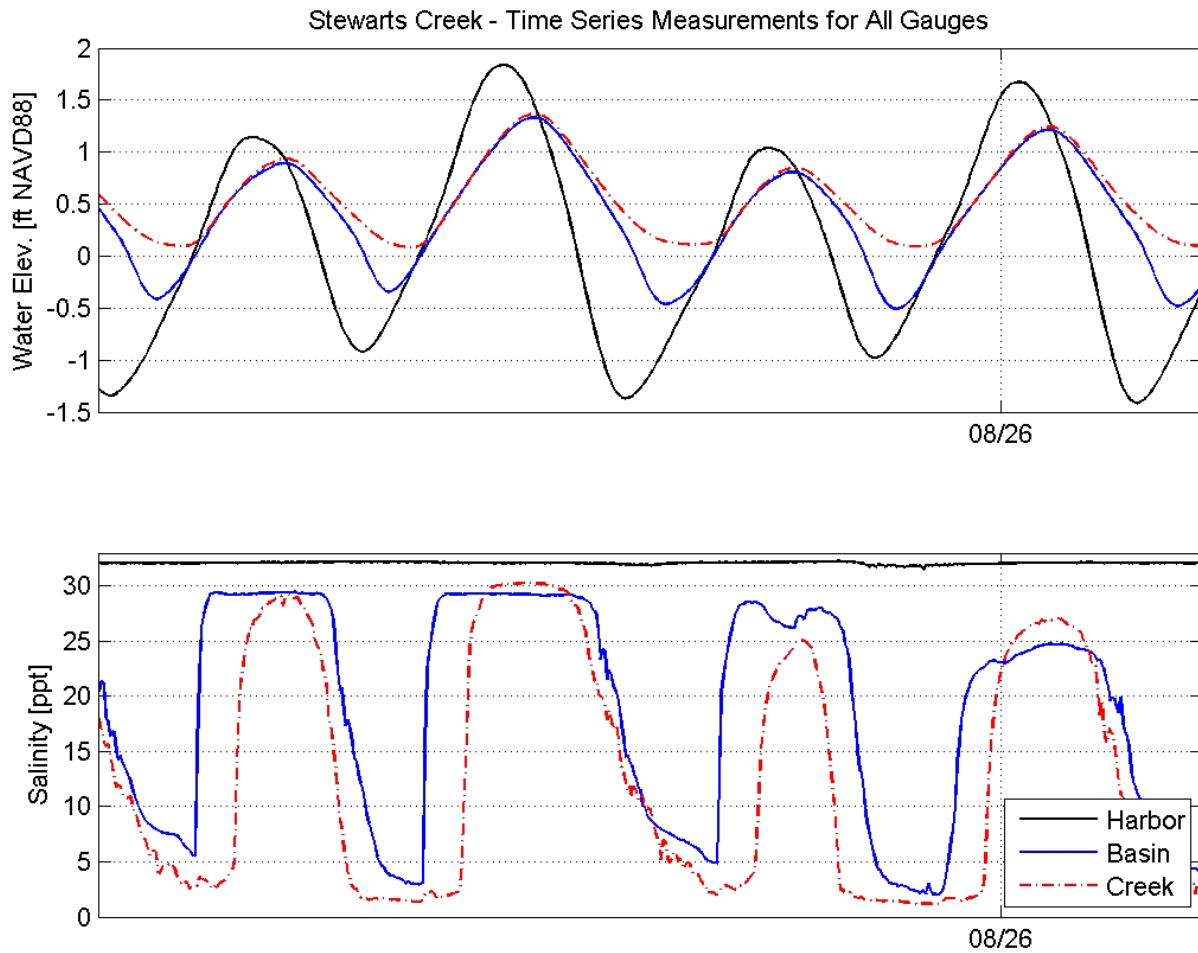
Figure 5. Example of neap tide conditions for water surface elevation (top) and salinity (bottom) at Stewart's Creek.

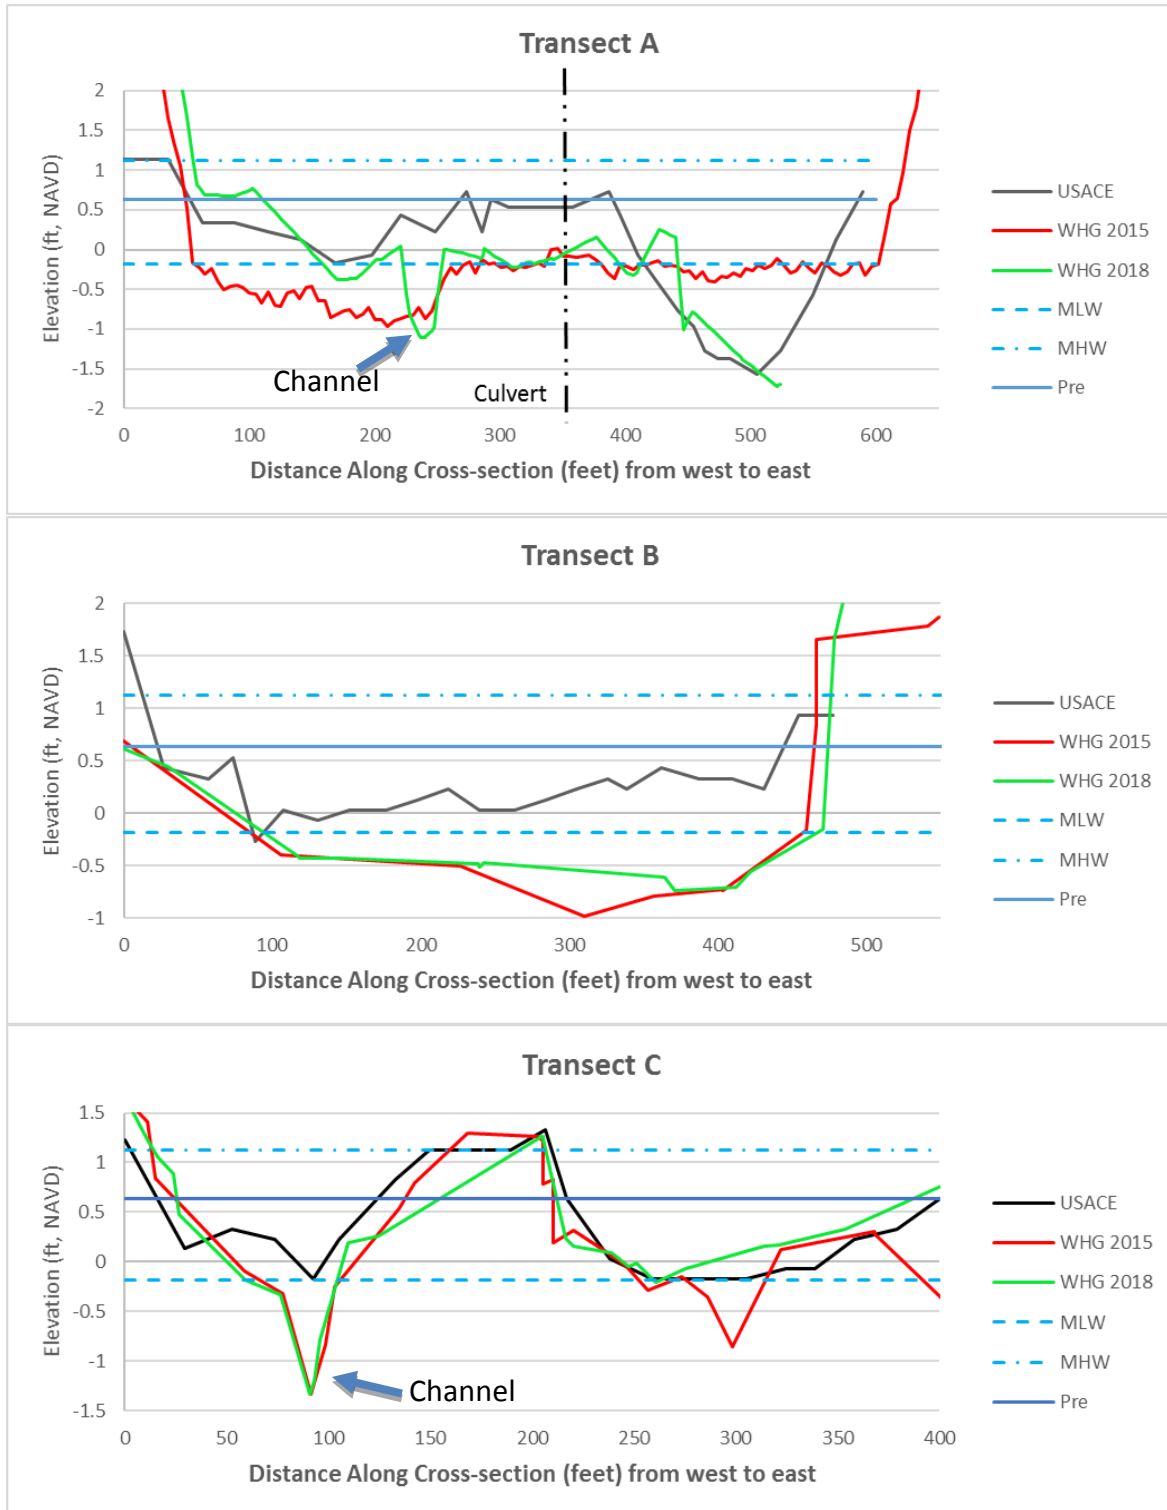
- Cross section A: This cross section is located upstream of the culvert inlet, and bisects the lower basin including the flood shoal. This area has been dynamic since the project was constructed, including net erosion in the central portion of the lower basin. A 1 foot deep channel has been established on the western side of the flood tide shoal located about 250 ft from western shoreline of Stewarts Creek since the culvert was installed.

- Cross section B: This cross section bisects the central portion of the main basin, and the bedform changes have been variable. From the pre-construction survey to the 2015 post-construction survey, a 0.5 – 1 ft thick layer of sediment eroded from this cross section. More recently, the 2018 survey of this cross section matches well with the 2015 survey; however, the data indicates there has been up to 0.5 ft of accretion and shoaling in the central portion of the basin since 2015. This is consistent with the observation of a flood tidal shoal forming.

- Cross section C: This cross section bisects the upper portion of the main basin and includes an island dominated by *Phragmites*. The 2015 post-construction survey showed two new channels, approximately 1-1.5 ft deep, formed on both sides of the island following replacement of the culvert. The 2018 survey of this cross section indicates that while the western channel has been maintained, the channel to the east of the island has accreted and filled in. The field team observations support the measurements as they could not locate a channel east of the island during the benthic sampling.

To summarize, the cross-section elevation surveys indicate a layer of sediment has eroded from the intertidal and subtidal portions of the main basin of Stewart's Creek since the replacement of the culvert. A main flow channel has established along the southern and western portion of the main basin, following its historic flow path.

Figure 7. Cross section from lower (top), middle (middle), and upper (bottom) basin of Stewart's Creek.

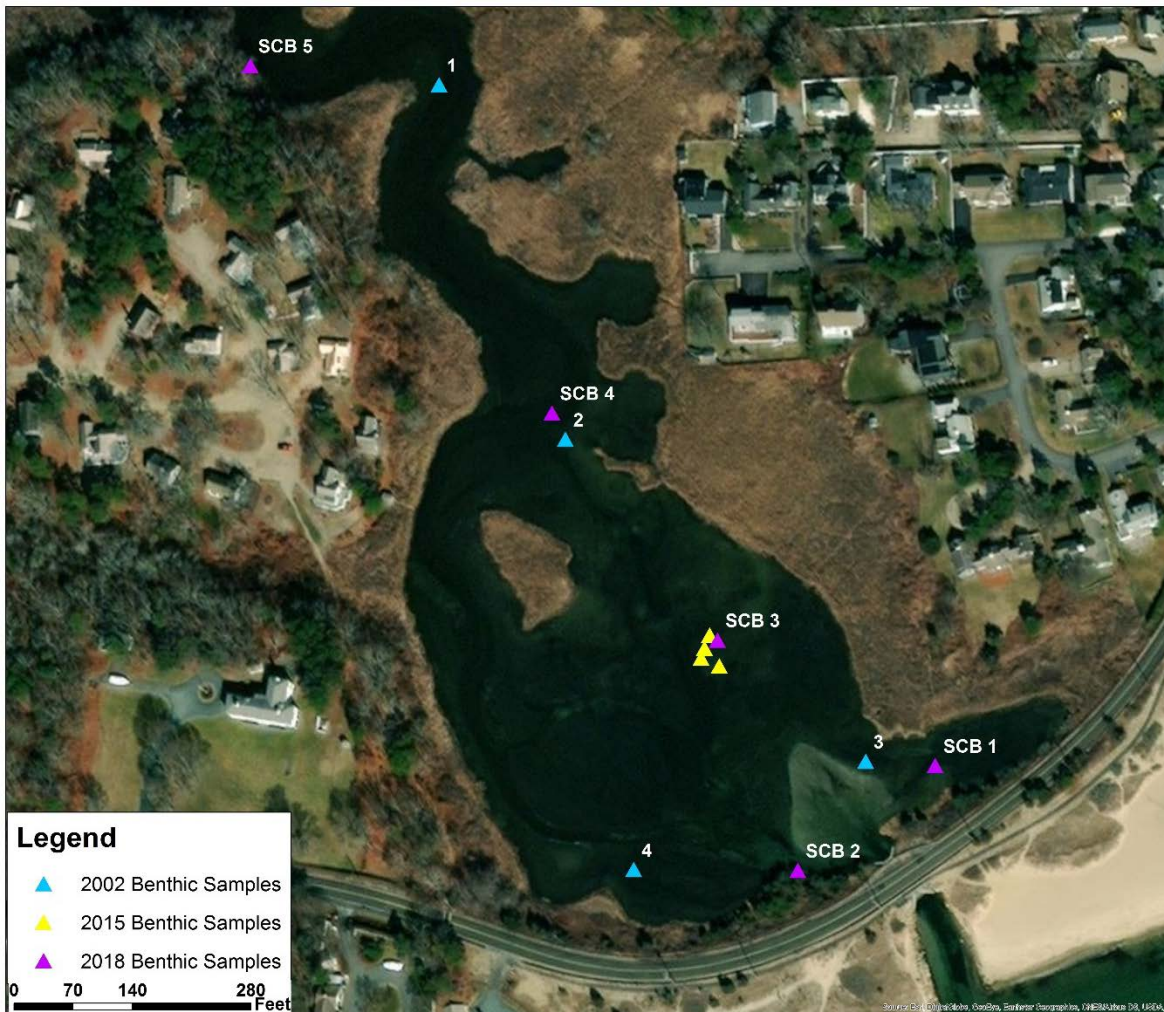
Figure 8. Year 5 Benthic invertebrate sampling locations at Stewart's Creek.

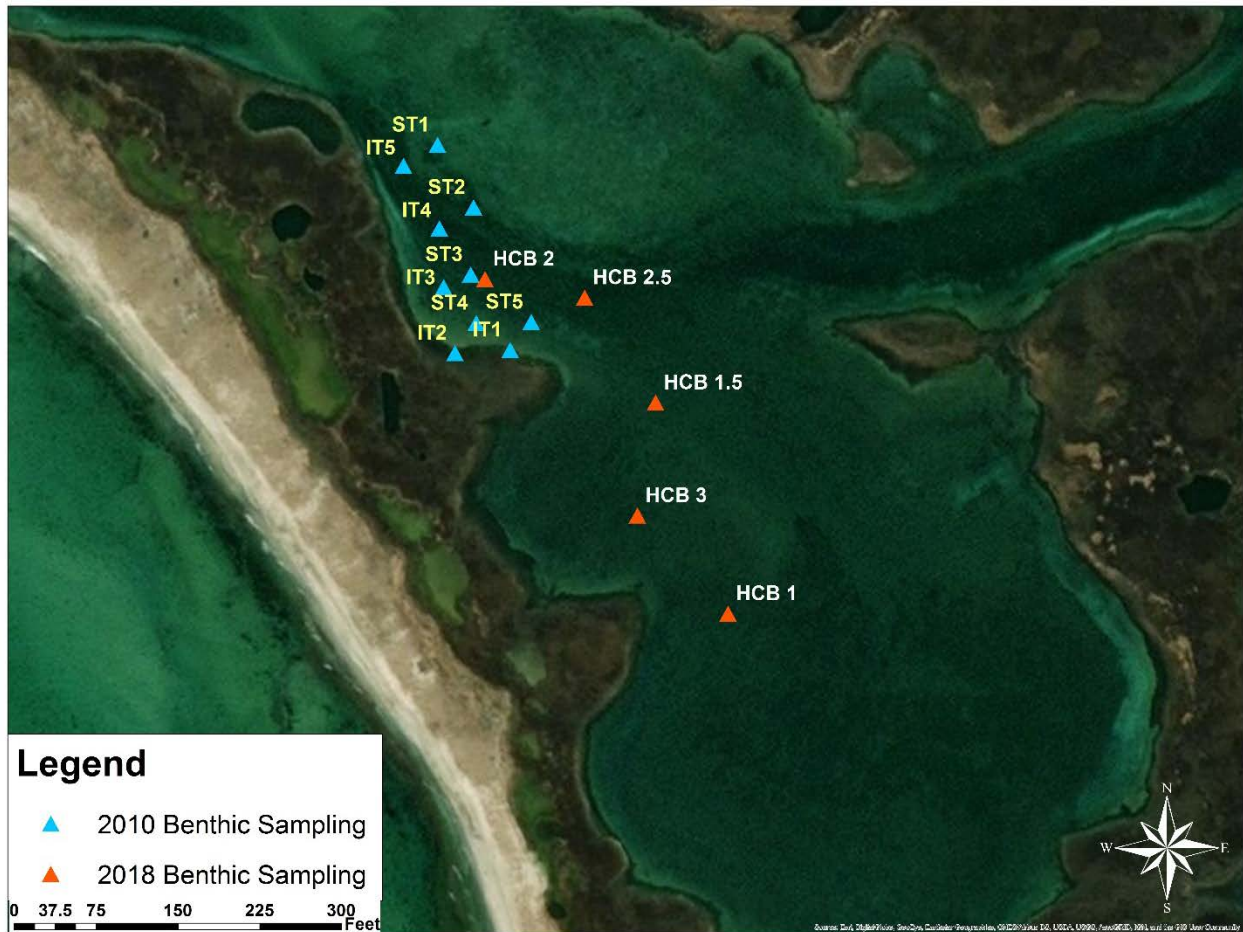
Figure 9. Year 5 Benthic invertebrate sampling locations at Hall's Creek (reference site).

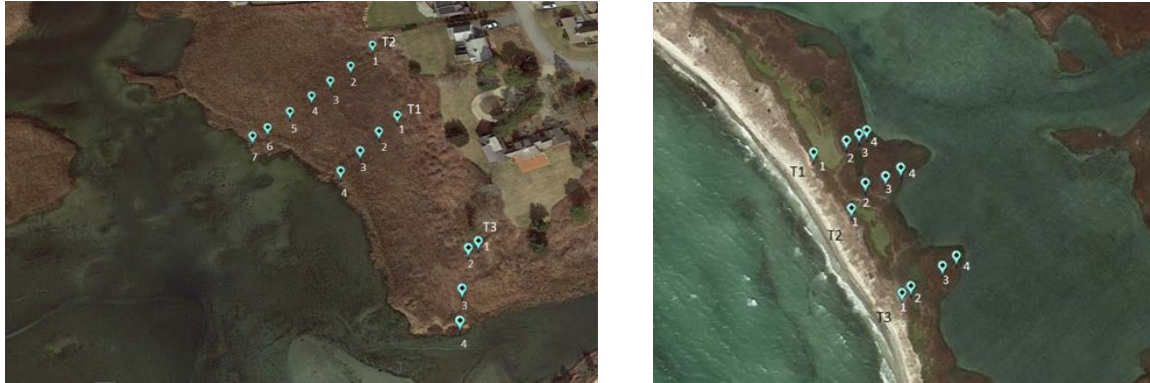
Figure 1. Location of vegetation sample points in Stewarts and Halls Creeks. Stewarts (left panel), Halls (right panel), T# = transect number, and number = points. Each point had three vegetation plots associated with it.

As in 2015, three transects were established on marshes at both Stewarts Creek and Halls Creek (reference site). The 2018 transects started at about the same locations as transects sampled 2015 (within 1 m), but stations (points) along the transects were close, but not the same as points sampled in 2015. Nonetheless, both the 2015 and 2018 transects provide a detailed overview of the vegetation from the upper part of the marsh to the creek/marsh interface.

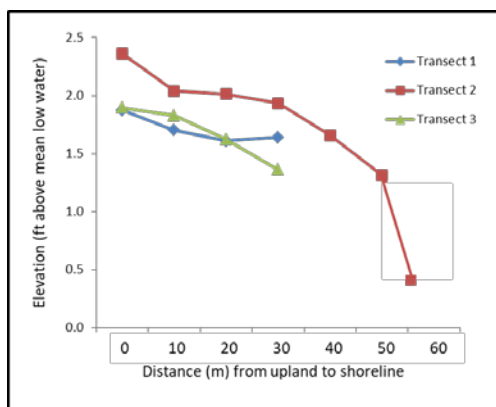
Results. Marsh surface elevations in Stewarts Creek gradually declined from stations nearest the upland to the creek edge (Figure 2). During two tidal phases in August, neap (8/17/18) and spring (8/24/18), none of the stations had water flooding the marsh surface, except during high neap tide for Stations S6 (+2.5 cm) and S7 (+9.3 cm) of Transect 2 (**Table 1**). At spring high tide, water elevation was at the marsh surface (0.0 cm) at Station 7 of Transect 2 (**Table 2**). At stations nearest the upland border, water was 7.8–12.0 cm below the marsh surface during spring high tide and 2.0–6.3 cm below the marsh surface at high neap tide. Water level in stations nearest the marsh/creek interface seemed to respond most closely to tidal fluctuations in Stewarts Creek, but tides belowground in the marsh interior were more muted and lagged behind tides in the creek. Surprisingly, belowground water levels in the marsh near the upland border were higher at low tides than at high tides, possibly because (1) groundwater is being discharged to the surface of the marsh near the break in slope at the upland border and (2) tidal fluctuations in the marsh furthest from the creek (at the upland border) lag behind tidal fluctuations in the creek at the marsh/estuary interface.

Figure 2. Marsh surface elevation at Stewarts Creek stations along the three transects.

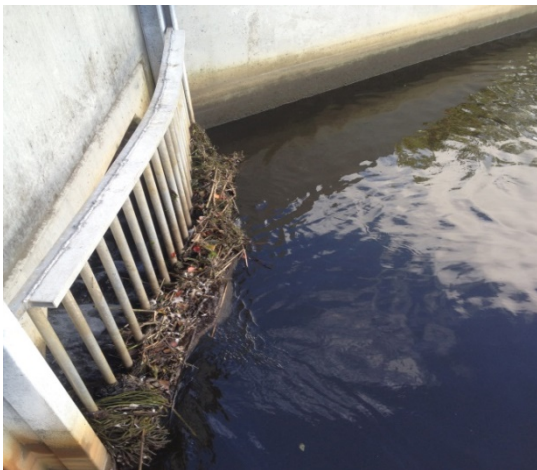
The chosen model would have identified a particular opening (dimension) that was an optimal compromise between flooding the marsh and avoiding the flooding of private infrastructure. However, It is conceivable that the culvert dimension chosen by the model (or based on an iterative series of run models) identified culvert dimension properly, but that grating (**Figure 3**) on the upstream end of the culvert was added by project designers (or insisted upon by managers) as a safety precaution¹², but without considering its potential effect on tidal exchange. The grating has 13 bars (each 1.75" in diameter), which reduces the effective width of the culvert opening from 72" to 50" (producing a 31% narrower opening). The grating also collects wrack during ebb flows, which would further reduce the amount of potential tidal flushing. This constriction in the culvert opening (by the grate and wrack) would reduce the amount of tidal flushing that could potentially occur, likely enough to fail to meet flooding expectations (predictions). Tidal flushing could be improved by more frequently removing wrack that accumulates on the upstream side of the culvert opening, but the biggest improvement could be obtained by removing the grating altogether and using other infrastructure (outside the channel) to make it difficult for people to access the culvert opening from shore.

Figure 3. Wrack collecting on grates on the upstream side of the new culvert under Stewarts Creek during ebb flow.

¹² Presumably, the grate is there to prevent people who waded too closely to the culvert from getting sucked into it during strong ebb flows.
