# Adult Community Center

## Town of Barnstable ADA Transition Plan

August 2021

Institute for Human Centered Design

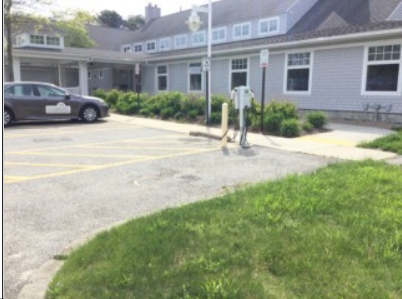
ID	Location	Floor	Room	Element	Type	Photo	Issues	Current Measure	Recommendations	Quantity	Price	Cost Estimation
<b>Approach and Entrance</b>												
<b>Exterior Access Route</b>												
1	Electric Parking Near Main Entrance	Ext.		Exterior Access Route	Exterior

Relocate EV parking space so the route to the building is not blocked if a car is parked there.	1	Labor	\$0
2	Garden	Ext.		Exterior Access Route	Walkway

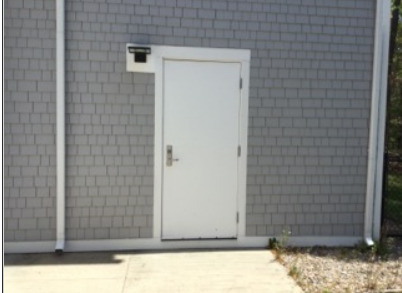
Directional sign to accessible emergency exit not provided	-	Provide a directional sign indicating the location of the nearest accessible entrance.	1	232	\$232

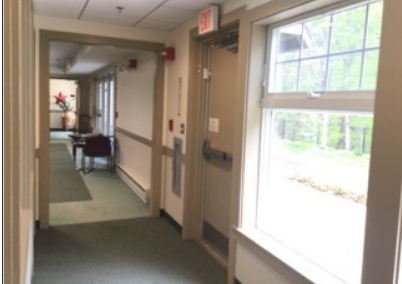
Tactile exit sign not provided Illuminated ISA symbol not provided (MAAB)	- -	Ensure a tactile exit sign with raised characters and braille is provided at exit door. Mount sign between 48"- 60" above the finished floor located on the latch side of the door. Provide an illuminated sign with the International Symbol of Accessibility.	1	432	\$432

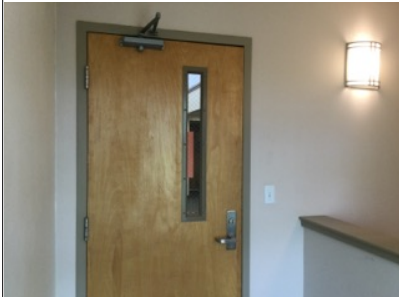
Floor level designation not provided	-	Provide a sign on the interior of the stairway enclosure indicating the floor level.	1	232	\$232
23	Exit Near Stair	1		Means of Egress	N/A

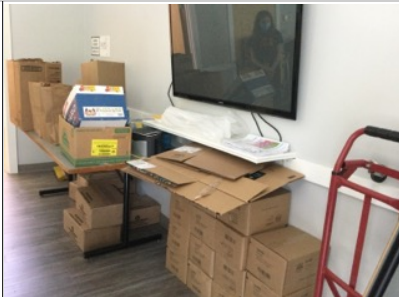
<b>Interior Access Route</b>												
24	Art Room	2		Interior Access Route	N/A

Obstructed by protruding objects	11"	Relocate shelf so it does not protrude into the circulation path.	1	Labor	\$0
25	Stair	1		Interior Access Route	N/A

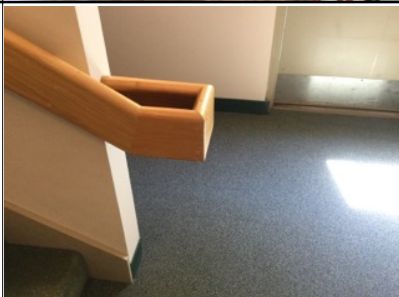
Obstructed by protruding objects	11.5"	Provide a cane-detectable barrier under the portion of the handrail that protrudes.	1	217	\$217

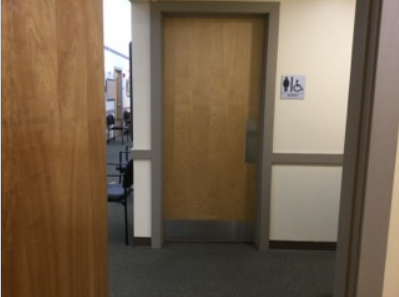
Door requires > 5 lbs. of force to open	11 lbs.	Adjust closers so doors do not require more than 5 pounds of force to open.	1	Labor	\$0
38	Exercise Room	1		Doors, Doorways, & Gates	Emergency Egress

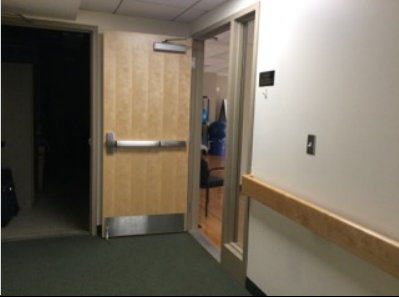
Door requires > 5 lbs. of force to open	20 lbs.	Adjust closers so doors do not require more than 5 pounds of force to open.	1	Labor	\$0
39	Men's Toilet Room	1		Doors, Doorways, & Gates	Toilet Room

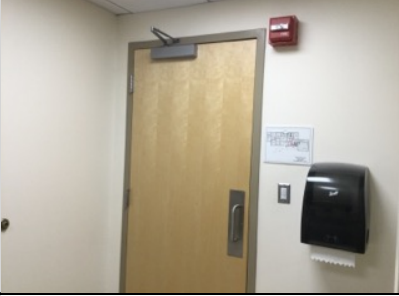
Door requires > 5 lbs. of force to open	14 lbs.	Adjust closers so doors do not require more than 5 pounds of force to open.	1	Labor	\$0

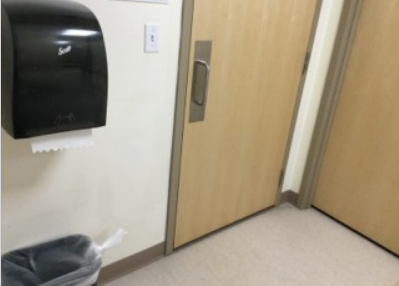
40	Women's Toilet Room	1		Doors, Doorways, & Gates	Toilet Room

Door requires > 5 lbs. of force to open	10 lbs.	Adjust closers so doors do not require more than 5 pounds of force to open.	1	Labor	\$0

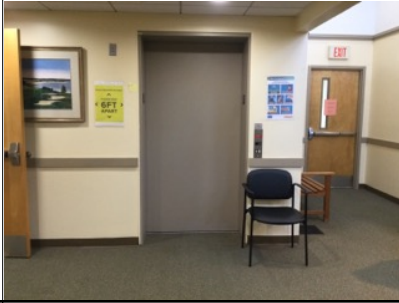
Remove chair to maintain the clear floor space at the elevator call buttons.	1	Labor	\$0
45	Elevator	1		Elevator	Interior

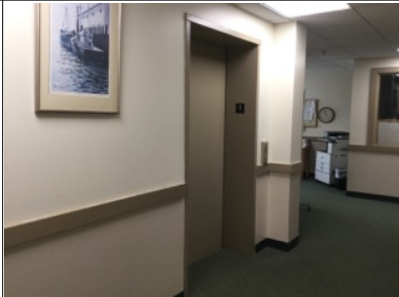
Visible or audible hall signals not provided	-	Note: Visible hall signals were not required before 2010 in existing elevators. When renovation occurs, install visible hall signals.	1	-	\$0

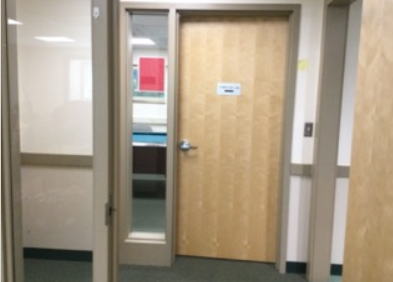
Raised characters not provided on sign Sign not located on the latch side of the door	- -	Provide text with raised characters duplicated in braille on sign. Locate sign alongside the door on the latch side.  Ensure the sign reflects the actual use of the room.	1	232	\$232

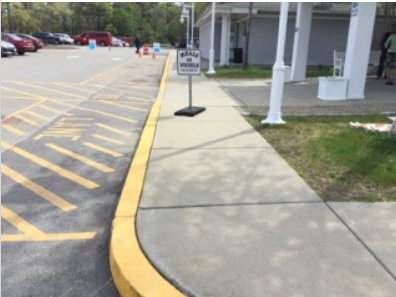
Visual characters < 40" above ground	27.5"	Mount visual sign so that the baseline of the lowest character is 40" min. above the finished floor.	1	Labor	\$0
53	To Multi - Purpose Rooms	2		Signage	Designation

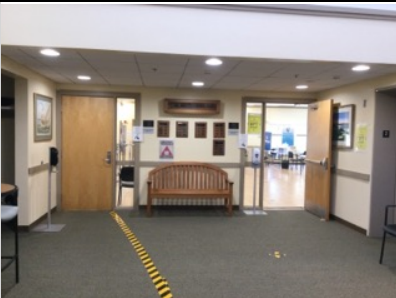
Sign lacks 18" min. by 18" min. clear floor space	-	Relocate bench to ensure there is 18" min. by 18" min. clear floor space centered on the sign.	1	Labor	\$0
<b>Service Counter</b>												
54	Reception Desk	2		Service Counter	N/A

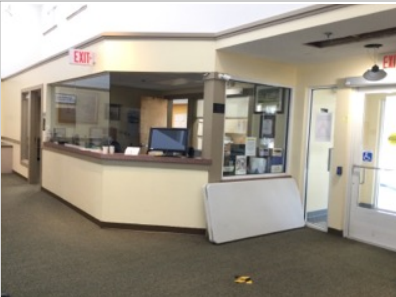
Counter > 36" high	41.75"	Provide a counter that is 36" max. above the ground or finished floor.	1	880	\$880

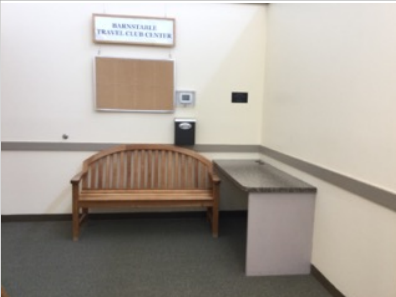
<b>Operable Parts</b>												
55	Near Art Room	2		Operable Parts	Other

Clear floor space is not provided	-	Relocate bench to maintain a 30: by 48" clear floor space at the mail drop off user feedback.	1	Labor	\$0

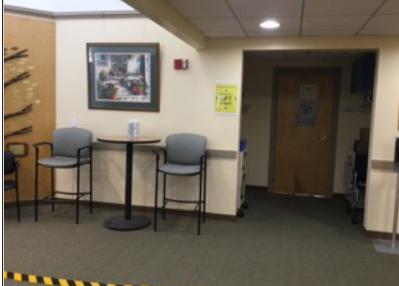
60	To Closet Near Multipurpose Rooms	2		Dining or Work Surfaces	Work Surface

Top of dining/work surface < 28" or > 34"	42.5"	Provide at least one work surface with top between 28"- 34" above the floor and 27" clear height underneath.	1	700	\$700

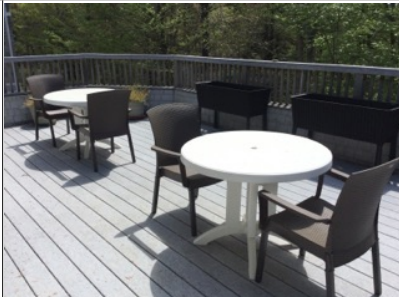
<b>Picnic Tables</b>												
65	Deck	2		Picnic Tables	N/A

Toe or knee clearance at tables not provided	-	Provide at least 1 dining surface (or ensure that 5% of dining surfaces) have toe and knee clearance.	1	1400	\$1400

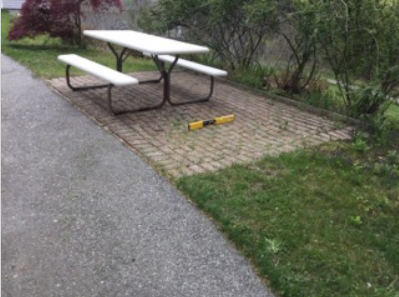
Toe or knee clearance at tables not provided	11.5"	Provide one picnic table with 19" min. clear space under the table for knee clearance.	1	1400	\$1400
<b>Exterior Benches</b>												
68	Bench - Right of Main Entrance/Exit	Ext.		Exterior Benches	N/A

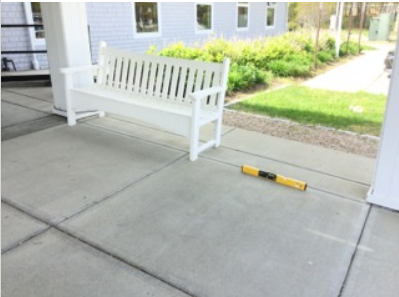
Cross slope > 1:50 (2.00%)	7.2%	Reduce cross slope to be no steeper than 1:50 (2.00%).	1	-	\$0
69	Bench - Left of Main Entrance/Exit	Ext.		Exterior Benches	N/A

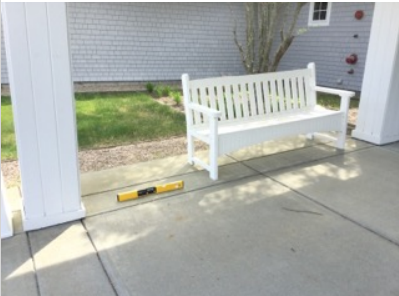
Cross slope > 1:50 (2.00%)	5.8%	Reduce cross slope to be no steeper than 1:50 (2.00%).	1	-	\$0
<b>Toilet &amp; Bathing Rooms</b>

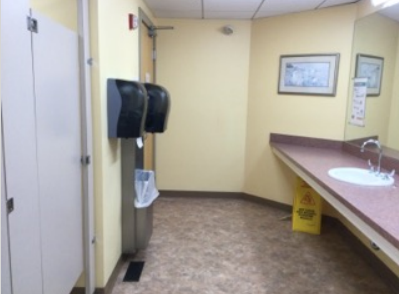
Dispenser acts as a protruding object	14"	Relocate dispenser out of the circulation path.	2	256	\$512

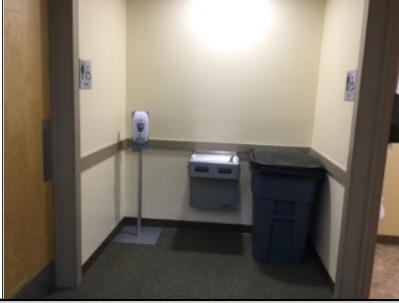
No drinking fountain provided for standing users	-	Provide an additional drinking fountain for standing users or install a Hi-Lo drinking fountain.	1	4028	\$4028
<b>Sink</b>												
84	Art Room	2		Sink	N/A

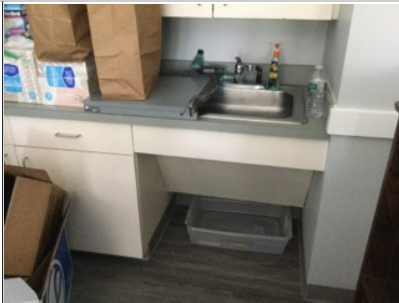
Toe and knee clearances not provided	-	Remove plastic container to maintain the required toe clearance.	1	Labor	\$0
85	Special Needs Room	1		Sink	Kitchenette
